# Moisture Problems in the Maritimes

by David Scott

Over the past few years, a number of field visits have been made to investigate moisture damage to wood-frame housing in Atlantic Canada.

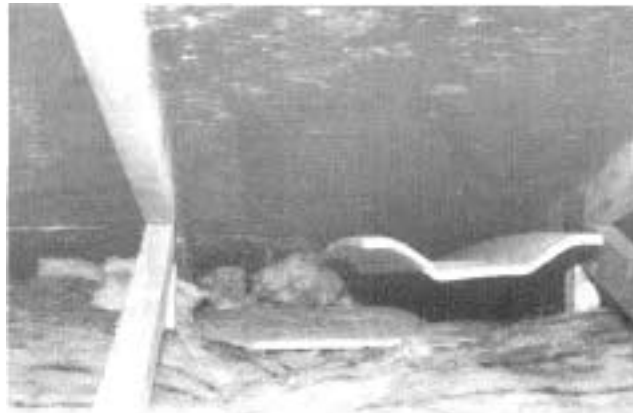
An inspection of the roof in March 1984 showed that all asphalt shingles were in place and appropriately tabbed down. The flashings around the roof caps for bath and kitchen exhaust fans were well sealed. The attic hatch was weatherstripped and the fiberglass batts were installed uniformly. Yet the waferboard roof sheathing had turned black with mold, and was saturated in the area immediately above the bathroom and common plumbing wall with the

Saturated roof sheathing blackened by mold and beginning to sag.

Several clear paths had now been discovered for moisture-laden air to leak from the kitchen into the attic (see diagram). After entering the attic, the moist air would rise until it hit the cold sheathing, where frost would form and melt to become "attic rain" during mild weather.

The builder sealed off the air-leakage paths and installed a hatch to the plumbing chase. The remaining wet sheathing dried within a week. The home owner was encouraged to eliminate indoor clothes drying and to use exhaust fans more often to reduce the relative humidity to a level of about 40 percent.

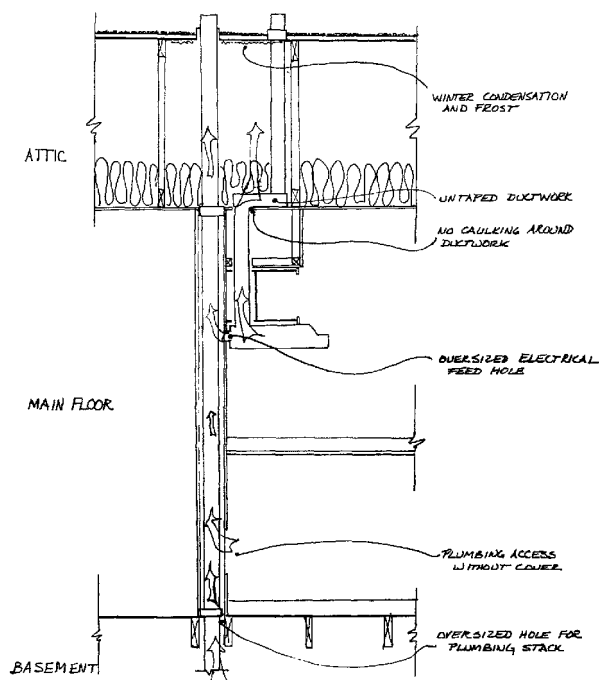
By the second week, the roof sheathing was still wet above the plumbing wall, so the researchers looked for other air-leakage sources. The kitchen range hood and cabinet were removed, exposing a large gap between the drop ceiling and range-hood duct. When the duct was removed, additional air leaks were discovered at the plumbing stack and through several holes drilled in the top plate. These holes to the attic were connected with an uncovered plumbing-access hatch located behind the kitchen cabinet next to the stove. A further check in the attic revealed untaped ductwork.

Vertical section of the air-leakage paths.

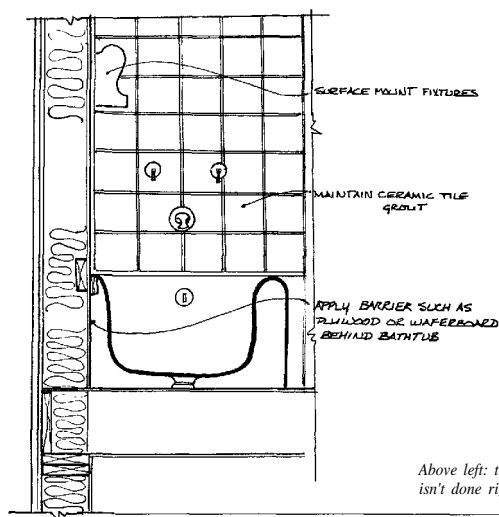
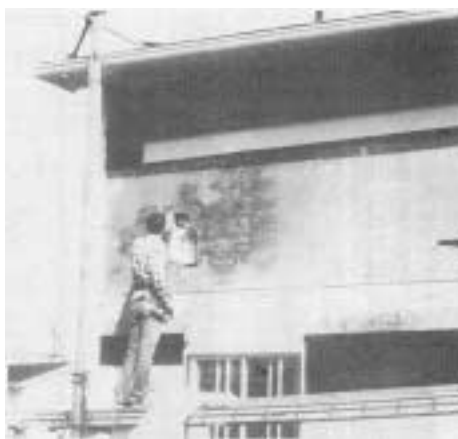
The moisture content of the plywood was about 15 percent across most of the wall, increasing to 30 percent in the center of the dark patches behind the soap dish. The researchers cut away the sheathing behind the soap dish and removed the friction-fit insulation. They discovered that the polyethylene vapor barrier had been cut to install the soap dish and a substantial amount of mildew and moisture had accumulated between the poly and the gypsum drywall.

The wall vapor barrier stopped at the rim of the bathtub, leaving friction-fit fiberglass insulation exposed to the area under the tub. Since the home owners noted that the soap dish had been loose for some time, it is difficult to assess the relative moisture contributions from water leakage during showers, air leakage at the soap dish, and diffusion and air leakage through the open area below the tub. These factors did, however, combine to overcome the natural drying potential of the wall in the area immediately around the bathtub. The remainder of the sheathing in the two houses was sound.

Above left: the right way to enclose a bathtub. Right: what can happen when it isn't done right.

These houses were built according to standard practice at the time. The plumber routinely roughs in the bathtub before the insulation is installed, which makes insulating below the tub difficult, and installing an air/vapor barrier there impossible. One approach is to install a barrier, such as a single sheet of plywood or waferboard, below the tub rim before the tub is installed. This reduces moisture buildup within the wall by limiting airflow and vapor diffusion into the wall cavity.

In addition, the movement of moisture through deteriorating ceramic-tile grout and at fixtures, such as soap dishes, set through the gypsum drywall is almost inevitable if the wall isn't carefully maintained. Surface-mounted fixtures at least allow the polyethylene and drywall to remain uncut, which will help to maintain air and vapor tightness.

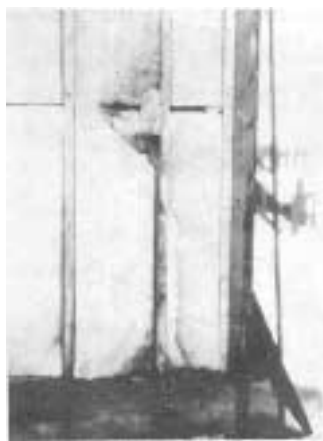
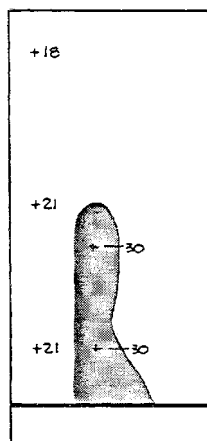
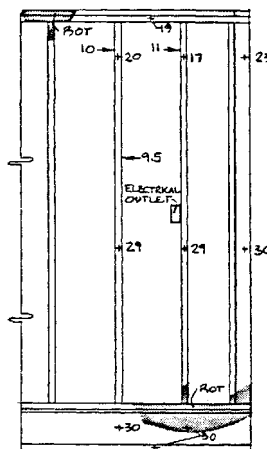
The plywood cladding on the southeast corner was removed, revealing a wet stain on the panel starting at the height of an electrical box and extending down to the plate (see photo).

Moisture-laden air apparently had leaked out through holes around and through the electrical boxes and condensed on the back of the siding. Here, water formed and ran down in a fan-shaped pattern to saturate the sill plate and header. The moisture content of the sheathing and studs varied considerably in relation to the proximity to the electrical outlet (see

Note blackened area around the electrical box. The numbers represent the moisture-content percentage of the plywood (middle) and framing (right) at that spot.

Substantial rot was found in the sill plates and headers behind the lower right- and upper left-hand corners of the panel. Both locations are below an electrical outlet (subject to air leakage) and an unflashed horizontal joint in the cladding (subject to rain leakage). The fiberglass insulation was dry, except where it was wadded in around the electrical box.
