# FINDING the FLAWS in SUPERINSULATION

*The thermal bugs in these 144 superinsulated houses were much the same as in any housing stock. So what have we learned?*

by Gary Nelson

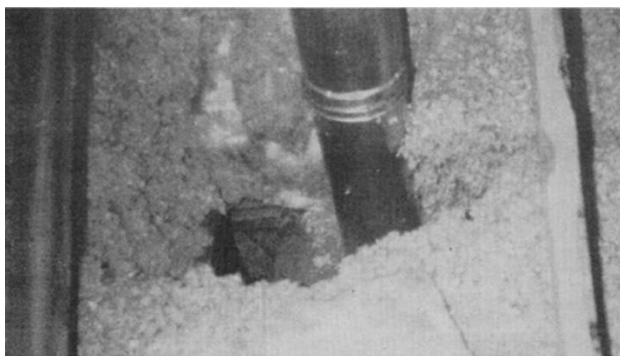
Figure 1. A chaseway for furnace and water-heater flues. The fiberglass batt used to block opening is streaked with dirt from leaking air.

As in conventional housing, we found that the largest source of air leakage was between the house and the attic. Figure 1 shows the top of a chaseway built for a gas furnace and water-heater vent. The firestop isn't large enough to seal off the top of this chaseway. The fiberglass batt that the insulator used to keep the blown insulation from falling into the chaseway is streaked with dirt that was filtered from the air that leaked through this hole. Many builders still seem to be unaware that insulation does not make an effective air barrier.

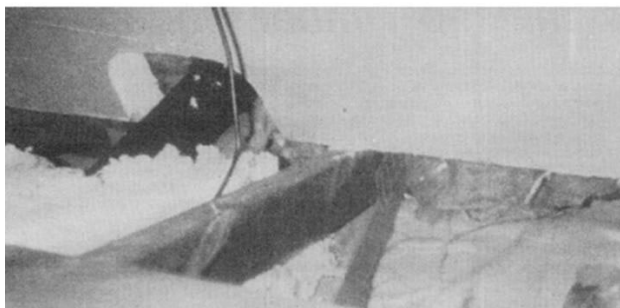
Figure 2. The top of a partition viewed from the attic of a split-level house. Note that there's no blocking atop the wall—a problem in every split-level in the study.

Figure 2, taken from the attic, shows the top half of the wall that runs down the middle of a split-level house. The wall has drywall on the attic side to protect the foam insulation from fire. The photo was taken after some blown fiberglass was removed from the area where this wall intersects the ceiling of the lower level.

Notice that there is no blocking to stop air from leaking out of the wall. Since these walls generally contain major plumbing, wiring, and duct runs, it is easy for heated air to get into the stud spaces of these walls. All split-level EEHD houses had this problem. Several houses used stud cavities in these walls for return-air ducts to draw solar-heated air from the top of the house down into a rock bed. In each of these houses, cold attic air leaked into these cavities, reducing the performance of the solar systems.

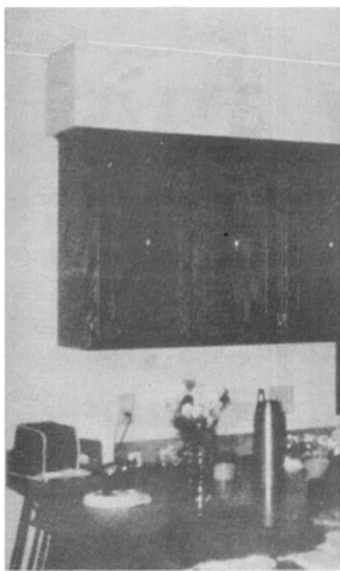
Figure 3 shows a soffit above kitchen cabinets. Figure 4 is an infrared photo of the same soffit, taken with the house depressurized. The dark soffit indicates that the soffit is cold due to attic air being drawn into the soffit. In Figure 5

**Figure 3** shows a soffit above kitchen cabinets.

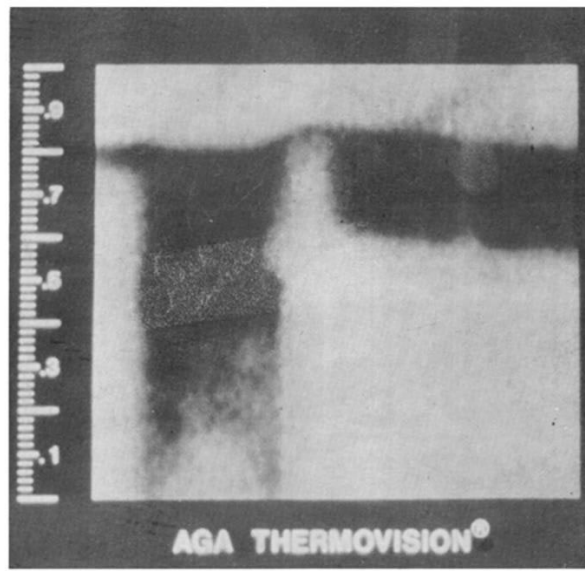
**Figure 4** (above left) is an infrared photo of the same soffit. The dark area is caused by cold air that leaked into the soffit through cracks in the attic floor shown in **Figure 5** (above right).

we see what the attic looked like just above the soffit. The pencil and knife are inserted to show the large cracks through which moist household air leaked into the attic from the soffit. The insulation directly above the soffit was darkened and moist from the leaking air and had settled.

In this house, a piece of plywood had been installed to keep attic insulation out of the soffit. Often there are just paper-faced batts stapled to the ceiling joists. And often one of these falls into the soffit, leaving a large hole between the soffit and the attic.

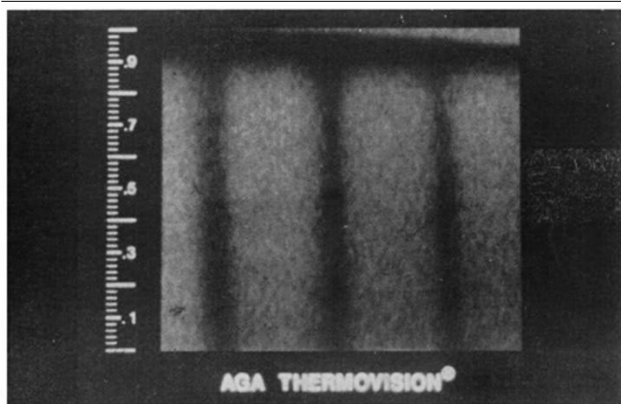
was not performing well. Figure 8 is an infrared photo of a well-insulated wall. Note that the studs appear to be uniform in temperature and width, and are clearly distinguished from the insulated cavities. The cavities appear warmer (lighter) and are also uniform in temperature. Figure 9 is an infrared photo of a wall that's not working as well. Studs are hard to distinguish because large areas of insulated cavity are as cold as the studs. Also the studs appear to get wider and colder at the bottom of the wall. The temperature at the bottom of the wall varies greatly from one cavity to another.

I've never seen these problem patterns in walls retrofitted with blown insulation. They are also uncommon in walls with paper-faced batts. All of the EEHD houses, however, were insulated with unfaced fiberglass batts. Unfaced batts are rarely installed so that they completely fill the cavities. There are usually many small airspaces between the drywall and the poly, between the poly and the batts, between the batts and the exterior sheathing, between the batts and the studs, and between the

In laboratory studies, researchers have found 50 percent reductions in the R-value of unfaced fiberglass installed vertically with air spaces on either side. The reductions were due to increased convection within the batt and within the wall cavity. This is probably what is going on in the wall in Figure 9. Most EEHD houses had some wall areas that looked good, indicating that the job can

Figure 9 shows a wall impaired by internal connection due to ill-fitting unfaced batts.

be done correctly. But unless you can persuade the insulation contractor to do a good job, I would recommend blowing insulation in after the drywall is installed, or using wet-spray cellulose blown into an open cavity.

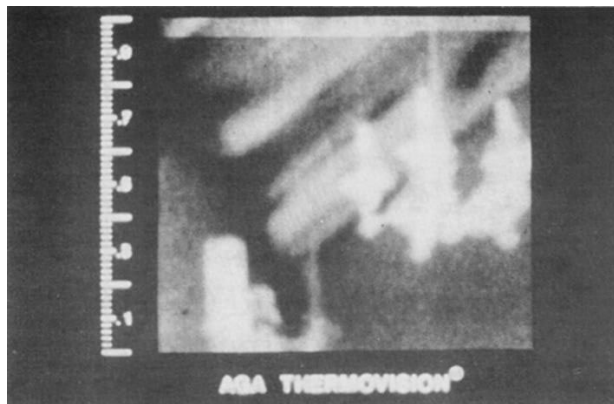
Another common insulation defect is shown in Figure 10. The photo shows a cathedral ceiling with cold streaks beginning at the bottom and extending up the ceiling. The coldest part of each streak appears at the bottom. I suspect ventilation air coming through the soffit vent is leaking between the drywall ceiling and the fiberglass batts that were installed between the trusses. No baffles were evidently installed to force air to flow over the insulation and into the ventilation space above the insulation.

Figure 10. An infrared photo of cold air chilling the lower portions of a cathedral ceiling. Combine this with high humidity and you can start a mold garden on your ceiling.
