# Straightening an Old House

by Carol U. Sisler

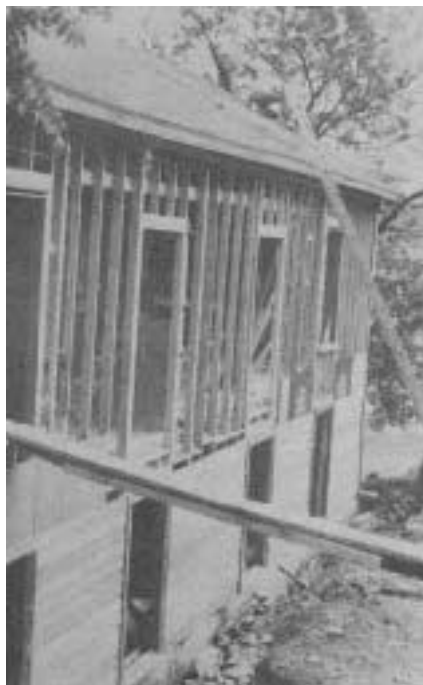
View of the east wall being reconstructed with the balloon framing.

earth which had pushed up against the east wall of the building on the first floor. The sill and posts had rotted. We provided support for the top plate and new studding for interior and exterior walling by erecting 16-foot balloon framing in eight-foot sections. This allowed the east side of the building to be lifted and supported by jacks as each frame section was erected.

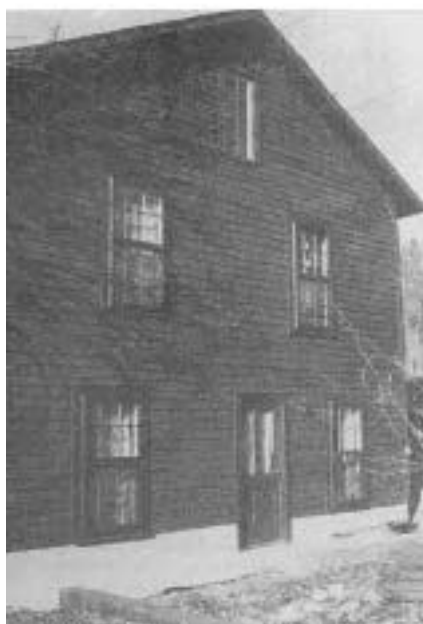
The finished product.

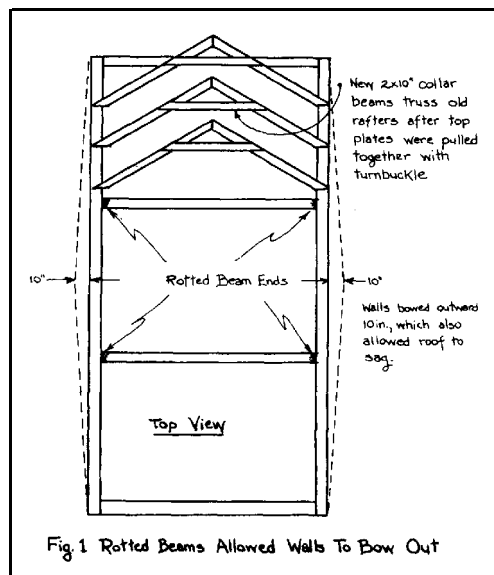
Fig. 1 Rotted Beams Allowed Walls To Bow Out

First, the old roof had leaked so long that the tenons of the beams, which acted as collar beams and which supported the second floor ceiling joists, had rotted. Also, the plates on which the rafters rested had separated from each other because of snow loads. Hence, there was a very obvious saddle in the roof. The base of the rafters in the middle of the building were 20 inches further apart than the base of the rafters at the gable ends (Figure 1).

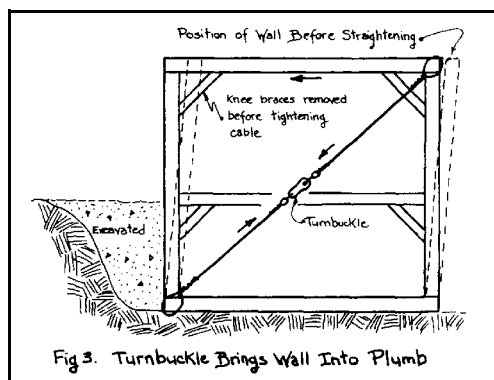
Third, the frame of the building was racked by the pressure of the earth on the east side of the building. As viewed from the gable ends, the top corners of the building stuck out 10 inches over the bottom corners. After the earth was dug away and the new east-wall frame was in place, this problem was solved by using the cable and turnbuckle again. This time the cable was attached to the top west corner and the bottom east corner. As the cable was tightened, the frame was drawn back to a rectangle (Figure 3).

All the old knee (corner) braces were removed after the cable was attached and before any attempt was made to straighten. New corner bracing, in this case ½-inch CDX plywood, was installed at the corners (as in platform-frame construction) before the cable was loosened and removed.
