# Commercial Calamities

by William Lotz

Commercial calamities can happen to anyone. Here are a few I've run into.

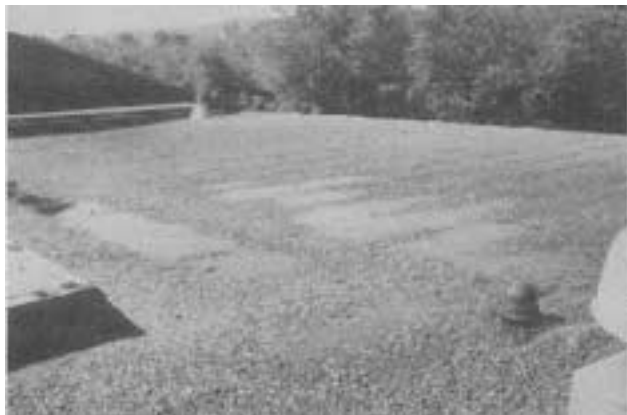
With this type of construction, there is no vapor barrier. The bagasse acts like a sponge all winter and soaks up the condensation that naturally will occur in the material. In the spring, the sun warms the BUR and vaporizes the moisture in the deck,

Damaged by winter condensation, the Tectum deck on this New Hampshire roof has sagged between the bar joists. Pounded water now collects in the depressed areas.

hence, drying it out. After 22 years, the cement-like binder holding the bagasse stalks together turned to powder, as a result of the constant wet-dry cycling. The structural deck was no longer structural. The deck panels resembled slices of baled hay. They sagged. After a rain, one panel fell out, the BUR split, and water poured into the classroom. The photo shows the ponded water on the roof where the panels sag between the bar joists.

We recommended to the School Board that they remove the existing BUR and deck and install a new steel deck, vapor barrier, tapered roof insulation, and a new single-ply roof system at a cost of \$10 per square foot. This failure demonstrates the need for a vapor barrier in the roof.
