CASE IN POINT

How I Learned to Love Balloon Framing

by Paul Hanke

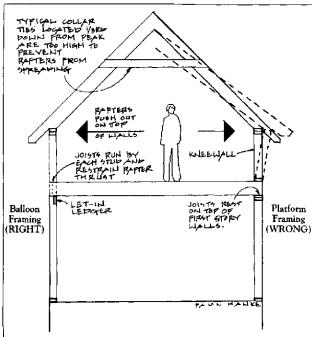
Controlling rafter thrust with balloon framing. Platform framing (shown on the right half of the diagram) allows the kneewall to act as if it were hinged at the bottom. Outward pressure from the rafters pushes the kneewall out at top, causes bowing of walls, and allows the ridge to sag. Collapse could result. Continuous studs, as in balloon framing (shown on the left) can prevent this problem.

The whole problem, of course, was caused by unrestrained outward thrust due to the pressure of the rafters leaning on each other. The situation was complicated by the fact that the kneewall acted just as if it were hinged at the bottom, which in effect it was. Normally attic joists would tie rafters together at the tops of second-floor walls and prevent the problem from occurring. In our situation, and many others which I have seen since then, such horizontal restraint is impossible, since horizontal ties would be so low that they would go directly through living space. In such cases balloon framing is the solution of first choice. A balloon-framed wall with continuous 12-foot studs from plate to plate (instead of an 8-foot wall with a

kneewall on top) would have been securely tied to the opposite wall by the second-floor joists.

After a good laugh, we turned our attention to permanently bracing the framing. With the wall more or less back to where it belonged, we simply attached a diagonal brace from the top of a stud near the center of the kneewall, running downward through the floor where we secured it to a floor list. One brace seemed to be enough, since no further movement was noticeable after we released the comealong. Fortunately an interior partition was planned for that location, so the brace would be concealed with a wall.
