# *Special Report:*

# TROUBLES

## WITH

# SYNTHETIC STUCCO

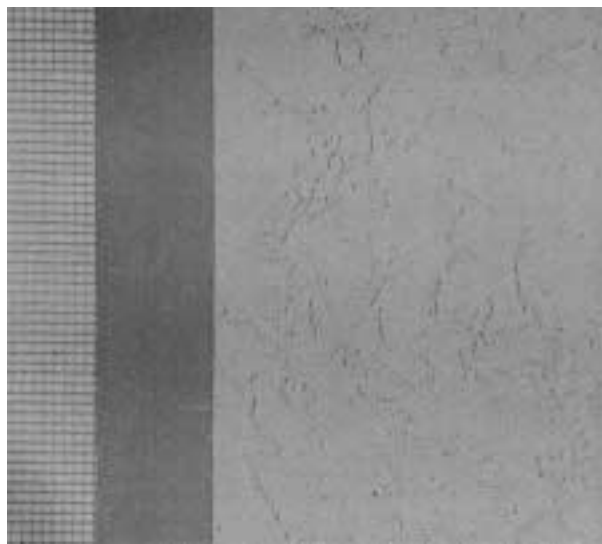
*Soft-coat synthetic-stucco systems typically consist of (from the outside in): a thin polymer-based surface coat, fiberglass mesh embedded in a base coat of portland-cement and polymer, expanded polystyrene insulation, adhesive, and substrate. The most common substrate is gypsum sheathing, which is highly vulnerable to water damage.*

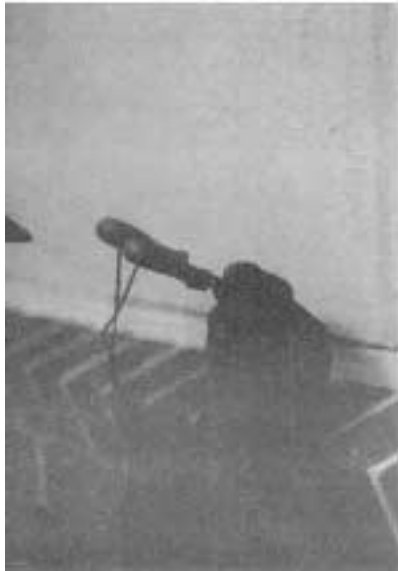
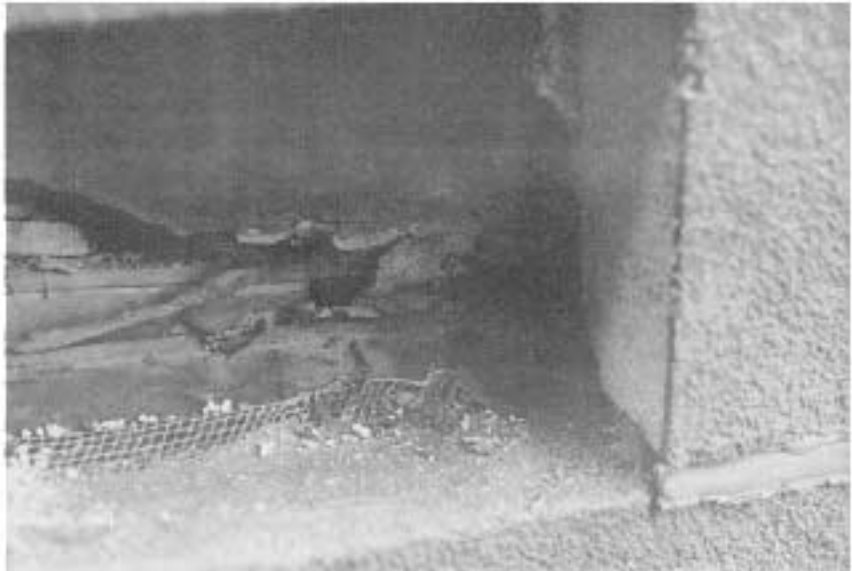
Two projects had especially large areas of delaminated sheathing where up to 80 percent of the insulation had come free of the substrate. The finish was intact and on the building, but could be moved by pushing on it. Because the reinforcing mesh is sufficiently strong, it prevented the finish from falling off the wall, even with large areas totally free. This obviously is an advantage in that it keeps a bad situa-

*This structure looked good on the outside, but moisture readings (left) indicated wet sheathing. Further investigation revealed that some buildings had large areas of damaged and delaminated sheathing (right) from water that penetrated at trucks and horizontal sealant joints.*

tion from becoming a disaster. It also illustrates one of the really disturbing facts we discovered during the investigation. The EIFS appeared to be in reasonable condition on some buildings with no complaints of leaks in the apartments. But when the test cuts were made, the gypsum sheathing was saturated, large areas delaminated, and the studs were rotting. The fact that the structure could be rotting without any obvious sign of distress is unacceptable to a building owner.

Moisture meters were used to determine the wetness of the gypsum sheathing. Most of the cracks allowed water penetration, especially wind-driven rain. The water was found to move easily through the insulation until it was trapped by a horizontal joint or between the insulation and sheathing, causing deterioration of the joints and sheathing. Moisture contents of 25 percent and greater were common. Test cuts showed that gypsum sheathing with moisture readings of over 20 percent was deteriorating and no longer had adequate strength.

There are, however, several solutions to this problem. A weather barrier such as 15# felt or Tyvek can be placed between the sheathing and the finish system. This, however, requires a system with mechanical fasteners to secure the insulation board to the studs. The weather barrier could also be placed between the studs and the sheathing. This will allow adhesive attachment while protecting the studs and interior. A third alternative, more expensive but of higher quality, is a durable sheathing material such as Durock or Wonder-Board. These materials are perhaps ideal substrates because they will not deteriorate when wet, the adhesive will not fail when wet, and they are reasonably priced. There should still be a secondary weather barrier behind them because of possible water penetration at the joints.

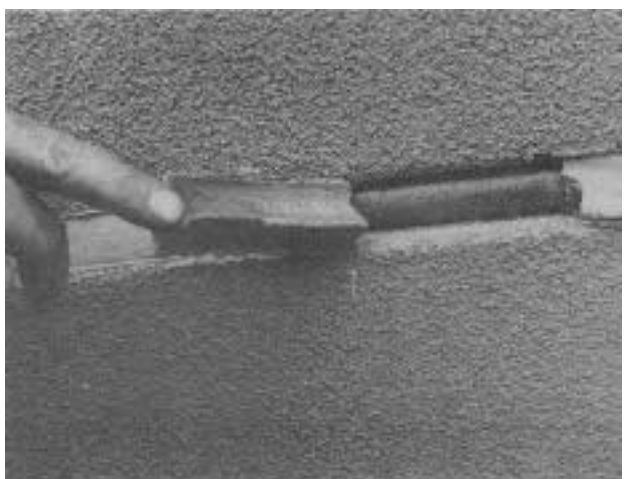
the finish coat. This is really a failure of the finish in cohesion. That is, the finish coat pulls apart with some of the finish remaining adhered to the sealant and some to the base coat. This occurred within the first year on several buildings, and is a condition that allows water to enter. The finish coats are emulsion acrylics which re-emulsify or soften when kept wet. This is not a problem on the face of a vertical wall, but can be a problem on sloped areas such as window sills. The required 6-in-12 slope is adequate to drain rain water but wet snow can stay for several days.

Repeated wetting and drying of the finish in laboratory tests and of samples at my desk reduces the time necessary to soften the finish. About an hour after placing a damp paper towel on the sample, the softened finish is easily scraped up with a finger nail. Yet the U.S. manufacturers require that the sealant be applied to this finish. The European systems require that the sealant be applied to casing beads or similar accessories.

*Many sealant failures were attributed to the fact that the sealant is applied to the finish coat, which will soften if it remains wet for a period of time. Failed horizontal sealant joints were a major source of water penetration.*

Also remember that polymer is several times more expensive than cement, because the applicator will remember this and its bearing on his profitability. Delete as many sealant joints as possible and all V joints. Inspect all of the joints and require all mesh to be completely covered with base coat. While I could not recommend that you not follow the manufacturer's specifications, if we were to use a soft-coat system again, we would caulk to the base coat—not to the finish. ■

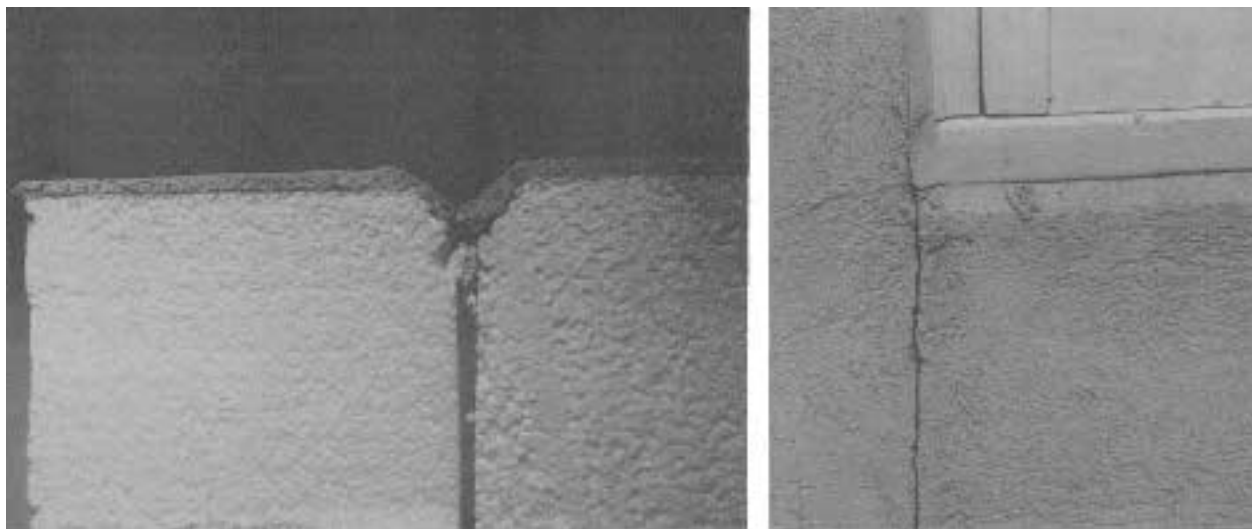
**Diagonal cracks at window corners and other large wall openings.** The diagonal mesh required by the manufacturers to reinforce the corners had not been installed on most of the projects. It should always be used because there is always stress concentration at an inside corner.

**Cracks caused by gaps between the insulation boards.** When the insulation is not tightly butted the resulting gap is partially filled with base coat. This forms a T-shaped cross section in the base coat, and because it is rigid in comparison with the flat areas of base coat, stresses are concentrated here and cracking is common. The manufacturers' literature does not adequately

**Cracks at V joints.** V joints are more rigid than the surface because of the V shape, which causes stress concentration and consequent cracking at the base of the V. These joints tend to "hinge" open when the surface is in tension. V joints are not allowed in Europe, but are commonly used here to limit the area in which the applicator must maintain a wet edge when applying the finish coat. Joints are frequently located at window jambs and heads, which is where insulation board joints also occur. When one or two V joints meet at a window corner the diagonal mesh is virtually impossible to install, and cracks are all but guaranteed. The manufacturers may require the diagonal mesh, but they also allow details that prevent its use.

V-joints are likely to crack—particularly where they fall over insulation joints (left). The gaps between insulation boards are caused by adhesive that gets squeezed between the boards. Window corners are also vulnerable to cracking (right) unless extra reinforcing mesh is used as recommended. It was missing in most of the buildings studied.

earlier. Make sure that there are no gaps between insulation boards. If you can see it or put a credit card in it, it is too wide and could cause a crack. Adequate base-coat thickness and total embedment of the mesh is imperative. A second application is the only sure way of getting enough base to provide good strength.
