Flash and Caulk

by William Lotz

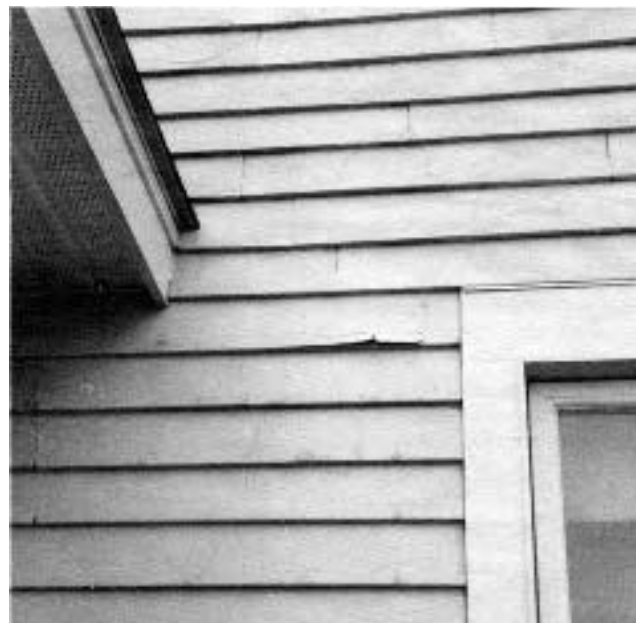
Figure 3. Where this roof and wall meet, the flashing leaked, and water saturated the clapboards, causing the paint to peel.

Finally, the architect on this project had designed a variety of "interesting" intersections of roofs and wall cavities. The flashing was either forgotten or poorly done, and as a result, the clapboards under these areas were saturated and the paint was peeling (see Figure 3). By the end of the year, the contractor will have spent \$250,000 repairing the problems with the vapor barrier and the flashing on this project.

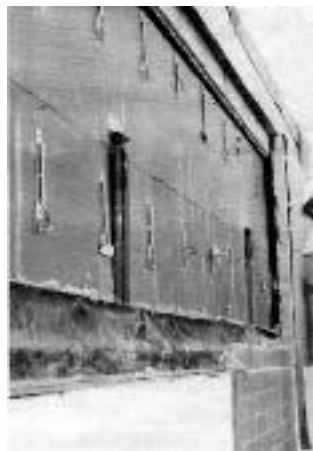
Let's review a few cases. Recently, I was called to look at a water problem at a hospital in the Midwest. The exterior wall was brick. Behind the brick there was a small air gap. Then came a layer of gypsum, 6 inches of insulation, and, finally, foil-backed drywall. The problem was that the gypsum and insulation were soaked, and water was sweeping through to the drywall.

large quantities of water had poured into the cavity between the gypsum sheathing and the brick exterior. The builder had intended to install elastomeric flashing at each floor level to channel rain penetration out through the weep holes. But the flashing installation was sloppy and water was everywhere inside the wall cavity.

Figure 1. Elastomeric flashing was supposed to channel rain penetration out through weep holes in the brick veneer. But the flashing installation was sloppy and water was everywhere inside the wall cavity.

Now 100,000 square feet of brick exterior is being removed to retrofit a vapor barrier (see Figure 1). This case turned into a \$4 million dollar lawsuit; it is still in litigation.

It is especially important to install flashing with meticulous care when it is in an inaccessible location. The retrofit on this hospital will use the same flashing principle, but the flashing will not be elastomeric. Rather, they will use a flashing laminated from copper, glass-fiber, and kraft paper. The laminate has a thin layer of copper on the wet side, for durability. The other side of the flashing, the dry side, has a glass-fiber-reinforced kraft paper that gives it tensile strength and puncture resistance.

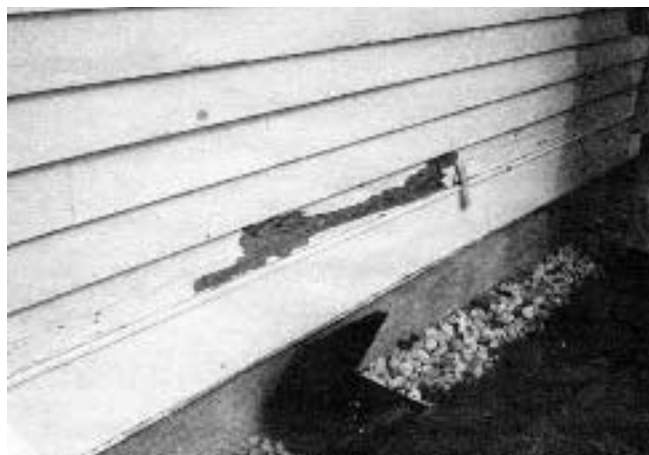
The second case involves an apartment building in Portland, Maine. The building was only two years old, but the paint was peeled off from the clapboard in sheets. After taking over 1,000 readings for moisture and examining a few wall sections we cut out with a chain saw, we concluded that there were three causes for the peeling. First, the electricians had cut holes in the poly vapor barrier, allowing inside moisture to get in behind the wall. Second, the occupants weren't using their bath-exhaust fans (the fans were cheap and noisy). Third, the flashing was poor in three crucial areas: where the balconies were attached to the house, where the roof and walls intersected, and all along the sill trim board (see Figure 2).

Figure 2. The flashing above the trim board was tilted inward causing the bottom clapboard to be constantly wet.
