Framing & Truss Troubles

by Michael Lennon

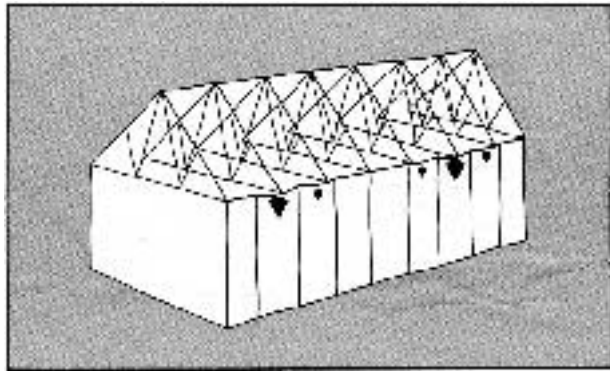
On some jobs we've seen trusses set 24 inches on-center on single top plates between studs - causing a sag.

Elsewhere, partitions with single top plates bore the ends of trusses set at 24 inches on-center. The top plate was sagging under the weight wherever the load was not applied directly over a stud.
