Rising Damp Dilemmas

by Michael Lennon

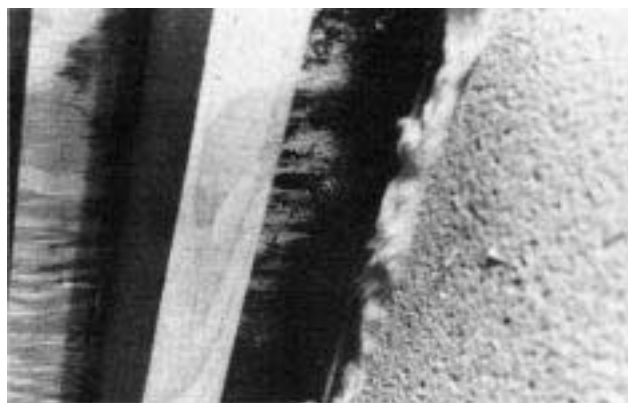
Condensed moisture rotted the floor sheathing in the band joist area of this Virginia crawl space. The rest of the floor sheathing, as well as the band joists, was unaffected.

My glasses fogged when I entered the crawl space and water pipes were dripping wet. But worse, about 4 inches of floor sheathing between the first inboard joist and the outside wall was blackened and wet. This was difficult to see unless you looked straight up from against the foundation wall. Much more moisture was moving up out of the soil than one would have guessed from its appearance. The need for ventilation and a ground cover was confirmed. The moisture had wetted the floor sheathing only in the cavity formed by the last joist. Although the soil moisture had diffused throughout the crawl-space air, only the cold portions of the perimeter condensed it out. I was shocked at the advanced state of wood rot in such a short period of time.

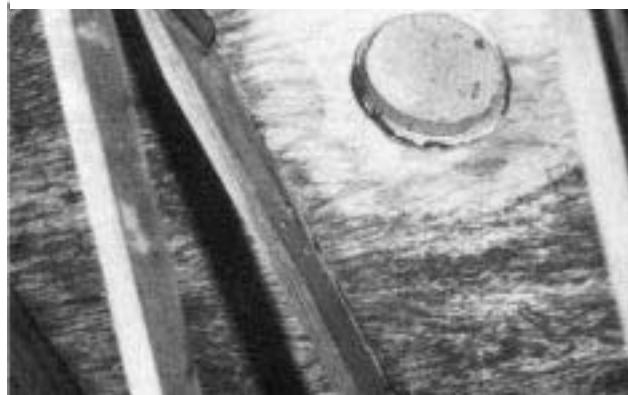
Basement moisture rose to the attic and condensed on the underside of the roof sheathing, causing black mold. The scuttle-type roof vent succeeded in protecting an area about one foot in diameter.
