# FOUNDATION CATASTROPHES: CAUSES & CURES

Skimping on the  
foundation  
can expose the homeowner  
—and yourself— to a  
whopping repair bill

by Thomas Florence  
and  
J. Stephen Gregory

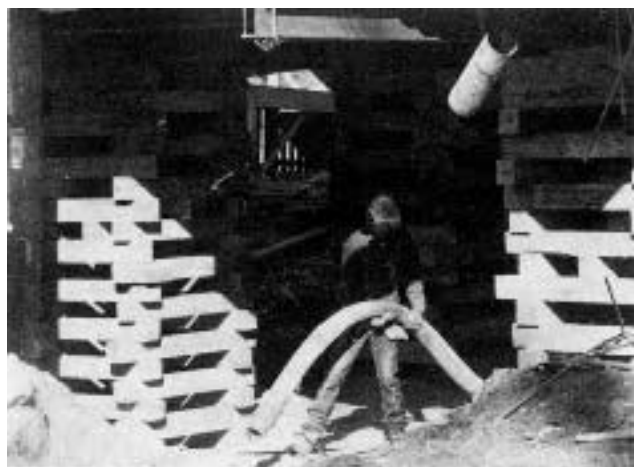
After this house was jacked up and supported with cribbing, a worker pumps in concrete for new footings. Repairing a failed foundation can cost a hundred times what it would have cost to do it right the first time.

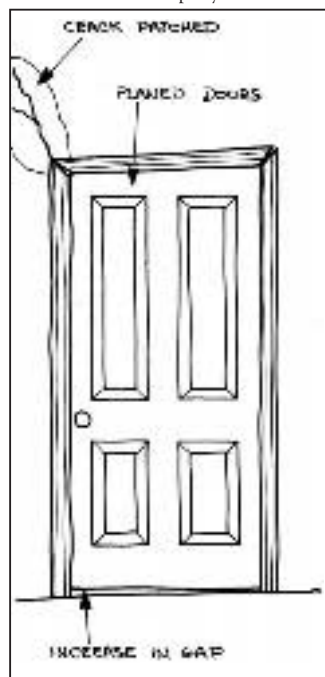
Upon inspection, we found a cracked foundation and extensive reflected damage throughout the house: cracked plaster, sticking doors, and trim separa-

tion (see Figure 1). From experience we knew these symptoms meant that the foundation and center supports were settling at different rates, probably as a result of bad soil conditions, cracked footings, and clay backfill around the foundation. OTL established a benchmark that later confirmed the house was settling under the Lally columns at about 1/8 inch per month — or 1 inch per year. Since the

Figure 1. A failed foundation radiates reflected damage throughout the house — such as separated trim, gaps in the threshold and sticking door.

Lally-column pads supported 50 percent of the load of this structure, their failure was causing most of the damage.

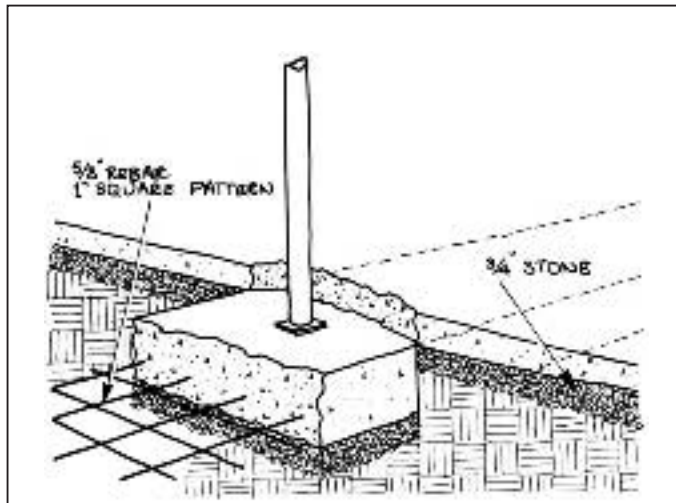
Figure 2. A ground beam supports the Lally columns and significantly reduces the potential for settling by dispersing the load over a large area.

**Phase five: Lallys and floor.** After the concrete from the first pour had cured, the six 3 1/2-inch Lally columns were cut to fit snugly into place under the carrying timber and placed on plates on the new ground beam. The structure was jacked slightly to release the load from the cribbing, which was carefully removed, section by section, and the ground beam was loaded. Now that the house rested on the Lally columns and new ground beam, work could begin on the floor. First, the oil tank, the furnace, and the remainder of the floor were removed. Trenches were dug for 8-inch furnace and oil tank pads (this meant excavating 12 inches

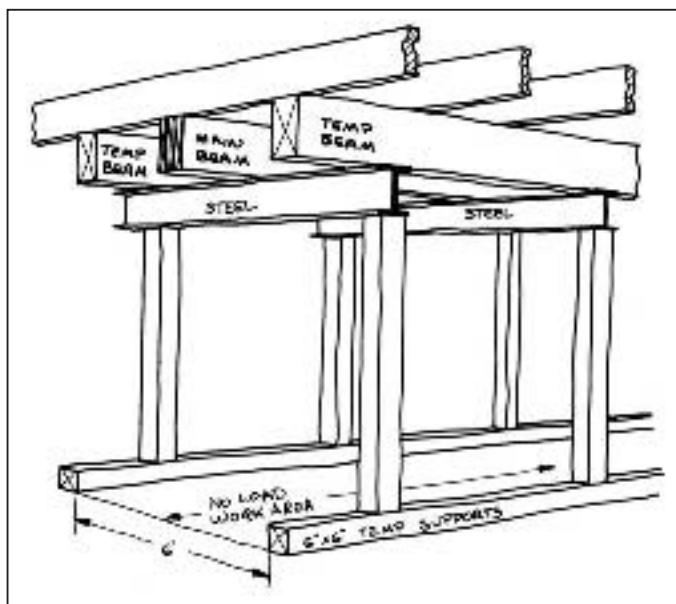
Figure 3. Two temporary carrying beams run parallel to the main beam and distribute stress and load during jacking and cribbing.

We installed the cribbing by running two 44-foot temporary steel beams parallel to the existing basement center beam. Other steel beams were placed at 90 degrees to the temporary timbers to support the center carrying timber (see Figure 3). Once the building was shored, jacking started. The owner was thrilled to find that doors worked, cracked closed, and the house felt solid as a rock.

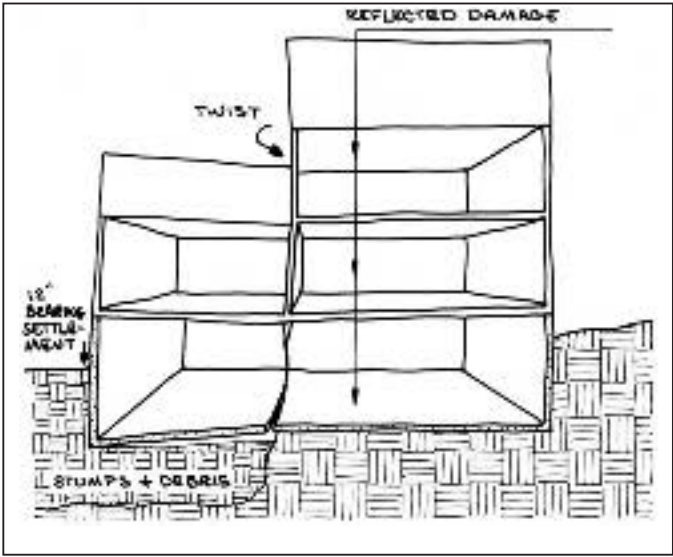
In 1986 when the town installed a catch basin in front of the house to correct a rainwater run-off problem, the owners soon complained that the town should pay for accelerated settling caused by the catch basin. But the soils engineer they retained disagreed. He said the settling was caused by an 8-inch-thick layer of decomposing logs and stumps 2 feet below the surface, dumped near the house and filled over prior to the construction (see Figure 4).

**Phase three: excavation and demolition of the foundation.** When we excavated we found partially decomposed squarely sawn 3-foot logs 8 inches under the lower half of the structure. The builder apparently stuck them in for fill and took no precautions against settling. The foundation literally fell apart of its own accord. We easily topped 20-foot sections of the wall, and broke them up with a jack hammer.

Figure 4. Excavation revealed 3-foot sawn logs under the part of the house that dropped 12 inches. The owners adjusted the settling by sawing the legs of furniture and cooking in deeper pots.

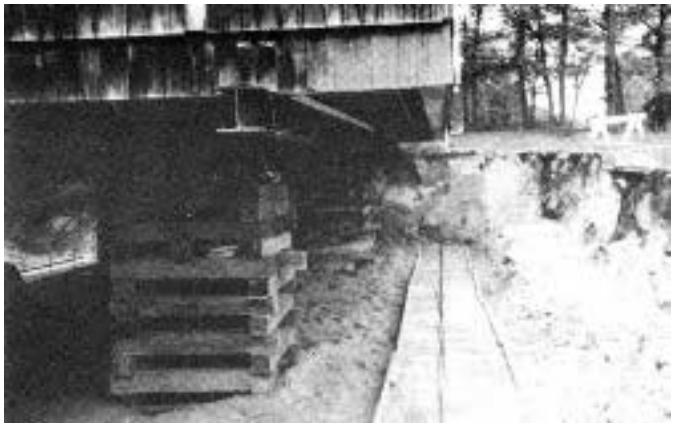
Figure 5. After jacking, the house was cribbed and continuous footing poured. The vertical #4 rebar will be wired to corresponding rebar in the block wall.

**Phase four: installing the footings and foundation walls.** We hauled away the debris and prepped the area for footings. The footings and 3-foot square, 12-inch deep Lally column pads were formed. Even wider, doubly reinforced footings were formed where the most settling had occurred. Rebar was installed in one-foot grids, with vertical rods placed every 3 feet. 4,000-psi mix was poured. A concrete-cored, reinforced-block wall was built with Durawell-steel lattice every other course for lateral reinforcement (see Figures 5&6). Corresponding to the rebar in the footings, we placed #4 rebar every 3 feet and wired it.

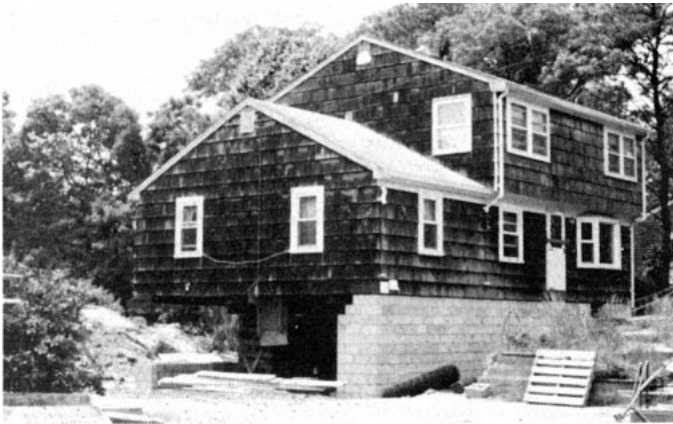
Figure 6. A concrete-cored reinforced block wall was built with Durawell-steel lattice every other course for lateral reinforcement. After the wall was in place, the house was lowered; cribbing and jacks were removed.
