Wet Sills and Rotten Posts Radiate Damage

by John Leeke

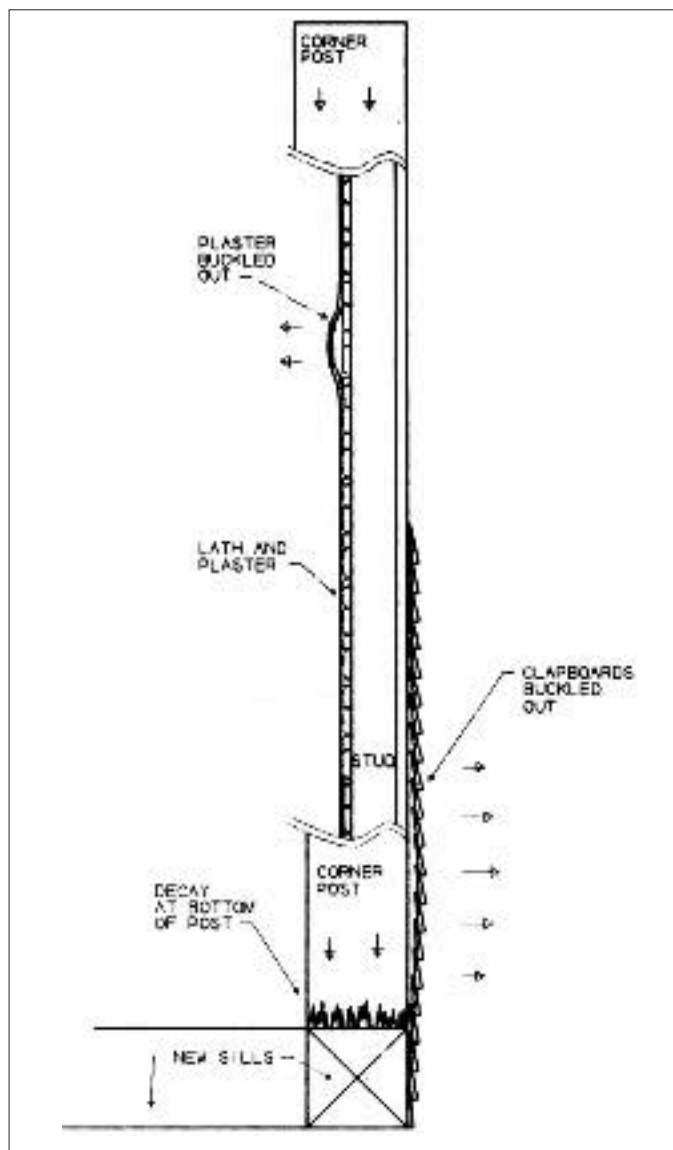
The owner of an 1830s timber-framed cape-style house was concerned about an unusual bulge in the plaster near the corner of an exterior wall. The plaster bowed out from the surface of the wall in a horizontal area 6 inches high and 5 feet long. It bowed out from the flat surface of the wall about 1 1/2 inches.

The plaster had been in good condition less than two years earlier, but when I checked it out it was completely separated from the wood lath beneath. The space between the plaster and lath was hollow. There weren't any signs of water that could have weakened the plaster, so I began to suspect some unusual movement within the wall.

When I removed the corner boards from the exterior, I found the cause of the bulging above. The new sills had been replaced with green pine that still had more than 30-percent moisture content. The end of the original post was sitting on the new sills. The post end was continuing to decay and had reinfected the new sill (see Figure 1).

The contractor hadn't replaced the post end but did do an especially effective job of sealing the outer shell of the building with two layers of tar paper. Of course, this trapped mois-

Figure 1. As the corner post dropped due to a decayed bottom, the added weight compressed the plaster and clapboards. Since the sills and studs remained stationary, the outer skins of the wall buckled and separated from the wall. While the damage to the plaster is not severe, it indicates serious structural damage below.

ture within the wall, leading to further decay of the post and new sill.

The solution in the first case involved some expensive backtracking. First a 2-foot section of dry pine timber was scarfed onto the end of the post. Then the owner had a difficult choice to make. He could remove the clapboards and replace the tar paper with something more breathable. Or, he could just close up the corner and hope the trapped moisture wouldn't damage other parts of the house. He decided to pay the price to take out the tar paper. Tyvek was laid on the wall before the clapboards were replaced.

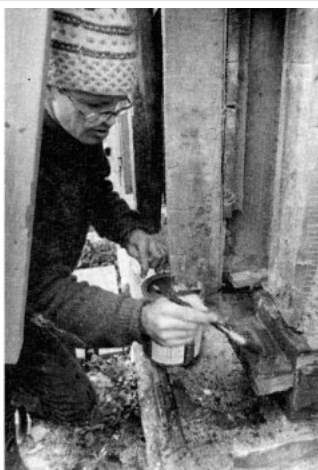
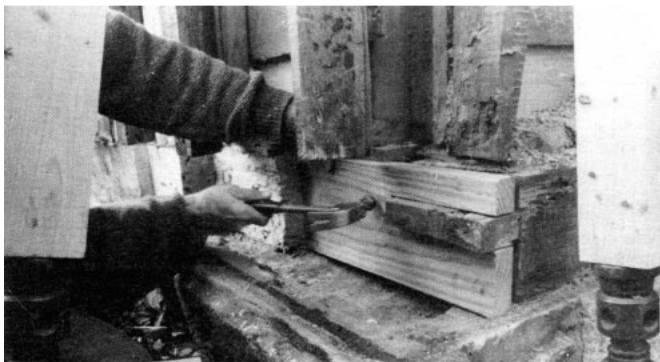
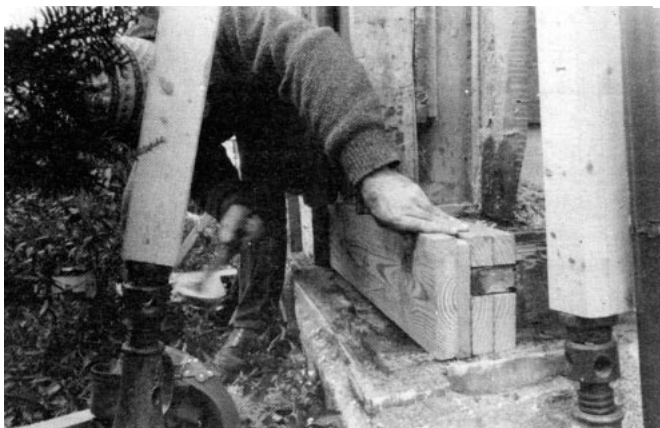
ber-framed house. When they removed the old clapboards near the bottom at one corner, they found the sheathing too decayed to hold clapboard nails. And underneath, the front sill and end of the corner post was just as punky.

The post end and sill had been replaced 40 years ago. The sill and corner post decayed again due to water entry through the joint between clapboards and the corner board. The earlier repair job didn't effectively address the water entry that caused the problem.

The original builders of this house knew the joint between the clapboards and vertical trim was a trouble spot. They flashed behind the joint with overlapping "slips" of wood 1/8 inch thick by 3 inches wide. This flashing wasn't replaced when the sill was repaired 40 years ago. Conse-

Figure 2. After treating the surrounding wood with Cuprinol fungicide (top) contractor Bill Noon, of Sanford, Maine, patches in a section of replacement sill built-up from 2x10 pressure-treated lumber. Notice how the first layer of replacement stock (center), and successive layers (bottom), are stepped back for a sturdy connection to the existing sill.

quently, water soaked in and decayed the replacement sill.

For the second case, the solution was less costly. It took only a day for one carpenter to cut out the decayed sill and post, and piece in pressure treated 2x10 lumber (see Figure 2).

The carpenters worked a narrow strip of aluminum flashing underneath the joint between the new clapboards and the existing corner board. This will help keep any water that penetrates the tight joints from soaking into the framing.
