# Water Hazards & Your Building's Health

Still not convinced that moisture problems are real in today's buildings? Here are four soggy examples from an Iowa builder and consultant

by  
**Bill  
Eichs**

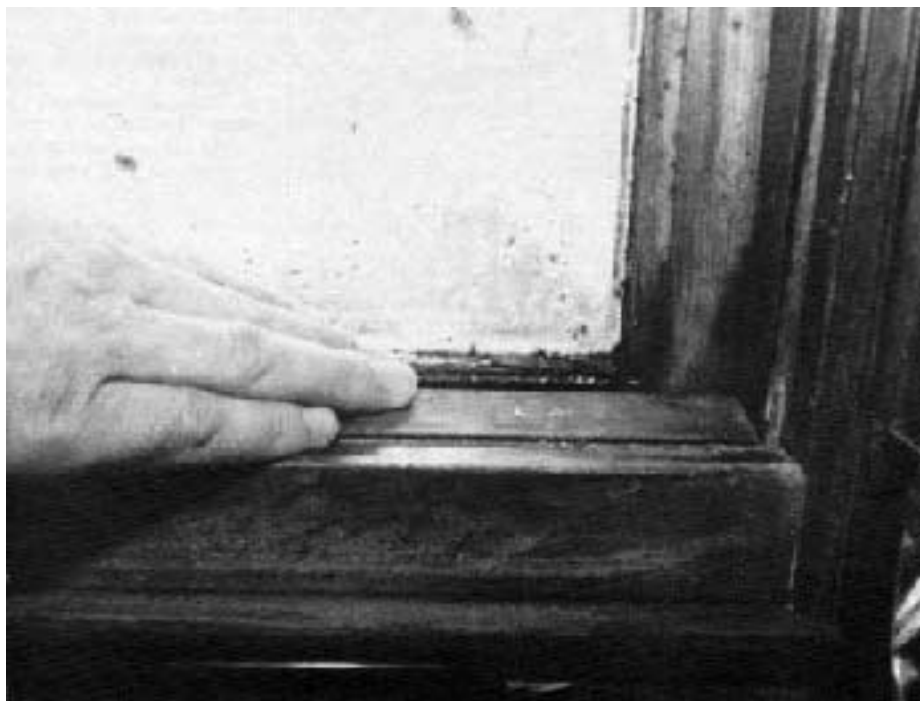
*When windows show this much condensation, humidity levels are too high and should be corrected by eliminating moisture sources and increasing ventilation.*

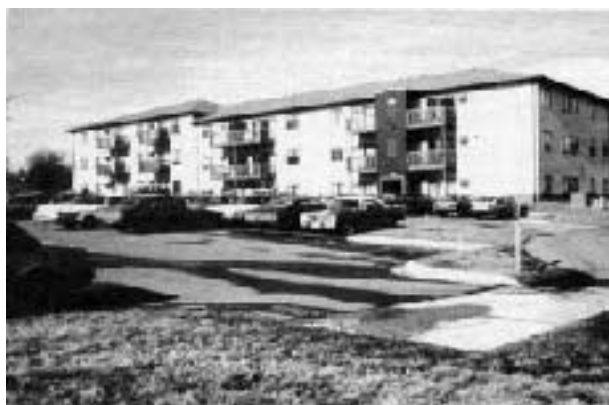
Cold interior surfaces generally have fewer causes: wind blowing through the insulation (windwashing), or misplaced and missing insulation (see Figure 2). If indoor humidity is high, these cold spots will breed mold and mildew growth on the drywall or wallpaper.

**Figure 2.** Insulation defects can cause cold spots on the interior surfaces of a home. Moist interior air can condense on these cold surfaces, causing mildew growth or rot.

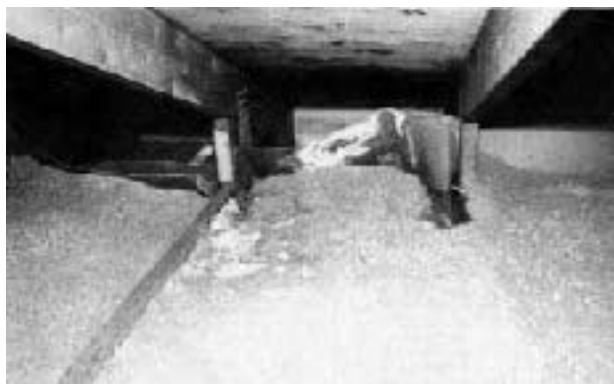
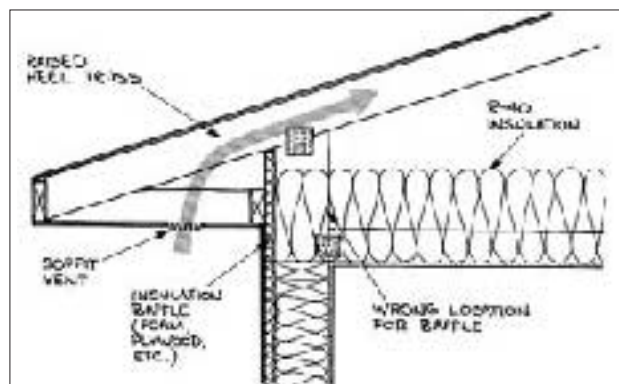
The attics were insulated with blown-in cellulose, which forms a better air barrier than fiberglass. However, the insulating was poorly done since many of the infiltration stops (baffles) were improperly located flush with the inside of the wall (see Figure 4). This created a cold ceiling corner and defeated the purpose of using raised-heel "energy trusses."

**Figure 4.** These insulation baffles (left) are ineffective since they are misplaced and damaged from heavy condensation. The baffles should be rigid and placed as shown (right) to keep wind from blowing under the insulation (windwashing), causing condensation, mold, and mildew at the ceiling corners.

My recommendations included correcting the obvious insulation and bath venting problems, as well as ventilating all third floor units continuously with a 60 cfm roof-mounted exhaust fan. To reduce the stack effect, I suggested two American Aldes, humidity-controlled fresh-air inlets for each unit, and a time-delay switch on all bath exhaust fans that kept them running 15 minutes after the lights were switched off.

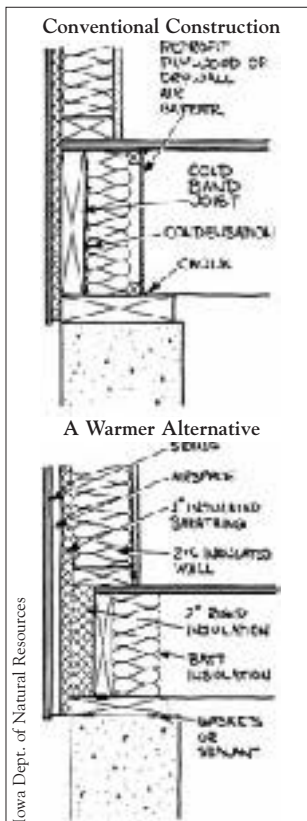
After noting a loose-fitting vapor barrier on the crawlspace floor, I removed one of the fiberglass insulation batts at the band (rim) joist.

When the owner saw it was black with mold, he knew the attic was the least of his problems (see Figure 5).

**Figure 5.** Conventional band or rim joists have cold interior surfaces that can condense moisture. The solution: Carefully retrofit airtight blocking between the joists (top) to keep moisture air out; or, in new construction, insulate the band joist on the exterior (bottom) to keep the band joist warm.

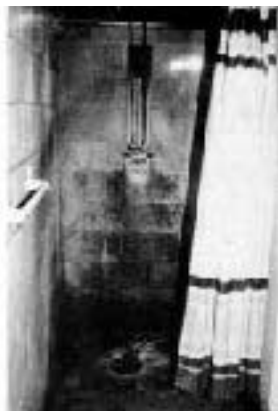
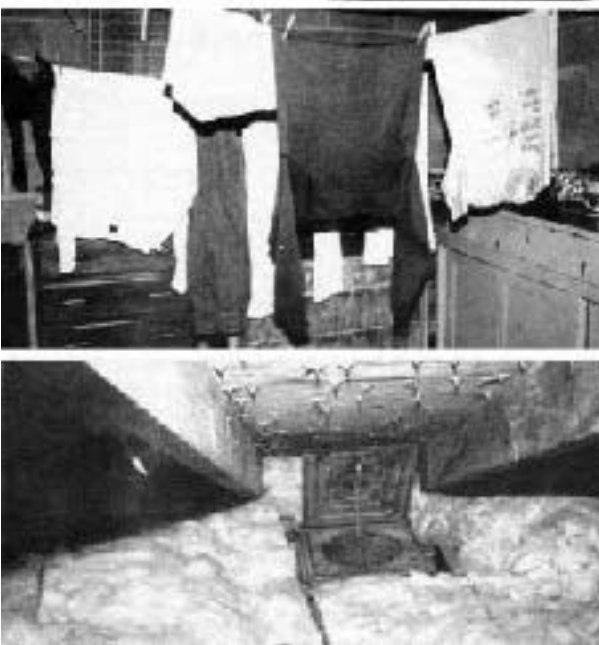
**Figure 6.** These sources of excess moisture—a shower without an exhaust fan, clothes drying in the basement, and a bathroom exhaust vented into the attic—are easy to fix if homeowner and builder are aware of the damage they can cause.

The insurance company hired me to sort out the facts and analyze the problem. I looked at a lot more than the furnace (see Figure 6). I found poor site drainage away from the foundation, a sagging and leaking rain gutter, a heavily used basement shower with no exhaust fan, a main-floor exhaust fan ducting into the attic, lots of house plants, a family with both a teenager and a baby (lots of showers and lots of laundry), and a clothesline full of wash hanging out to dry in the basement (they were proud of how much energy they saved by not using the dryer).

up to 68 percent, which was the primary cause of the paint peeling and blistering. Contributing causes were wind-driven rain that penetrated the siding, and deteriorating putty around the windows.

In this case, I suggested improving the site grading, repairing gutters and downspouts, adding an exhaust fan for the basement bath, and cutting down the basement clothesline.
