Chimneys and Moisture

by John Leeke

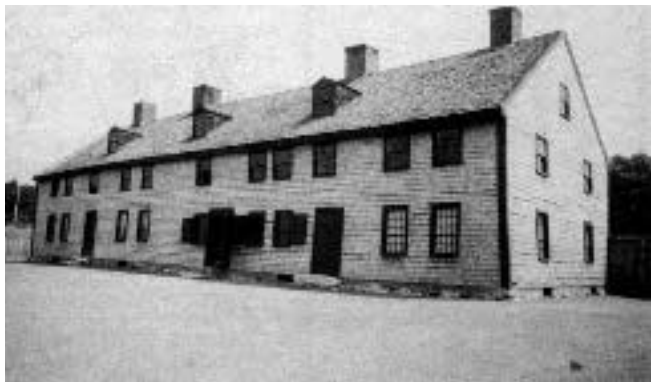
Figure 1. These four brick chimneys at the Fort Western Barracks museum had persistent leaks.

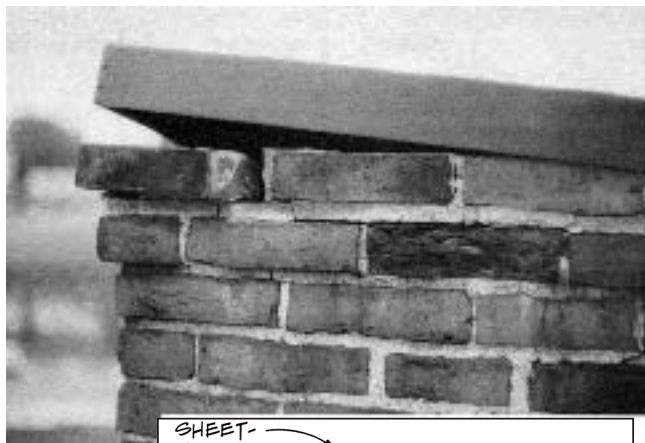
Just two years later, when I arrived to look at the job, the pans were loose, mortar joints in the top three courses had cracked, and the brick was deteriorating (see Figure 2). The repair didn't last because the mason who had repointed the chimney didn't think about possible conflicts between the way the chimney had been used historically, and the way it was being used now (as museum space). The repair technique might have been appropriate for a leaking 1950s chimney, but not for historic masonry.

The modern use of the building as a museum put the fireplaces out of commission, so moisture build-up was more likely to become a problem. Although sealed against rain penetration, the chimney was not completely tight. The slow leakage of air from under the cap created a "chimney effect" that drew moist air from the damp cellar up into the chimney.

In the winter, frost and ice formed between the top brick and lid, pushing up on the lid. The wire and nails broke the mortar joints, leaving loose bricks. Also, the lip of the lid bound the perimeter of the cap, limiting the cap's natural expansion. Moisture trapped in the masonry began to cause spalling.

Figure 2. To keep out the rain, a sheet-metal lid was wired to nails in the mortar joints of each masonry chimney cap (inset). Still, moisture trapped in the brick caused spalling. Also, ice formed under the sheet-metal lids and pushed them off the brick.

At Fort Western, we rebuilt the top courses of the chimneys and left gaps in some vertical joints, the third course down from the top, to allow ventilation. Weights hanging inside the flues will hold the lids in place, rather than wires and nails, and allow the caps to move. The museum staff also plans to reduce moisture in the cellar.

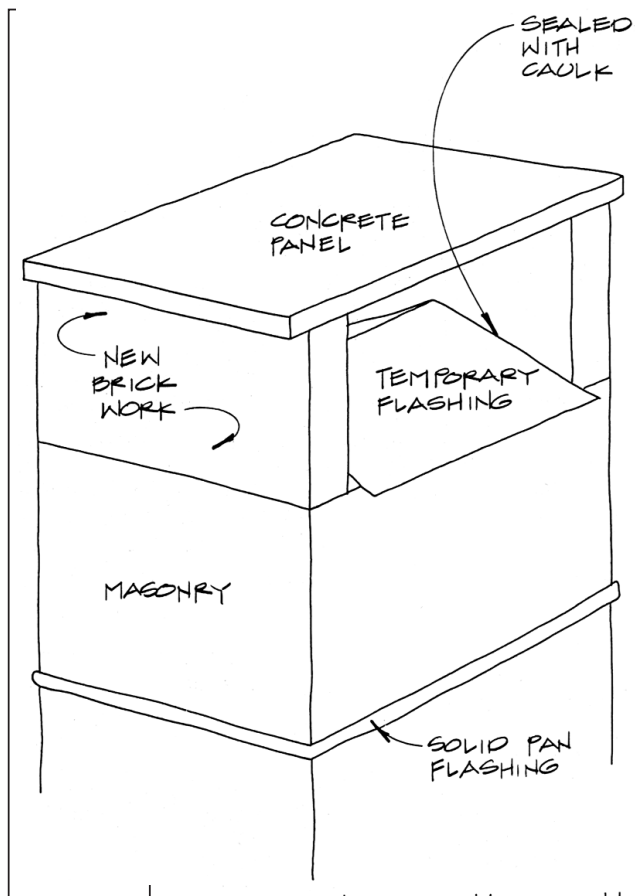
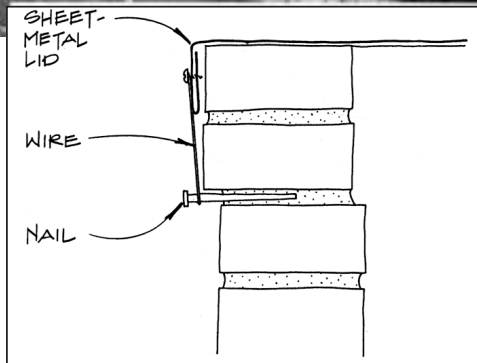
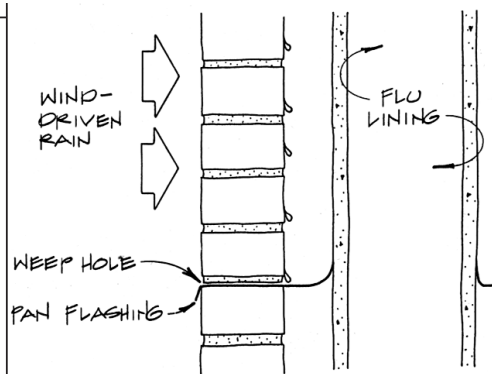
Figure 3. Neither the concrete panel nor the temporary flashing stopped the persistent leak. The solution was a solid pan flashing (inset), which catches wind-driven rain that penetrates the brick. Weep holes allow the water to escape.

Tired of the perpetual drip, the owners called in a mason who added a concrete panel supported by new brick above the cap and coated the chimney flashing with tar. The fireplaces still leaked. The mason came back and repointed the cap with

I called in Nick Whatley, of Morningstar Masonry, in Bodendham, Maine, to take a look. He explained that once a brick wall is saturated, even low-velocity winds will drive water right through the wall of a brick cap, causing leaks within the chimney. Also, water can penetrate through the fine hairline cracks in the rigid cement repointing mortar. The structure of the chimney was still flexible, but the repointing mortar wasn't. As the chimney moved slightly in the wind, most of the mortar had broken its bond with the brick.

We put our heads together to come up with a solution. While exterior masonry sealers would help prevent water penetration, they would have required regular reapplication. Nick said the only sure way to solve the problem was to install a solid sheet-metal pan flashing just above the roof line to bring the water that gets in back out again (see Figure 3).

The pan covers the whole area of the cap and is turned down at the outer edges. Where flues penetrate the pan, the edges are turned up. Weep holes in mortar joints just above the pan guide water that drips down within the wall of the cap back out to the exterior (Figure 3, inset).
