Patching A Gable End Return

by John Leeke

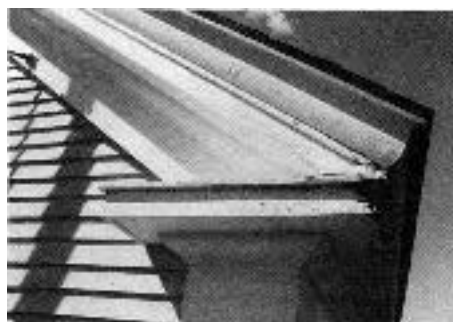
Squirrels had chewed a hole in the joint where the rake molding meets the gable end return and the front crown molding (see Figure 1). Repairs made about 15 years ago included cement mortar packed into the squirrel hole and sheet metal tacked to the outer surface of the soffit. The best I can say about these repair methods is they are expedient and low cost.

In only a few years, the repairs had caused more damage than if the hole had not been closed. The cement hadn't stuck to the sides of the hole, which permitted water to creep inside the return. That trapped moisture and promoted rot in the soffit. Also, the cement attracted and held water, making the situation even worse. And the sheet metal trapped water against the wood in the soffit and the lookouts.

Figure 1. Squirrels chewed a hole into the joint where the rake molding meets the gable end return and the front crown molding.

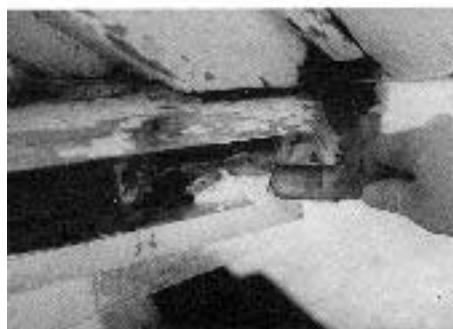
Figure 2. Wearing gloves, the carpenter works epoxy paste filler into the patch area with a putty knife.

Missing wood is replaced with epoxy paste filler. The paste is comprised of liquid epoxy resin and powder fillers that are added to thicken its consistency. On this job, we screwed a polyethylene-covered board to the soffit to act as a form. The poly kept the epoxy from sticking to the form. Then we pushed in the epoxy paste with a putty knife. The paste hardened, adhering to the consolidant-treated wood. Final strength and working properties are similar to the surrounding wood (see Figures 2 and 3).

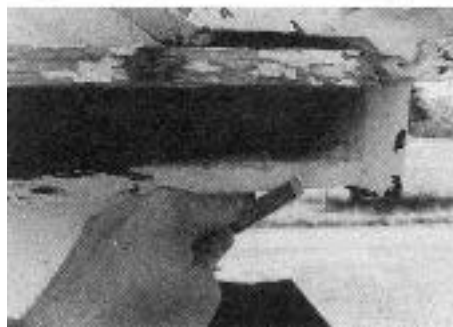
Figure 3. After the epoxy paste hardens, surfaces and edges are chiseled or rasped to match the adjacent wood.
