## Assessing Surface Decay In Structural Timbers

by John Leeke

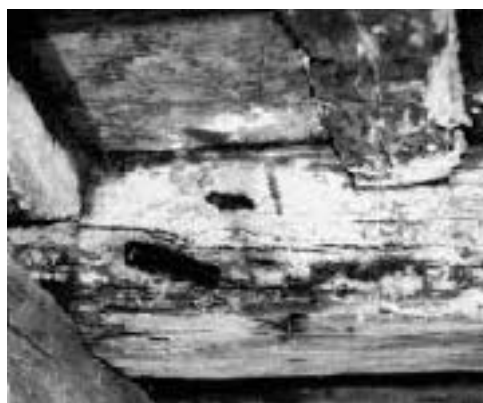
The usual procedure is to make test probings with a knife or an ice pick and to take boring samples if needed. By probing with an ice pick throughout the cellar, I was able to determine that the damage penetrated the timbers from 1/2 inch to as much as 2 inches in the case of one main girder (see Figure 1). I also found that the top surface of the timbers was not damaged.

**Moisture the culprit.** The deterioration had been caused by excessive moisture in the cellar. The addition in recent years of ventilation and a concrete floor seemed to have mitigated the moisture buildup to some extent. But while the cellar generally stays dry, it does become wet on occasion. Water marks on the cellar walls gave some indication

**Figure 1.** Dry, powdery surface decay extends 1/2 to 2 inches into the timbers. Half of the 4-inch blade of the ice pick easily penetrates wood softened by insect and fungal decay.

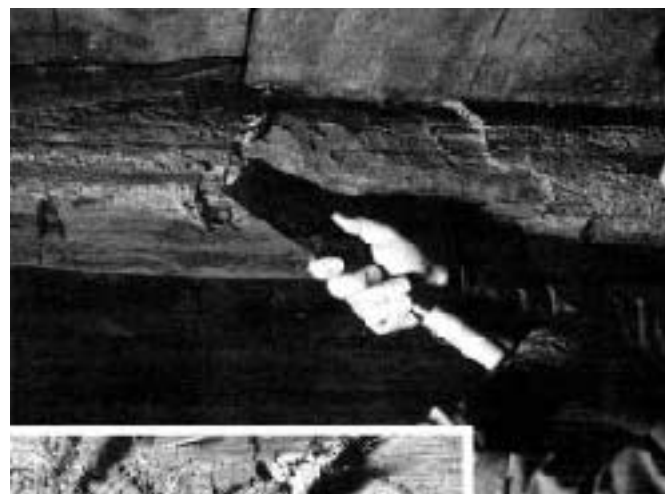
**Figure 2.** The author chisels decayed wood off the surface of a timber. With sound wood exposed (inset), it will be easy for the owner to monitor future decay activity.

The owner agreed to this technique but, because the decay had affected approximately 560 linear feet of framing, we had to come up with a cost estimate. We first chiseled a test section to obtain a unit-cost figure that could be projected to find the cost of the whole project. Based on the estimate, we decided to remove the surface deterioration in several representative areas of the basement (see Figure 2). This treatment would not affect the strength of the timbers because the decayed wood did not contribute to their strength.

of extensive decay. The project is still ongoing, but at this point it appears that we will only have to replace one section of one of the main girders. The girder is badly decayed in one 3-foot section, with only about one-third of the sound wood remaining. The repair will involve supporting the adjoining floor areas, cutting out about a 6-foot section of the girder, and scarfing and bolting in new wood of the same dimension and species with mortises cut for the floor-joist tenons.

As for the excessive moisture in the cellar, it seems to have been caused primarily by the ground settling into a reverse grade around the perimeter of the house. Landscaping will take care of that problem, which should dry the cellar considerably. As long as the basement remains dry, it is unlikely that the deterioration of the timbers will continue.
