Stairs Built to Last

by John Leeke

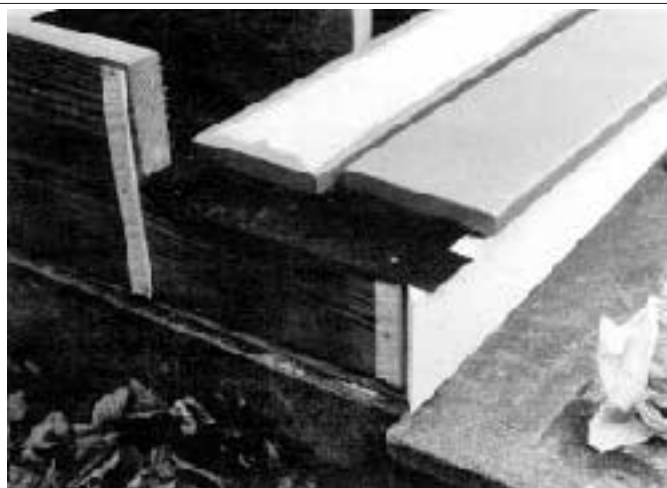
Figure 2. Details of construction. Vertical strips space the end trim boards out from the stringers to allow ventilation. Lead flashing under the stringers and tar paper over the stringer tread cuts keep water out. Treads, risers, and other woodwork are all backprimed.

- I set lead flashing under the stringers and the bottom riser to prevent moisture from seeping from the concrete base into the wood.
- As I nailed on the treads, I laid tar paper over the stringer tread cuts to divert any water seeping between the tread boards (see Figure 2).
- I spaced each end trim board out

from the stringers to prevent water from being trapped between the two boards.

- I rounded all edges and corners with a $1/16$ -inch radius so the paint would form a continuous film around the edge. If edges are perfectly square, the paint film will be thinner at the edge and will weather away quickly, allowing water to penetrate. I also rounded the front edge of the treads with a $1/4$ -inch radius to prevent excessive wear.

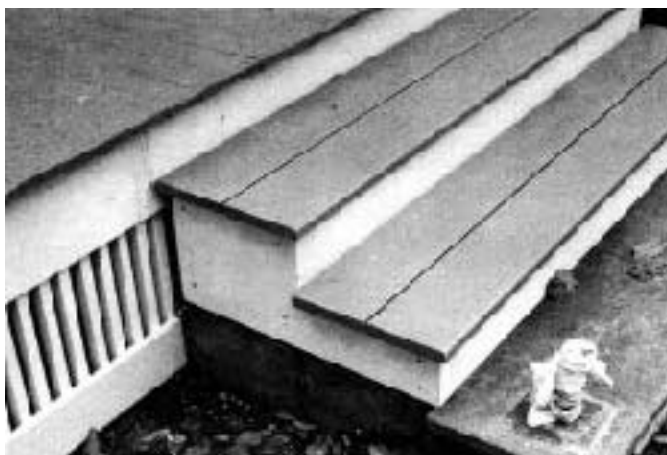
Figure 3. The finished steps fit in neatly with the rest of the porch — and will last.

On this job I backprimed and gave

the woodwork one top coat before installation. After installation the painters gave the steps an additional top coat (see Figure 3).

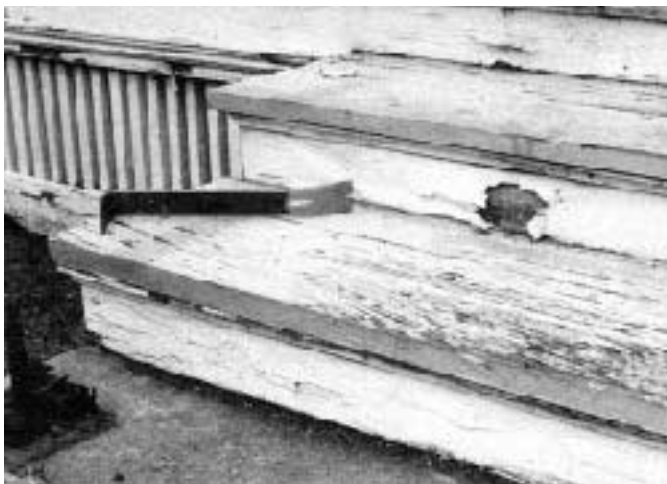
Decay had weakened the structural members underneath, so that the treads moved and shifted every time they were walked on. Peeling paint and checked wood gave the steps a shabby appearance (see Figure 1), but were only indications of the true problem, which was poor drainage.

In fact, a gutter downspout ended next to the house and had been dumping water underneath the porch for years. Also the landscaping around the edge of the porch had built up over the years, creating a reverse slope so that the water had nowhere to go. The excessive moisture was the root cause of the structural and finish damage to the steps.

Figure 1. Paint peeling down to bare wood indicates excessive moisture in the woodwork. The buckling paint on the second riser is a result of decay.

When the steps were completed I also installed a drainage system to eliminate the original cause of the moisture buildup.
