## CASE STUDY:

# FLAT TRUSS FAILURE

BY STEPHEN SMULSKI

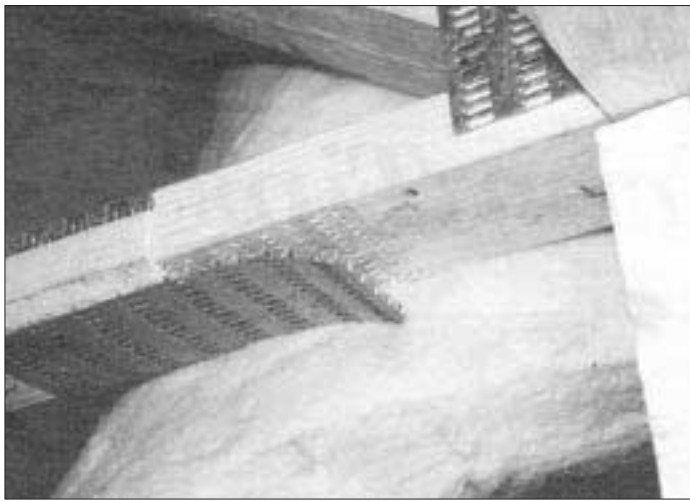
plate teeth were embedded could easily fluctuate from as low as 6% during the winter to 14% or higher during the summer. Since installed eight years before, the truss plates had endured eight cycles of across-the-grain shrinking and swelling of the wide face of the flat-sawn chords. This cyclic movement caused the chord faces to cup alternately concave and convex with respect to the plane of the plates, ratcheting the 3/8-inch-long teeth out of the lumber.

All of the withdrawn plates were embedded in the wide face of the chords, where shrinkage and swelling are greatest.

Although this case is admittedly unusual, it should serve as a cautionary tale. It's unlikely that truss plates would have withdrawn in this case if (1) batt insulation had been properly located above the plumbing and heating lines with the vapor retarder against the underside of the subflooring, or (2) the cold water supply and forced hot water heating lines within the closed truss space had been insulated to prevent condensation and reduce heat loss. The best way to prevent similar problems is to insulate the cold water supply and forced hot water heating lines inside any closed floor truss space, especially when the trusses separate a building's conditioned and unconditioned zones. ■

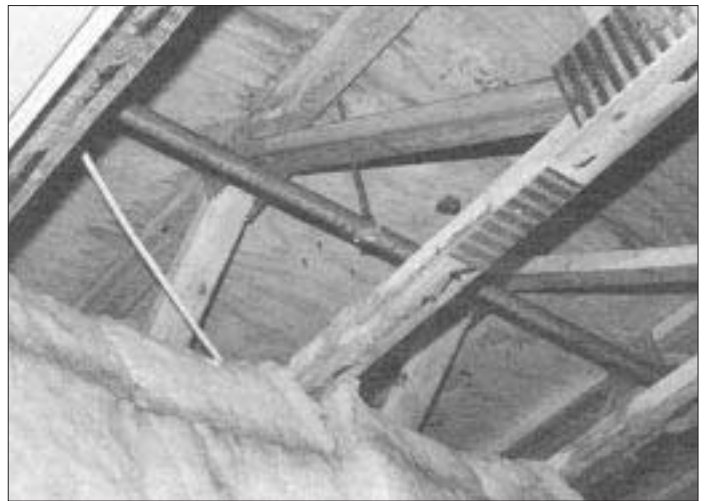
water pipes that ran through the cavity were coated with a heavy green surface patina, and were speckled with drip marks from water vapor that had condensed on their surfaces. The batt insulation located below these pipes was heavily stained and damp in places, as was the truss lumber.

Drip-marked pipes and stained insulation indicated too much moisture in the truss floor cavity.
