# Water in the Walls: Three Case Studies

# Poor ventilation, shoddy vapor sealing, and green lumber can lead to serious structural and appearance problems

by Stephen Smulski

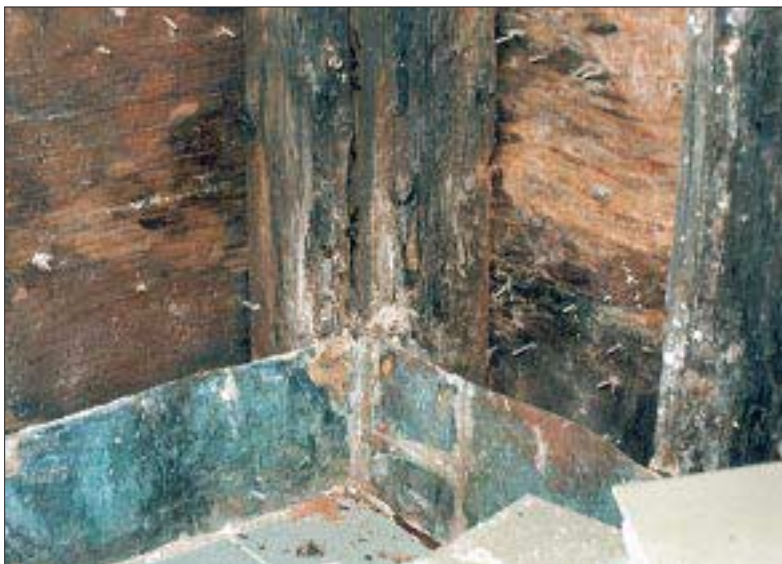
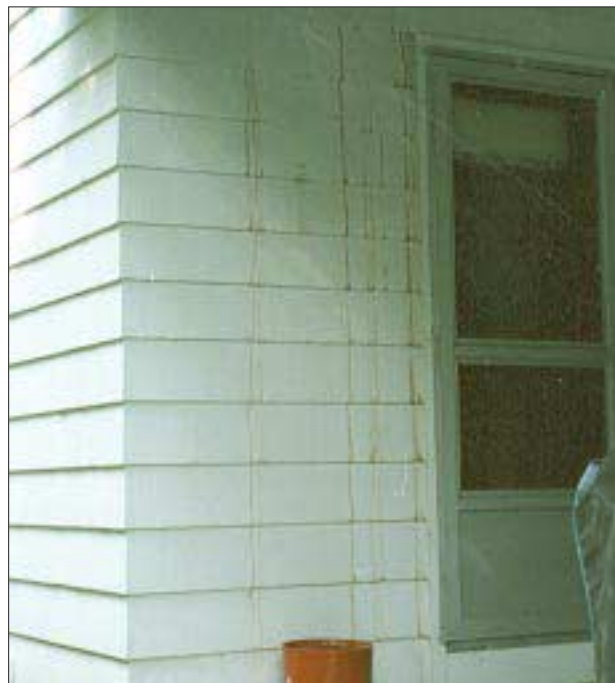
While renovating a bathroom in their 22-year-old home, the owners were shocked to find wet insulation, severely decayed framing and sheathing, and live carpenter ants behind the tiled shower stall (Figure 1). Tucked into an outside corner, two sides of the stall were against exterior walls. The walls consisted of floor-to-ceiling ceramic tiles set on mortar and metal lath, standard gypsum wallboard, unfaced fiberglass batt insulation between 2x4 studs, plywood sheathing, and wood shingles. The bathroom

The shower pan and drain tested leakfree, and the owners recalled that the tiles and grout had only a few cracks. This told me that the cause of the problem was not liquid water leaking into the walls. Instead, a construction error — omission of a vapor retarder behind the wallboard — had let water vapor diffuse into the wall cavity. Lack of an exhaust fan also allowed water vapor and liquid condensation generated by showering to persist in the bathroom. This increased the chance that the moisture would get into the walls through hidden air leakage paths, then condense and freeze on the cold sheathing. When it melted in warmer

weather, the liquid water increased the moisture content of framing and sheathing to the 28% threshold required for decay. Carpenter ants followed.

My diagnosis was confirmed by the run-down staining on the home's white shingles outside and below the second floor bathroom. The owners remarked that despite washing the streaks off each summer, they always reappeared the following spring.

**Figure 1.** The framing behind this shower stall (above) rotted because bathroom moisture leaked into the walls. The excess moisture also caused extractive staining on the home's siding (right). The solution was to add a bath fan that vented moisture directly to the outside.

To prevent future problems, I recommended that they add a vapor retarder to the warm side of the exterior wall and install a bath exhaust fan vented directly to the outside. Running the fan would reduce the amount of moisture infiltrating into the wall to a negligible amount.

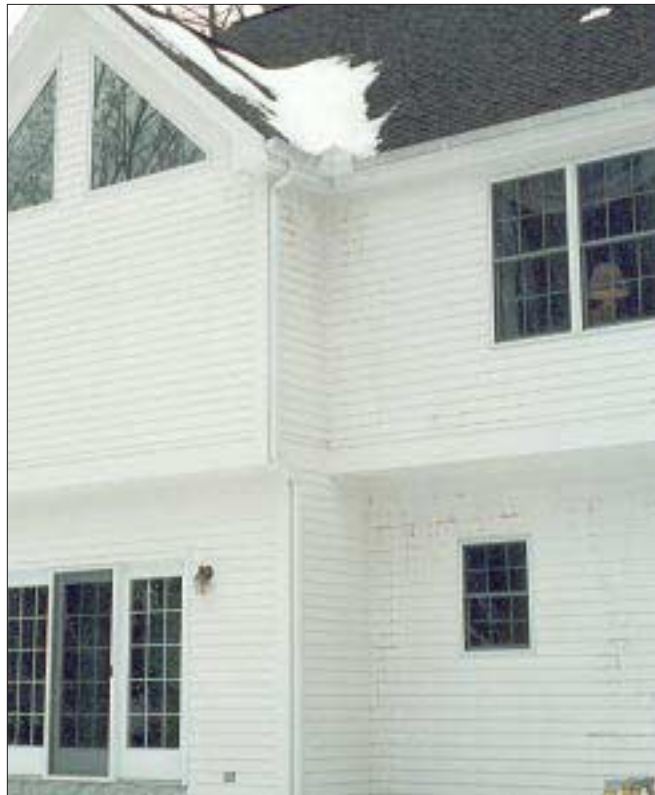
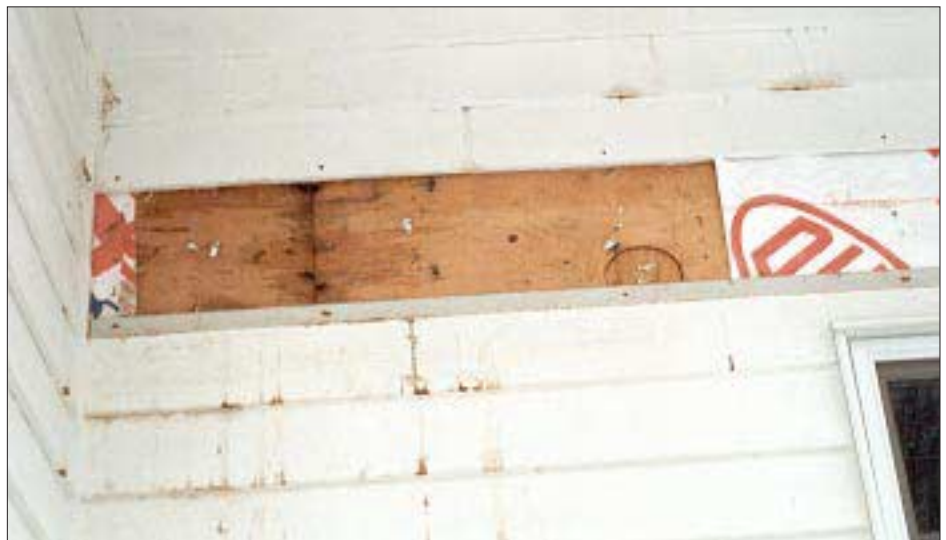
**Figure 2.** Water vapor from inside this new house — caused in part by green framing lumber and a dryer vented directly into the basement — leaked through the walls and caused extractive staining on the primed and painted siding (below).

When I removed the siding in a heavily stained area, I found liquid water and extractive staining on its backside (see Figure 2). Water also saturated the plywood sheathing behind the wet and stained air infiltration barrier. Siding, sheathing, and framing checked in at 33%, 50%, and 30% moisture content, respectively,

instead of the 12% to 15% that I would have expected. Though I found no decay, conditions were ripe for rot. The reason rot hadn't yet taken hold was that it was simply too cold outside.

The cause of the wet siding was excessive indoor humidity. Sources included a humidifier on each of the home's two forced-hot-air heating systems, a clothes dryer vented into the basement, four bathroom exhaust fans vented into the attic, a recircu-

lating-type kitchen range fan and, as shown by the S-GRN grade stamps, green framing lumber. Despite the weight of this evidence, the contractor insisted that the water vapor from inside his "tight" house couldn't be leaking through the walls. Not until I pointed out that there was no staining whatsoever on the attached garage did he finally come around.

humidity. To do so, I recommended that the builder disconnect the humidifiers and vent the clothes dryer, bath exhaust fans and kitchen range directly to the outside. Stains could be removed later by washing the siding with a dilute solution of oxalic acid (available from paint or hardware stores) once the framing, sheathing, and siding had dried to below 19% moisture content. Repainting with a stain-resistant primer would complete the job.

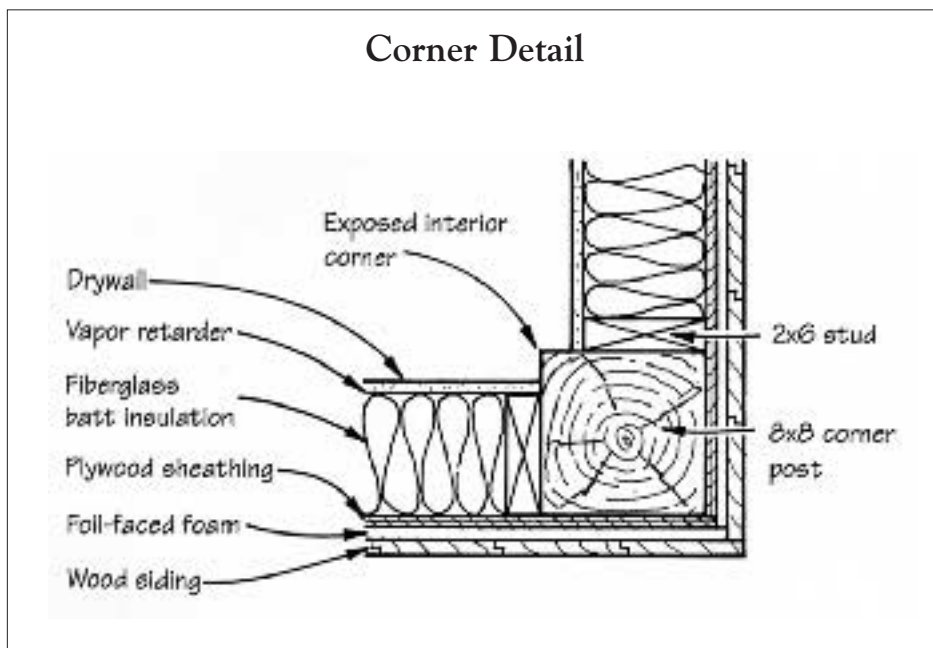
While adding a porch to their six-year-old hemlock timber-frame home, the owners found extensive decay in the corner posts. After removing more siding and trim, they found at least minor decay wherever the timbers contacted studs and sheathing.

Built-in during construction, the source of the decay-causing moisture was the huge gallonage of water trapped in the green (water-saturated) timbers. In an effort to make the house energy-efficient, the builder had boxed the timbers in on three faces with studs, sheathing, and rigid foam (Figure 3). This had severely retarded the drying of the timbers. As a result, the wood stayed at a decay-susceptible moisture content for years after closing-in. The timbers were forced to dry through the one face exposed inside the home. Corner posts were especially slow to dry because of the tiny exposed surface area.

**Figure 3.** While remodeling their six-year-old timber-frame home, the owners found that the corner posts had decayed along the outside edge. The builder had boxed in the green timbers with framing and sheathing, holding the wood at a decay-susceptible moisture content for years after closing-in. Drying could only take place through the one exposed corner.

Fortunately, enough of the corner posts' cross-section was still sound enough to make reinforcement or replacement unnecessary. Following my recommendations, the builder replaced the decayed studs and sheathing, and treated the timbers with a waterborne borate preservative to kill existing decay and prevent future infection.
