# ROOF VENTILATION RETROFIT

by Henri de Marne

**When flawed air and vapor barriers caused this roof to decay, a new venting system was the answer**

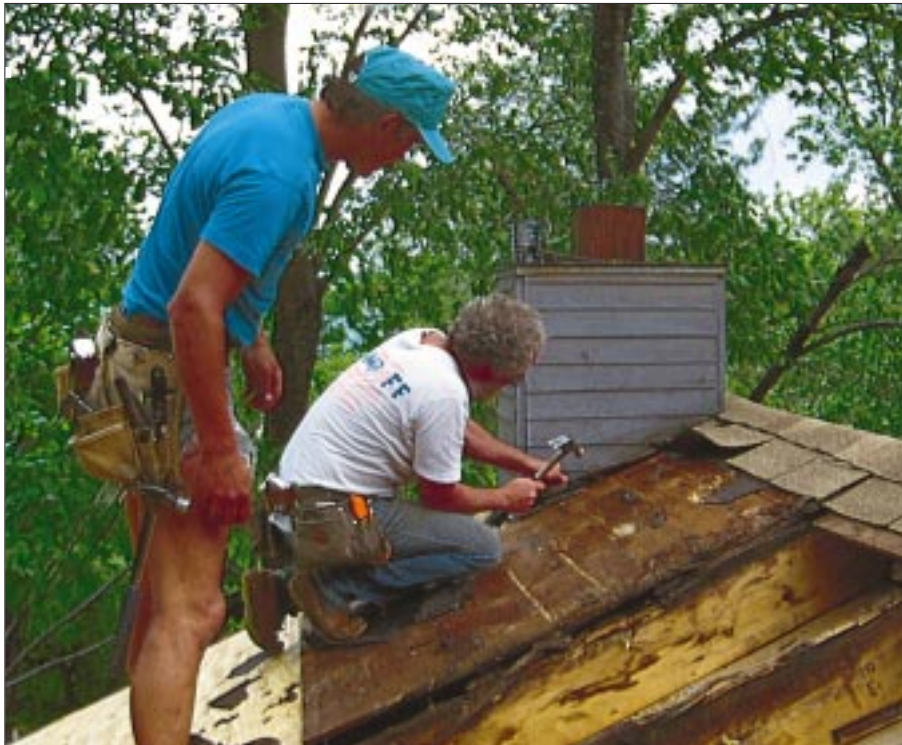
Workers tear off rotten sheathing over an unvented cathedral ceiling.

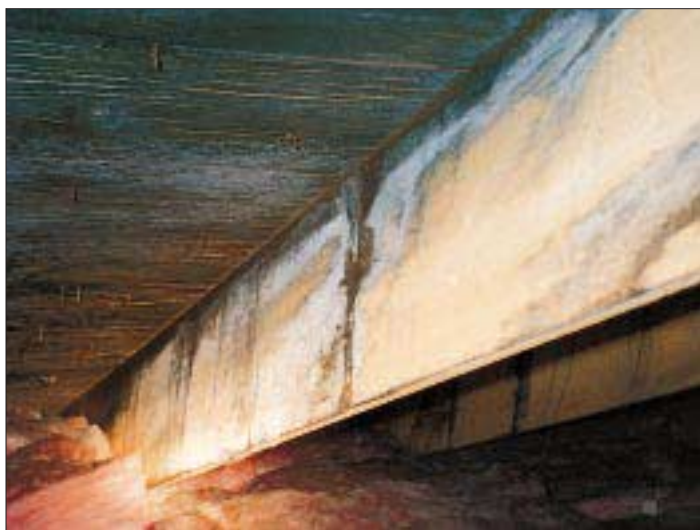
**Figure 1.** Moisture trapped in the attic raised the moisture content of the wood to well over 20%. Vigorous growth of several types of fungi turned the underside of the roof sheathing completely black.

What I found in the attic was beyond belief. The attic rafters were stained far worse than I remembered. But when I looked at the discolored roof plywood, my first thought was that someone had sprayed the sheathing with matte black paint (see Figure 1). Later, in helping to prepare the owner's lawsuit, I scraped off some samples and sent them to two wood toxicologists to have them assessed. The tests confirmed what I already knew: The several types of fungi flourishing on the sheathing were precursors to decay-causing fungi, and required over 20% moisture content in the wood to grow.

The obvious answer to the attic problem was to provide needed ventilation by installing continuous ridge and soffit vents. Adding ventilation to the cathedral roofs, however, would be difficult and expensive, because I assumed that there was not enough uninterrupted space for air circulation above the insulation. That would mean opening up the whole roof, because the rafters over the living room were well over 20 feet long. So I offered an alternative solution of sealing drywall cracks from the inside and painting with low-perm paint.

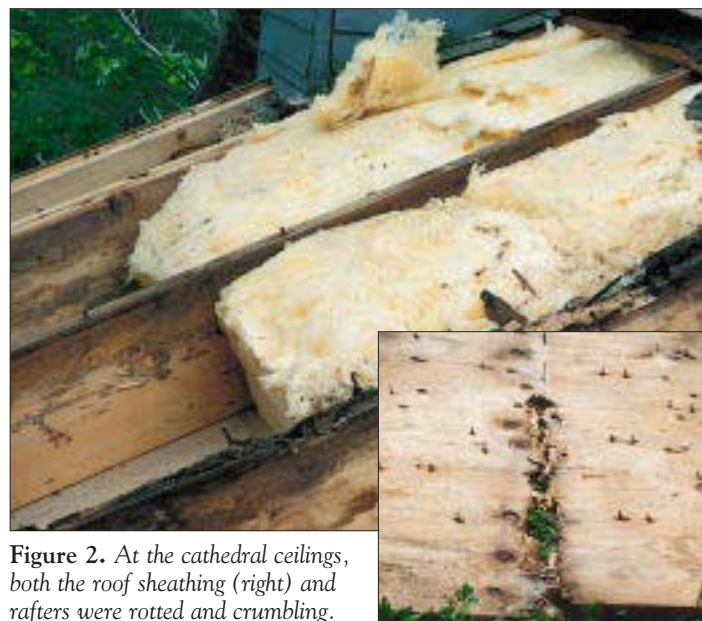
**Figure 2.** At the cathedral ceilings, both the roof sheathing (right) and rafters were rotted and crumbling.

The plywood, once exposed, was discolored and deteriorated, and was also quite soft. When the last of the nails was removed and the carpenter lifted the piece of plywood up on edge, it was so rotten, it literally sank into the rafters by a couple of inches (Figure 2). The underside was soaking wet and blotchy — black in places and white in others — from a variety of molds. The top 2 inches of the exposed rafters were also rotten. A second later, hundreds of carpenter ants rushed up out of the framing and scattered across the damp insulation.

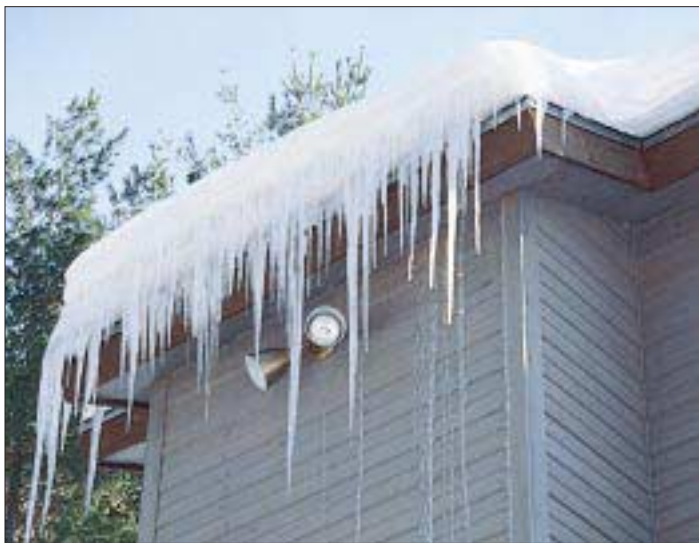
That winter, thick ice dams built up at the eaves (Figure 3). Water backed up into the structure, and ran down the outside wall and back along the cantilevered floor joists, finally exiting and freezing between clapboards on the first-floor wall. Water also ran steadily onto the floor of both upstairs bedrooms, soaking the carpet at least 4 feet into the room. When I went to look at the damage, I found the carpet pulled back and

**Figure 3.** The winter before repairs were made, huge ice dams formed at the eaves of this cathedral roof. Water backed up into the soffits and walls, soaking interior and exterior finish materials.

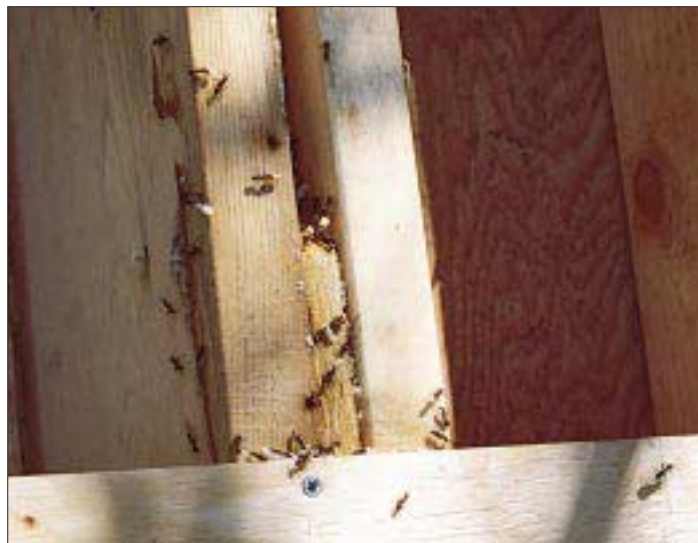
**Figure 4.** High moisture in the cathedral roofs created a perfect environment for carpenter ants, which tunneled into the insulation and nested in cracks between framing members.

At the cathedral ceilings, most of the moisture damage was confined to within 8 feet of the ridge. Much of the plywood sheathing was so badly rotted that it broke into pieces while the nails were being removed and again when it was lifted off the rafters. Hundreds of carpenter ants had nested in cracks and seams between framing members, and had tunneled into the fiberglass insulation (Figure 4).

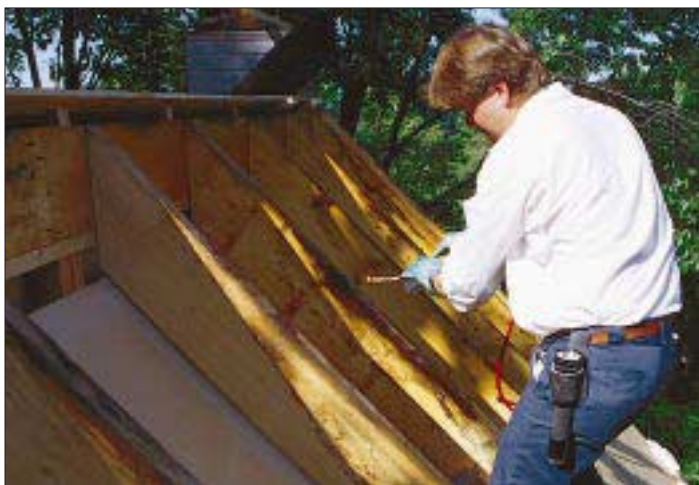
The top 2 inches of the rafters were also rotten; by contrast, the bottoms and lower two-thirds of the rafters' length were water-stained, but still sound. All of the fiberglass insulation was removed as a precaution against any remaining ant infestation. Before any new framing material was installed, the rotten parts

of the rafters were removed, and the entire area was treated with a fungicide and insecticide (Figure 5).

**Figure 5.** Before installing sister rafters and insulation, the existing framing was sprayed with a fungicide and insecticide.
