Misplaced Load Paths

by Robert Randall, P.E.

Kitchen Floor Overload

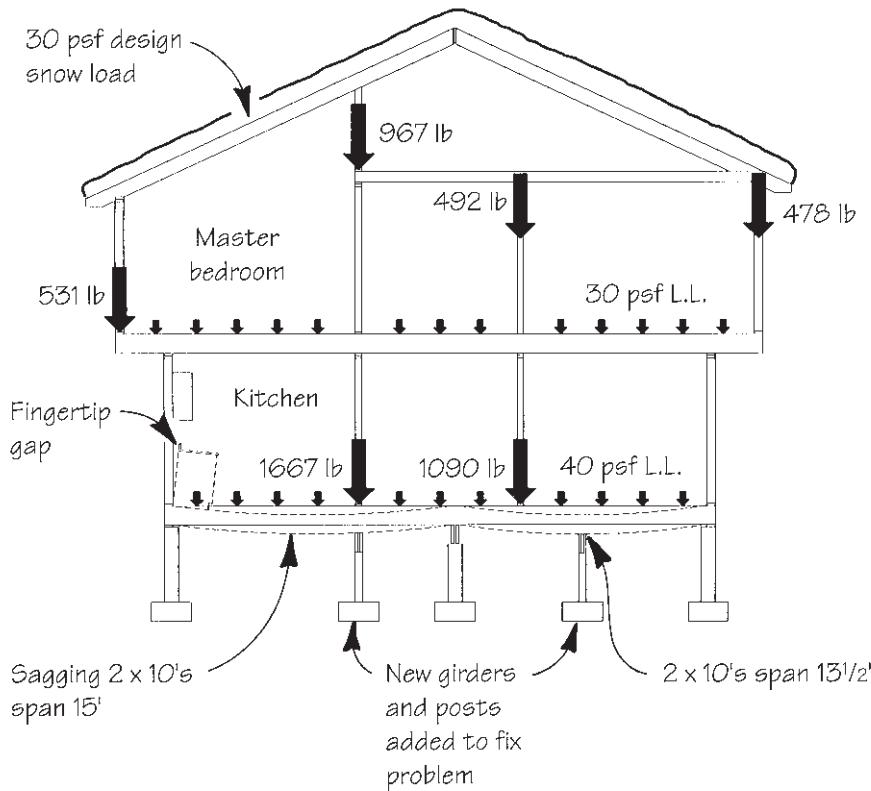
The illustration shows a section through the middle of the house. Rafters, joists, and studs are all set at 16-inch centers, and the forces indicated are the loads at various points carried by each rafter, joist, or stud.

The worst mistake by the designer was to overlook the fact that the cathedral ceiling in the master bedroom eliminated the truss effect that results from attic floor joists working with the rafters to form a triangle. This common roof-triangle "truss" normally transfers all the roof loads to the exterior walls. But with the addition of the cathedral ceiling, more than half of the roof loads were being carried by the interior wall of the master bedroom.

Additional loads from the attic floor, the dead loads of walls, and second-floor loads were all added in, creating a concentrated, or point, load on the first-floor framing. The 2x10 floor joists had probably been sized using a uniform load span table; the spans would have been pretty much maxed out even without this added point load.

The calculated bending stress ($f_b = 3,370$ psi) was more than three times the allowable bending stress in the kitchen floor framing, and almost as bad at the front of the house. While a structural collapse probably would not have occurred, the excessive sagging would have continued to cause problems with sticking doors and cracking tile and drywall, not to mention the gaping space behind the kitchen counter.

A fatal flaw of this house design was the upstairs cathedral ceiling, which interrupted the second story ceiling joists and placed more than half of the roof load on the interior wall of the master bedroom. This load, along with floor loads from the second story and attic, greatly overstressed the 2x10 kitchen floor joists. The numbers represent the total concentrated loads in pounds carried by each individual stud onto the joists below.

The builder, a man of integrity, agreed to jack the floors level, install additional girders and piers, and repair all the secondary damages at his own expense. He probably won't overlook the matter of proper load paths again. ■
