Rain Screen Siding R E T R O F I T

by Henri de Marne

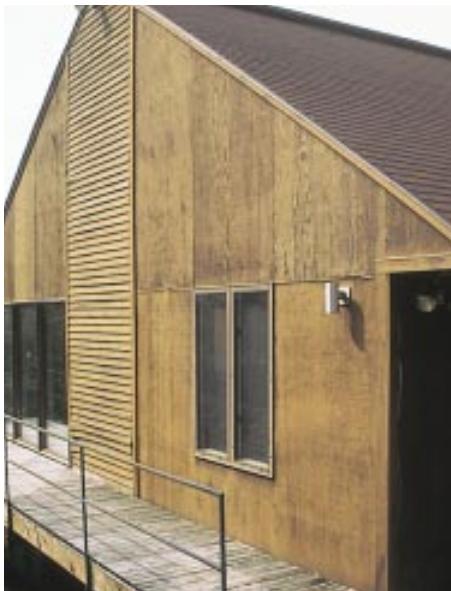
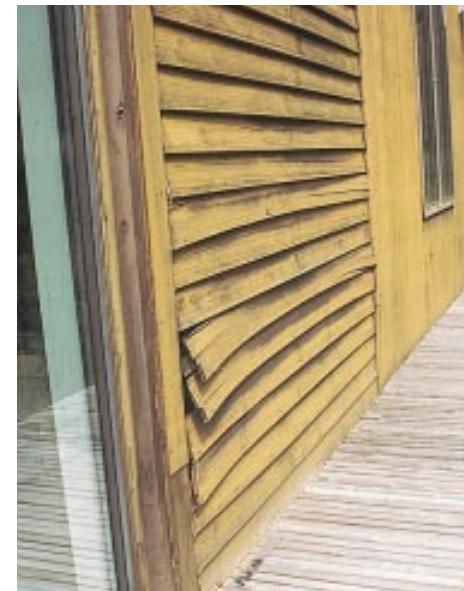
Figure 1. Years of sun and rain on the south-facing gable-end of this 17-year-old house (left) had caused delamination in the rough-textured T1-11 cladding (middle). Clapboards in the central feature strip had also cupped badly, exposing the underlying structure to moisture damage.

Recently, I had the opportunity to put a rain screen into practice during the repair of gable-end siding on a 17-year-old residential building. In this case, some of the mistakes described above were made, including the installation of spruce clapboards without any back-priming. The exterior wall was sheathed with rigid foam and clad with rough-textured T1-11 plywood. The exception was a "feature strip" at the gable, which had been sheathed with CDX plywood in plane with the T1-11 and clad with spruce clapboards. The bottom ten or so courses of clapboards suffered from severe cupping and warping, but had not rotted, despite the fact that they still

bore only the original coat of dark solid stain (see Figure 1). The exposed T1-11 siding had also begun to delaminate.

The solution was to remove the damaged materials and re-side the gable end with clapboards using the rain screen principle. This entails installing vertical furring strips to hold the clapboards off the sheathing, and providing for ventilation behind the siding. To make the repair, I worked with R.C. Volk Construction of Hinesburg, Vt.

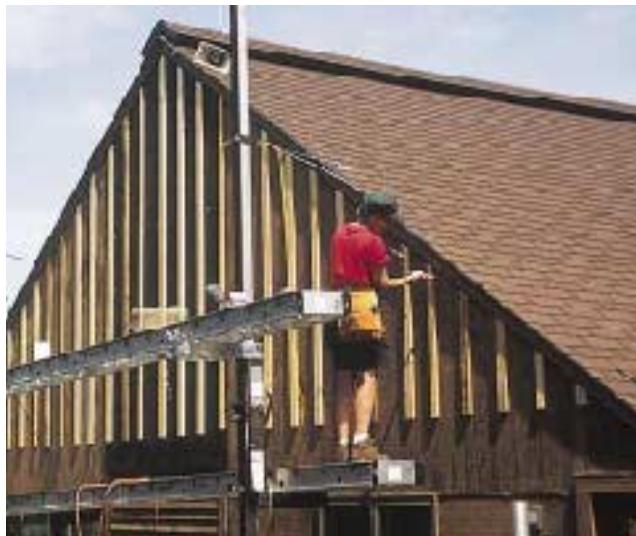
Figure 2. When re-siding the building, the author created a rain screen using vertical 1x3 furring strips 12 inches on-center. The resulting air space reduces heat buildup, and the equalized pressure on both sides of the siding prevents moisture from reaching the sheathing. The air space also permits any moisture that does accumulate behind the siding to drain freely.

To create an air space for the rain screen, the carpenters screwed 1x3 furring strips vertically at 12 inches on-center across the entire gable (Figure 2). They held the tops of the strips 2 inches below the existing rake boards to provide for ventilation. The air space between furring strips reduces heat buildup and allows any moisture to escape from behind the siding.

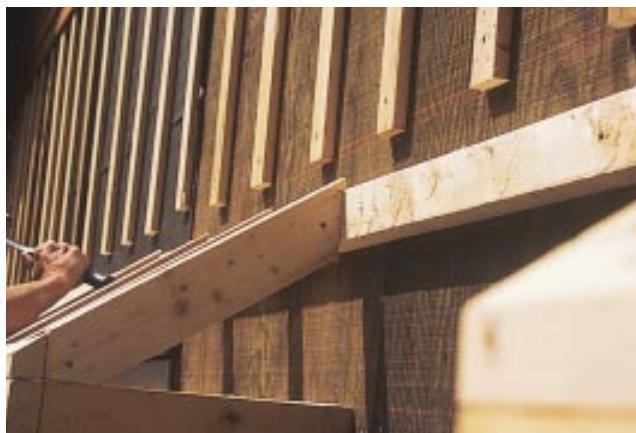
Figure 3. To protect both the windows below and the exterior shades, a shallow shed roof was built between eaves across the full width of the gable. The rafter tops were fastened high against a chamfered ledger to allow air entering through the soffit to flow into furring bays.

The bottom of the gable triangle received a short shed roof, which ran the full width between the eaves. This overhang was needed both to shelter the windows and to protect roll-down exterior shades, which the owner was installing to prevent overheating during the summer months. The top of the 2x4 ledger onto which the rafters of this short roof were fastened was chamfered, and the rafters deliberately held high (Figure 3), to allow air entering through the continuous metal soffit vent strip to pass freely into the bays between furring strips.

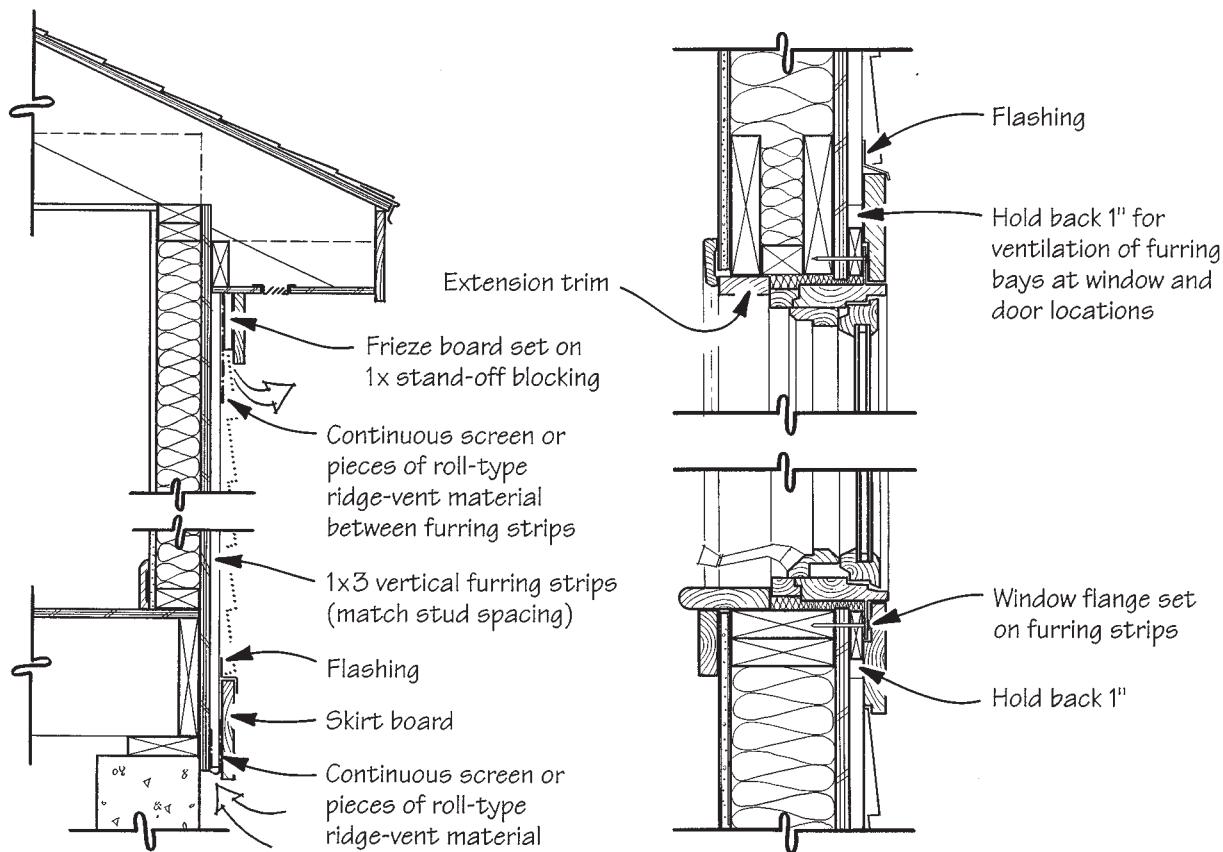
Figure 5. In new construction, install windows after applying a double-wide band of furring around the perimeter of door and window openings. Use screen and hardware cloth, or roll-type vent material, between furring strips at the top and bottom of rain screen walls to prevent insects and rodents from entering. Adjust frieze, corner board, and skirtboard details to accommodate the extra thickness of the rain screen furring.

Window and door openings. When using a rain screen on a conventional wall, the additional thickness of the furring strips creates some problems at door and window openings. In new construction, you can install the windows and doors over a double-wide band of furring attached to the sheathing (Figure 5).

Venting. In a standard rain screen wall, air will enter behind the skirtboard. To keep insects and rodents out, close off the bays created by the furring strips using screen and hardware cloth. An alternative is to insert pieces of roll-type ridge vent material between furring strips. Seal the top in the same way, but use a stand-off to hold the frieze board away from the siding.
