These oversights, omissions, and bad design details can lead to early failures

TIME BOMBS

by Martin Holladay

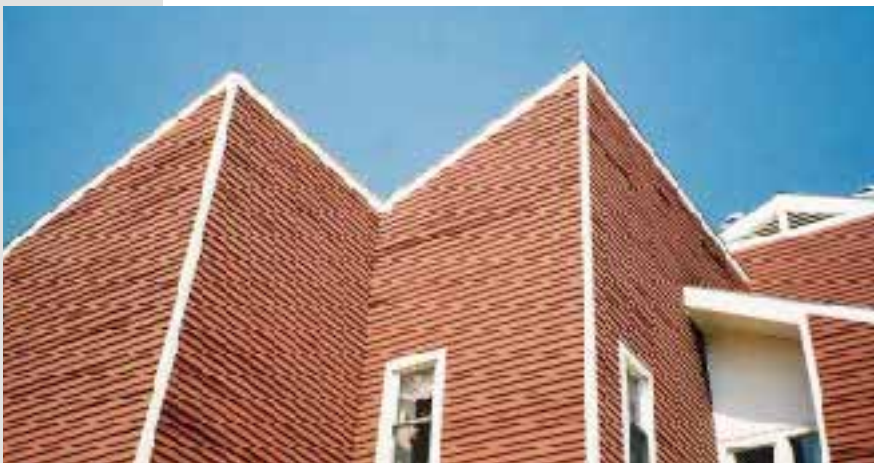
The clapboard siding on this building has no roof protection. It is curling and splitting, and requires repainting every three years.

Stinky roof overhangs, whether at the rakes or the eaves, greatly reduce the longevity of most types of siding. When siding receives the full brunt of the weather, it is alternately soaked by rain and baked by the sun. These humidity changes cause nails to loosen, paint to peel, and siding to rot prematurely.

In many cases, a difference of just a few inches in the width of a roof can make a big difference in protecting the siding.

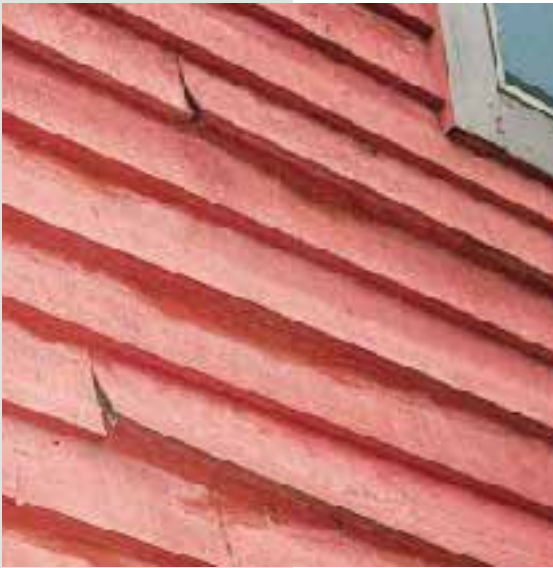
Smooth-shank siding nails that penetrate the sheathing, but not the framing, cannot hold clapboards for long. After just a few years, normal variations in humidity cause the siding to swell and shrink, ratcheting out the smooth-shank nails. Inadequately nailed clapboard siding soon begins to curl.

Locate clapboard siding joints over studs so that the nails penetrate the framing.

The solution is to use ring-shank siding nails, nailed into the studs. Most siding manufacturers recommend that ring-shank nails penetrate $1\frac{1}{4}$ inches into the nailing base, and that smooth-shank nails penetrate $1\frac{1}{2}$ inches. If you are installing $\frac{1}{2}$ -inch bevel siding, that means using 5d ring-shank nails or 6d smooth-shank nails. But if you aren't going to bother to locate the studs, it hardly matters how long your nails are: Since they'll only be hitting the sheathing, they'll only hold as well as 2d nails.

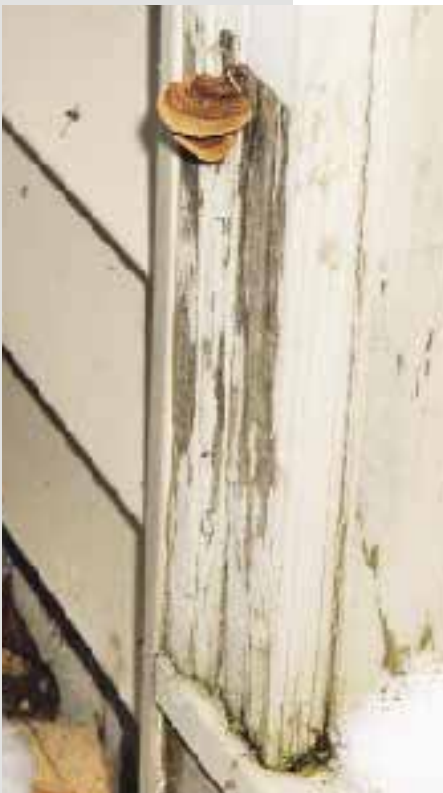
When an exterior door has no roof protection, the lower sections of the jambs and door are vulnerable to rot or rust.

Unroofed exterior doors can begin to deteriorate just five years after installation. They are vulnerable to direct wetting as well as splashback. Usually, the first signs of deterioration are jamb rot and rust spots near the bottom of the door.

Steel door proponents sometimes say that “unlike wood, steel doesn't rot.” Steel doors can rust right through, however, and it happens particularly quickly when the builder fails to paint them. The factory-installed primer on a steel door is not intended to be a finish coat of paint.

Exterior doors should be protected from rain by a roof that extends at least 3 feet beyond the door. A roof located high above the door — for instance, the rakes on the gable end of a two-story house — offers little, if any, protection against wind-driven rain.

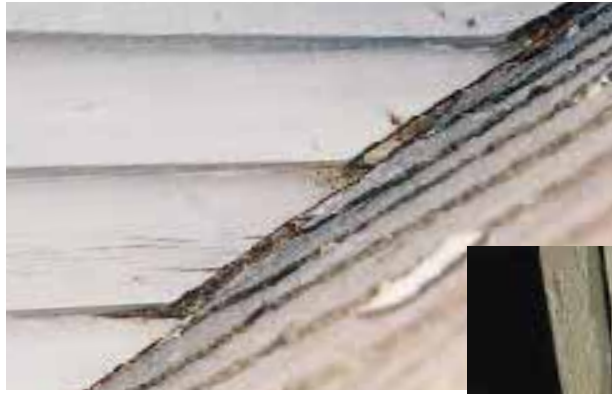
When an exterior wall with wood siding rises above a roof — for example, where a two-story house extends above the roof of an attached one-story garage — the siding and corner trim nearest the roofing can rot quickly. Rain bounces off the roofing onto the adjacent wall. Snow may sit on the roof for months at a stretch.

In the case of asphalt shingle roofs, siding is usually installed over step flashing formed from 8-inch aluminum squares. This gives 4 inches of flashing on either side of the crease. Some siding installers pride themselves on covering as much of the flashing as possible, bringing the end grain of the clapboard close to the roofing. On the contrary, the more exposed metal, the better.

Instead of butting wood siding and trim up to the roofing, it should be held back to prevent the wood from wicking up water, and to allow for drying.

Ideally, step flashing should be at least 12 inches wide, with 8 inches on the vertical side of the crease, and 4 inches on the roof slope side. That way, the siding and corner trim can lap the flashing by 4 inches, and still leave a gap of 4 inches between the siding and the roofing.

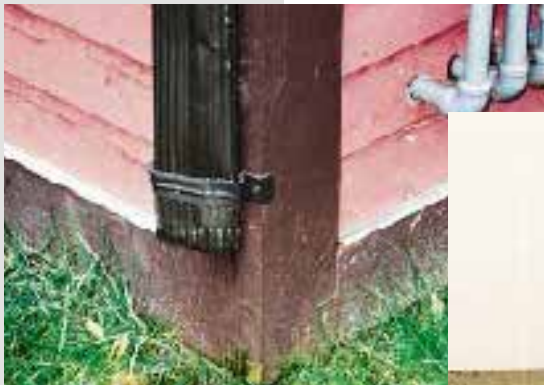
If the grade is too high, the water table and corner trim are kept constantly wet from splashback and damp grass.

Some design and workmanship problems are easier to fix than others. One of the most frustrating errors to encounter, years after construction, is a high grade. Ideally, the final grade should be at least 8 inches lower than the lowest wooden components of a building —usually, the water table or lowest course of siding. Unfortunately, far too often a builder establishes the final grade within an inch or two of the lowest course of siding.

By the time the wooden components nearest grade are beginning to rot — due to splashback or damp vegetation — landscape plantings are usually well established, and concrete walkways may have been poured. At this point, lowering the grade is very expensive. Worse yet, the builder didn't save any money by doing it wrong in the first place. Usually, establishing a lower grade at the time the foundation is back-filled won't cost the builder an extra penny; in fact, if it saves bringing in some fill, it might even be cheaper.

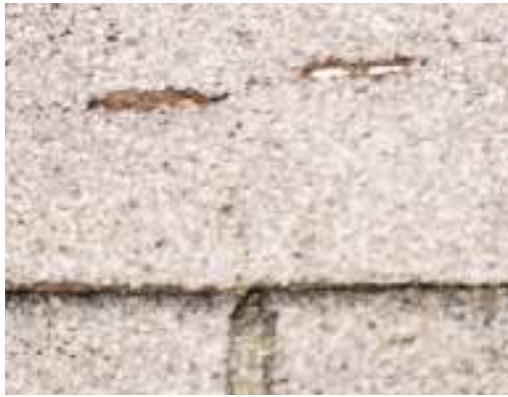
The main challenge when installing asphalt shingles with an air tool — whether a nail gun or a stapler — is accurate depth adjustment of the fasteners. If staples are left proud, the roofing will fail prematurely as the staples poke through the overlapping shingles.

Protruding fasteners can cause breaks in asphalt shingles.

The Asphalt Roofing Manufacturers Association recommends that only nails, not staples, be used to fasten asphalt shingles, although some manufacturers, including GAF, permit stapling. Regardless, fasteners must not be left proud.

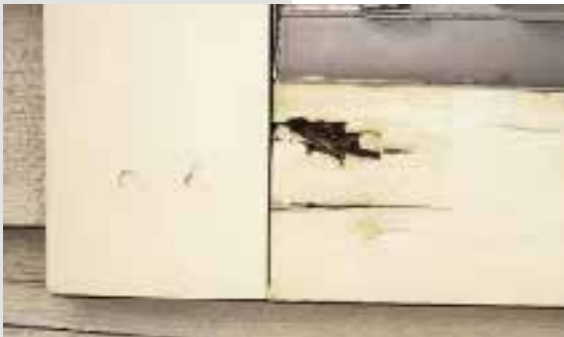
Because it catches water from the window sill above, the pine trim on this house began rotting after only five years.

A window should never have exterior casing installed like interior “picture-frame” trim. If the trim ends up proud of the sill lip, as was the case at one five-year-old house (photo), it acts as a sponge to receive all of the water dripping off the window sill.

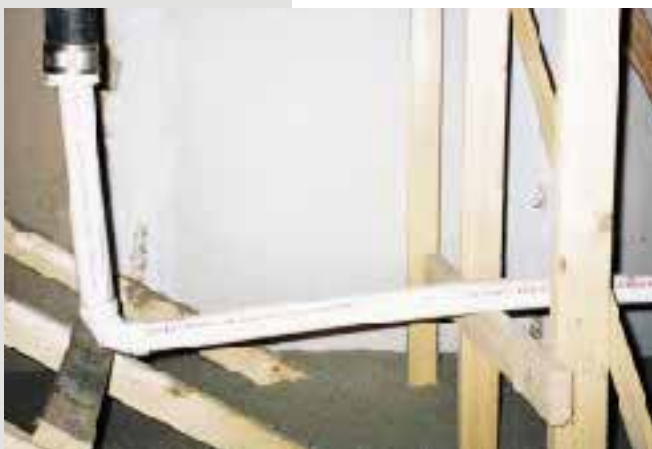
In the house where this photo was taken, the poorly supported PVC vent pipe was stressed by the added weight of the cast-iron transition through the roof. The sagging pipe formed a trap, and the vent became blocked by standing water. The source of the water was either rain entering the top of the vent, or condensation forming inside the cold pipe in the attic.

As a result, whenever the washing machine drained, the descending column of draining water created negative pressure, sucking the water out of the P-trap under the lavatory sink. The owners complained of sewer gas smells coming from the lavatory.

Most plumbing codes require horizontal lengths of plastic pipe, including vent pipe, to be supported every 4 feet. It is especially important to install a pipe hanger near the point where the vent turns to penetrate the roof.

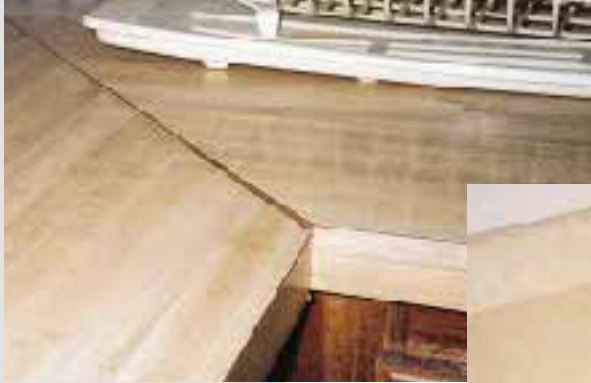
Over time, water will enter a mitered joint on a laminate countertop, causing the particle-board substrate to swell.

In theory, mitered joints in post-formed laminate countertops can work — if they are kept dry. (As we all know, kitchen countertops never get wet.) If these miter joints do get wet, the particleboard substrate begins to swell. If you prefer to use post-formed laminate for kitchen countertops, at least plan the kitchen to keep the miter joint as far from the sink as possible. If the sink is within 4 feet of the miter joint, you had better hope the homeowners don't use their sink very much.

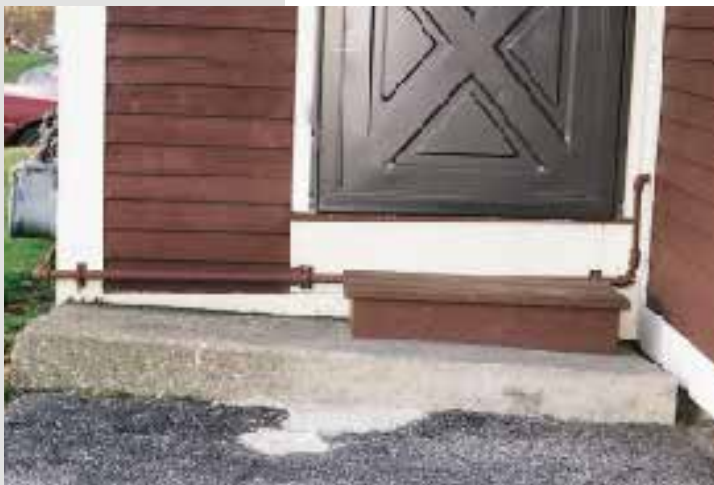
All too often, concrete slabs and stoops installed against a foundation heave or settle, occasionally because of frost action, but more commonly because the backfill compresses. Since the fluffiest, least compacted soil is typically closest to the foundation, slabs and stoops often lean toward a building as time passes. Rainwater hitting the concrete is then directed toward the building, raising the chance of basement flooding and rotting siding.

This wooden step (above) was built to compensate for a concrete stoop that settled. The photo at right shows how a settling patio slab directs rainwater toward the house.

There are various solutions to this problem, including extending a footing below frost level, or installing a deep layer of crushed stone under the concrete. At a minimum, backfilled soil should be thoroughly tamped with a mechanical plate compactor.

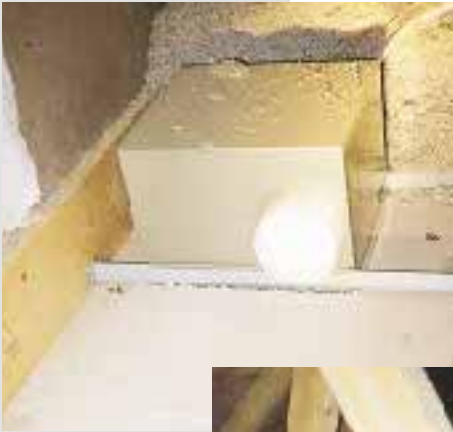
Whenever a bath exhaust duct terminates in the attic, the warm, humid exhaust air can cause mildew and ice dams.

What's wrong with blowing the bath exhaust (or the range hood, or the dryer vent) into the attic? After all, the attic has soffit and ridge vents, so it shouldn't be a problem, right? Actually, there are two problems with this idea: warm temperatures and high humidity. The warm interior air from the exhaust duct raises the temperature of the roof sheathing, melting the snow and leading to ice dams.

And since the interior air (especially bathroom air) is very humid, that moisture will want to condense on the cold surfaces in the attic.

In houses with a bath exhaust fan vented to the attic, the underside of the roof sheathing is often black with mildew. The soffit and ridge vents do not provide enough ventilation to handle the added warmth and moisture from an exhaust duct.

The bath exhaust fan should always be ducted to the exterior, never terminated in the attic. To be charitable, this is one of those items that is not so much a deliberate error as a forgotten detail. "Sure, I was going to get back up in the attic, as soon as the siding was done, to take care of that bath exhaust duct ..."

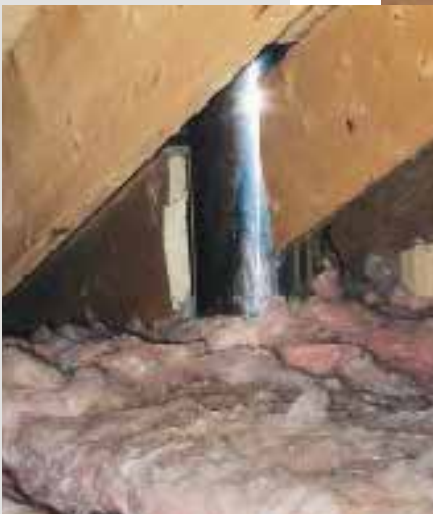
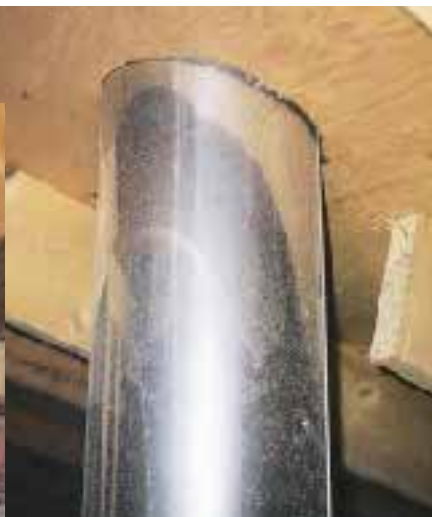
Maybe next time your heating sub comes in and installs a metal chimney, you should climb into the attic to look at his work.

Would a chimney installer really cut a rafter without installing a header? During my work as a home inspector, I saw this problem three times in three years.
