# Cleaning Up After the Storm

by **Bill Phillips**

## Disaster repair work provides satisfaction and a clear source of payment

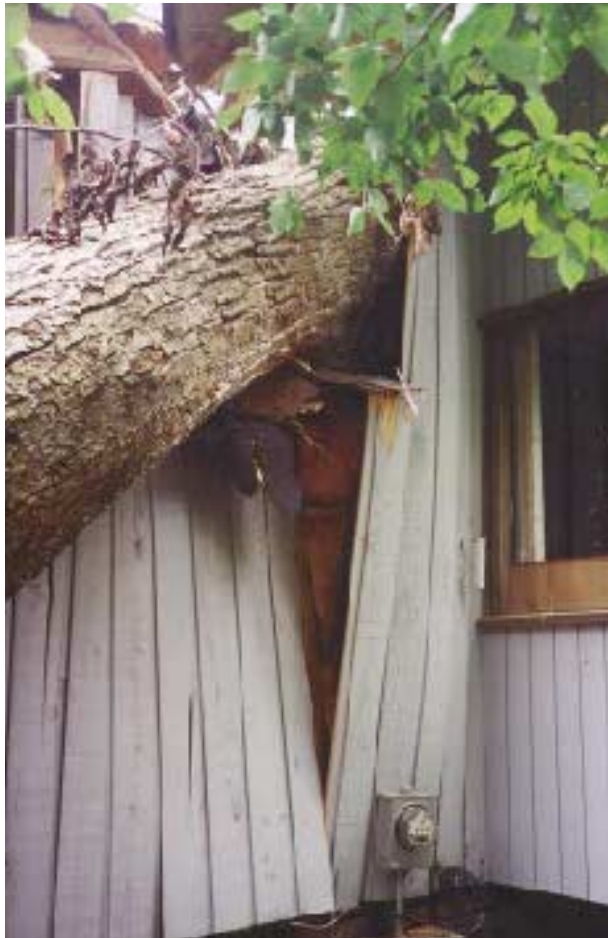
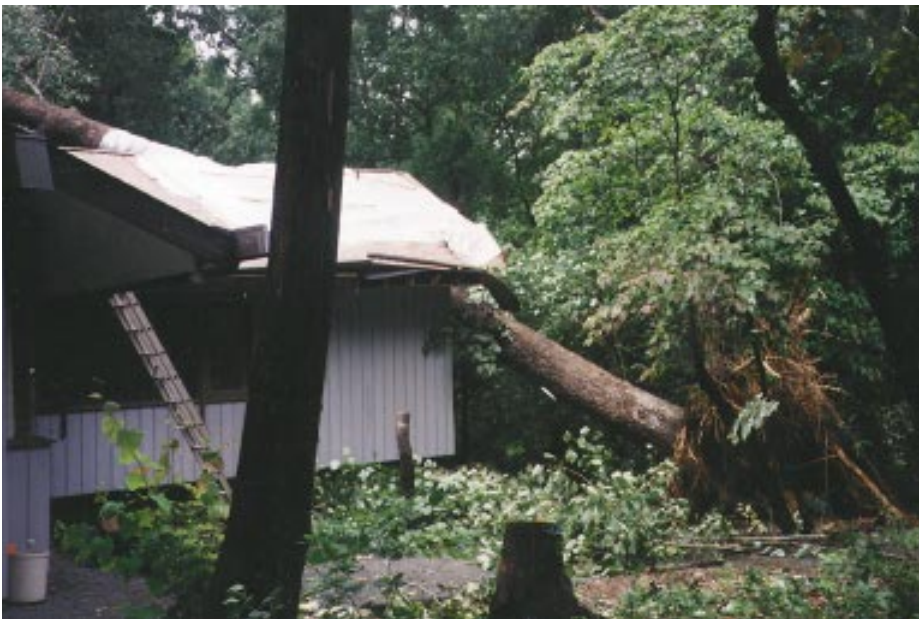
**Figure 1.** Felled by a September hurricane that veered inland, this mature poplar tree was an unwelcome house guest (right). The first order of business was to cover the gaping hole — and the tree within — with 6-mil plastic to keep out the rain (below).

road. I could not get into the drive of the home, since two or three trees were lying across it. But within an hour, I had plastic tacked down over an enormous poplar tree and a gaping hole in the roof (see Figure 1, next page).

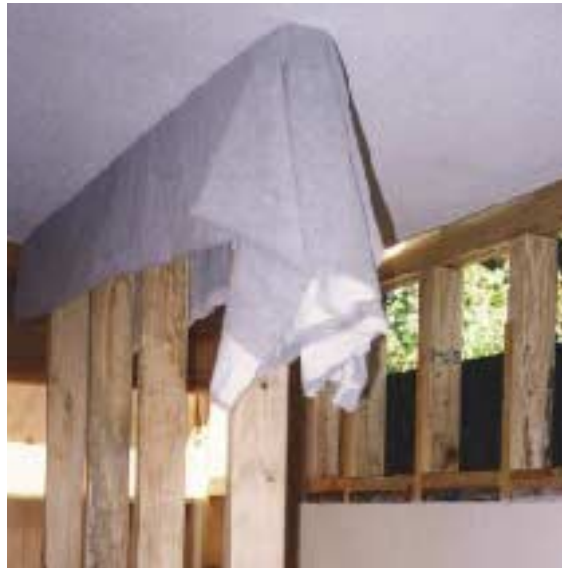
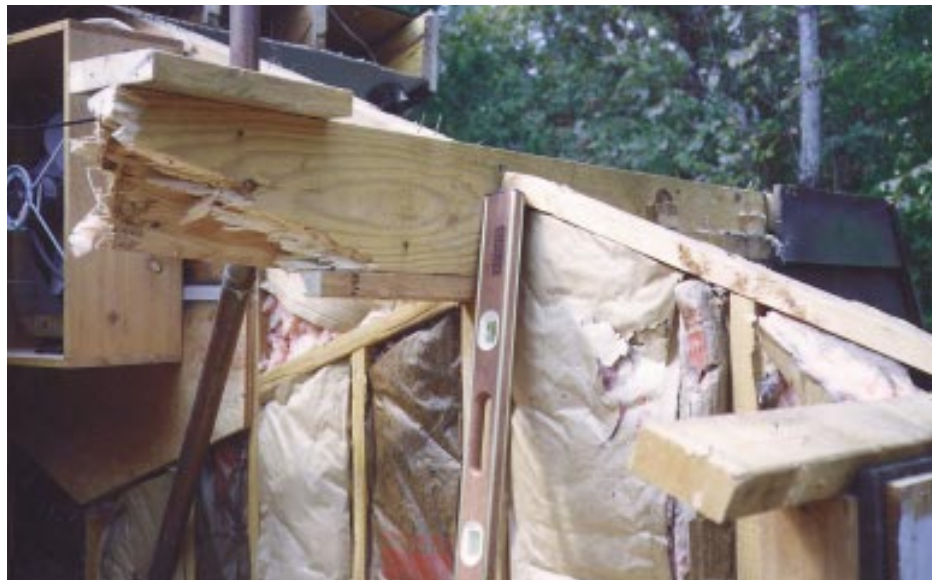
**Figure 2.** The undamaged bedroom ceiling was braced with a temporary wall cushioned by a folded drop cloth (left). Broken framing members like this 4x10 beam (below) were cut back to sound wood.

The master bedroom had been vacated for the duration and became the tool storage room. We covered the oak floor to protect it, even though we knew it would have to be refinished because of water damage at one end. Oddly enough, the textured bedroom ceiling was completely intact and did not need repair. To keep it that way, we braced it with a temporary wall in order to work on the adjoining exterior wall (Figure 2). The closet doors and bath door were removed, jamb and all. The bath ceiling was completely replaced because the ceiling joists had been split, and the entire closet area, interior and exterior, was rebuilt. We also replaced a 24x16-foot section of the roof.

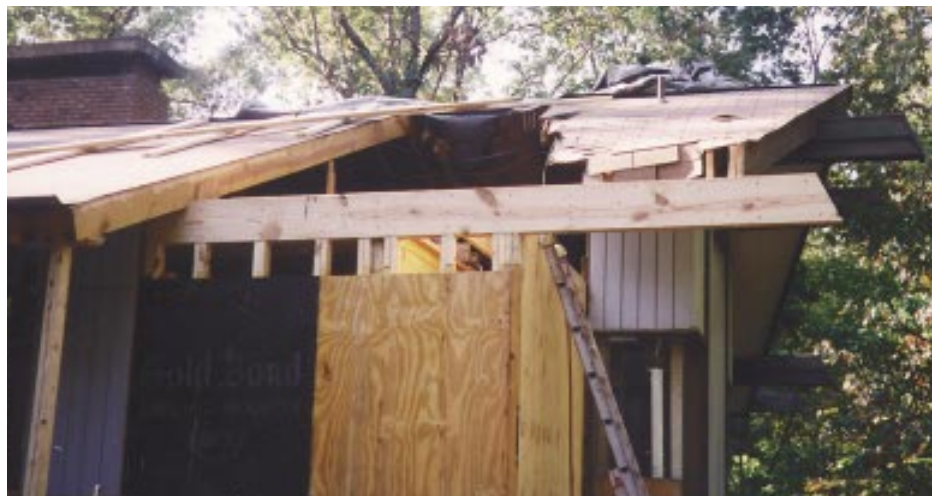
**Figure 3.** Replacing the cantilevered beams that supported the gable-end overhang was a time-consuming task that called for some discussion with the homeowner's insurance adjuster.

One interesting architectural feature of this house is that the gable ends of the roof have very wide overhangs and are supported by cantilevered beams secured well within the framing of the house. Since the ends of a couple of these beams had been snapped off by the tree, we had to remove enough roof to take out the old, damaged beams and install new ones (Figure 3, previous page). This was one of the tasks that didn't fit into the insurance company's statistics of averages for repairs, but once we explained the nature of the task and how time consuming it was, the adjuster was willing to add an amount for doing it.

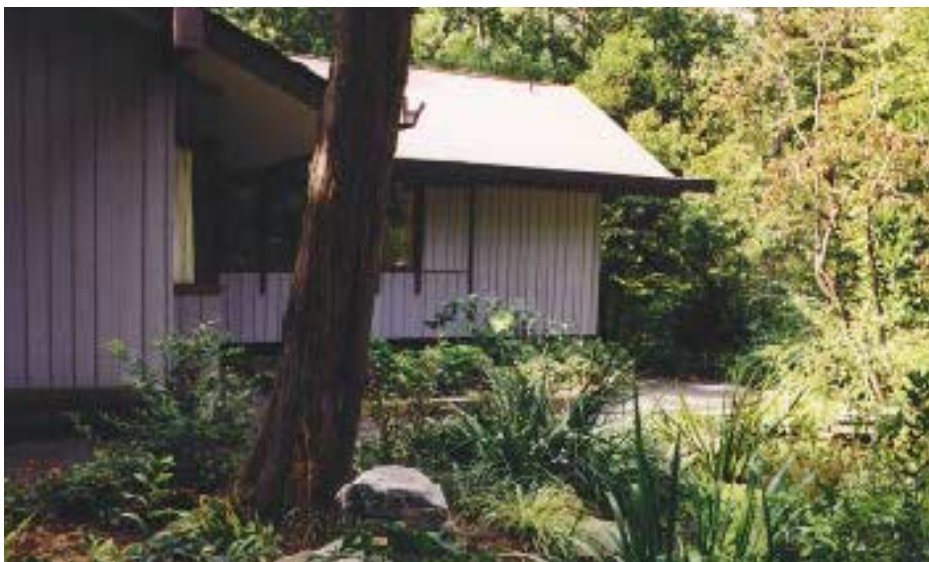
**Figure 4.** Eight weeks, 440 carpentry hours, and \$25,000 later, the house — shown here the following summer — was at least as good as new.

We started the job on October 1, 1996, and completed it, except for the roof shingles, on November 26. The carpentry took 440 hours, which includes my time working "hands on." Add to that the subcontracts, which included roofing, sheetrock, painting, and floor refinishing. The total cost of the completed job was \$25,060 (Figure 4).

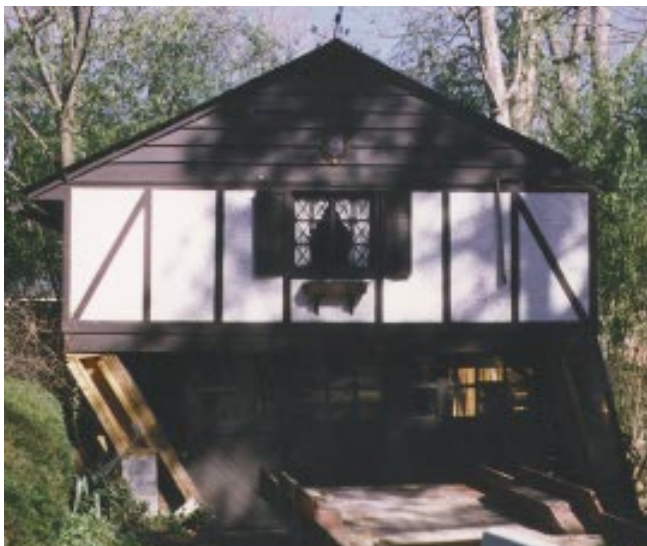
**Figure 5.** Same storm, different tree. Although the second-story apartment suffered relatively minor damage, the poorly braced walls of the two-car garage beneath collapsed on impact, bringing the structure to rest about two feet to the left of its original location.

completely knocked off its foundation by a falling tree (Figure 5). Because it was uninhabited, the appealing structure was a low priority for repair. A few contractors looked at it and suggested that it be torn down and rebuilt.

Though picturesque and inviting, this garage had not been solidly built. Had the walls been sheathed in plywood, I doubt the tree could have pushed it over. But since bracing was minimal and the siding was nailed directly to the studs, the building leaned easily about four feet off its foundation and came to rest against a tree on the opposite side. Had it not been for that small tree, the second floor would surely have ended up on the ground. Surprisingly enough, the main structure was still square and sound despite some damage at the corner where the tree hit.

Nevertheless, this structure had some serious problems. The first floor was beyond repair. The second floor would have to be lifted by house movers and placed back over the foundation, so that a new first floor could be rebuilt under it. Even so, I was convinced that building a new two-story garage would cost more than salvaging the existing one. Since I was the only contractor who showed any interest, I got the job.

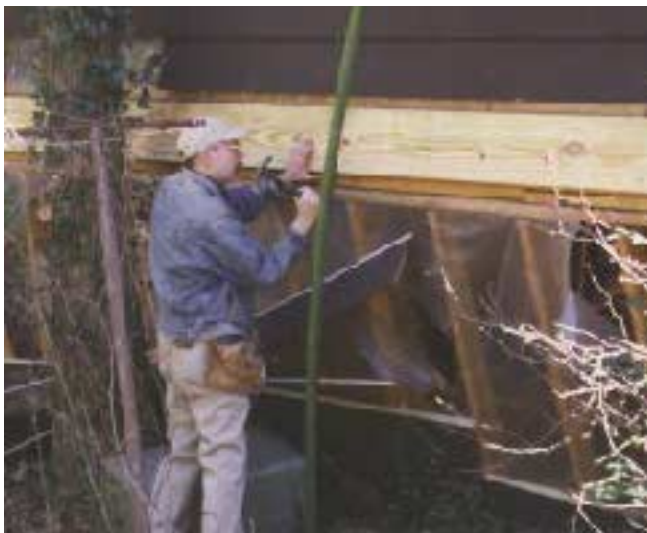
**Figure 6.** An initial attempt to jack up the second-story apartment was cut short when the midsection began to sag. To stiffen the floor structure before lifting resumed, reinforcing 2x10s were nailed to the rim joists.

and I nailed a reinforcing 2x10 along each side of the floor system (Figure 6, page 4).

After lunch, they tried lifting it again, and the center section held its shape, easing my concern about structural damage. Satisfied in their first step of lifting the weight of the second floor off the tilted first-floor walls, the movers braced the second floor at the raised position and called it a day. The second floor was still two feet off-center of the foundation, but it was lifted and secure. My crew and I spent the afternoon removing the first-floor walls.

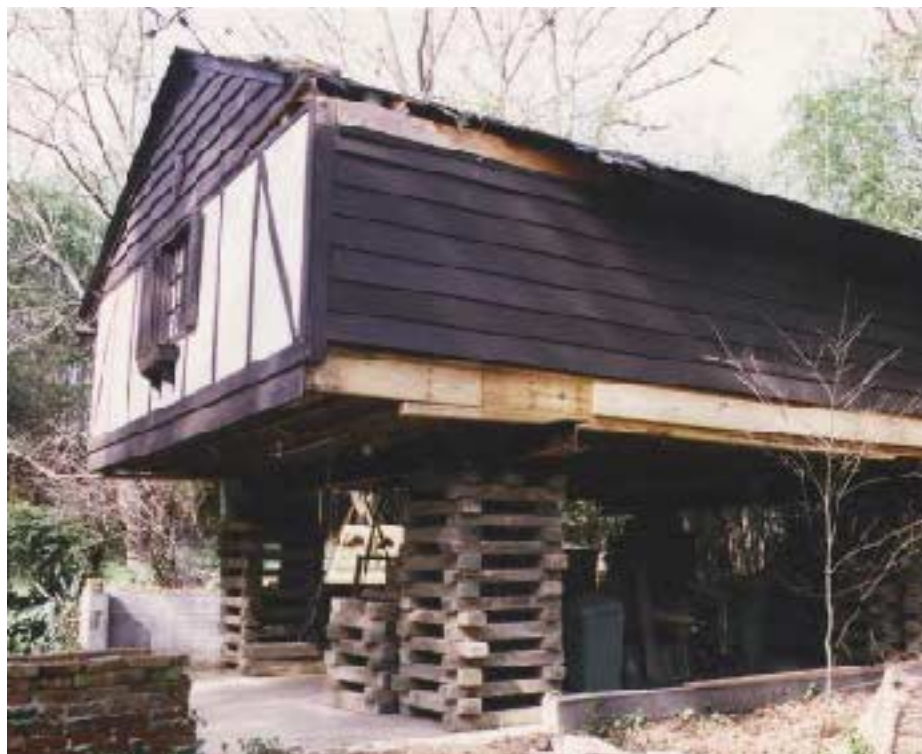
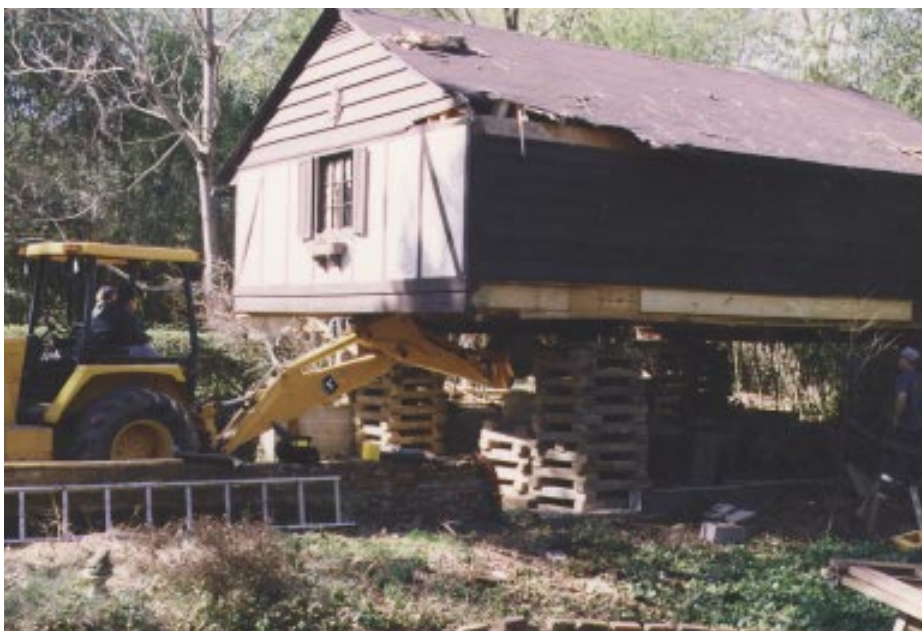
**Figure 7.** Once elevated on cribbing (top), the structure was carefully repositioned with a backhoe, aided by small steel rollers placed beneath the supporting steel I-beams (bottom).

In the morning, the movers returned to position the second floor over the foundation. They placed small steel rollers under the I-beams. Then one of the movers eased the shovel of his backhoe under the floor. With amazing precision he nudged the building, and it began to move (Figure 7, previous page). A gentle push in first one direction and then another, and in about an hour the second floor was sitting over the foundation, no more than  $\frac{3}{8}$  inch out of plumb at any corner — which for all we knew was as good as it had ever been. The movers jacked it up to the right height, readjusted it all around, and their job was done.

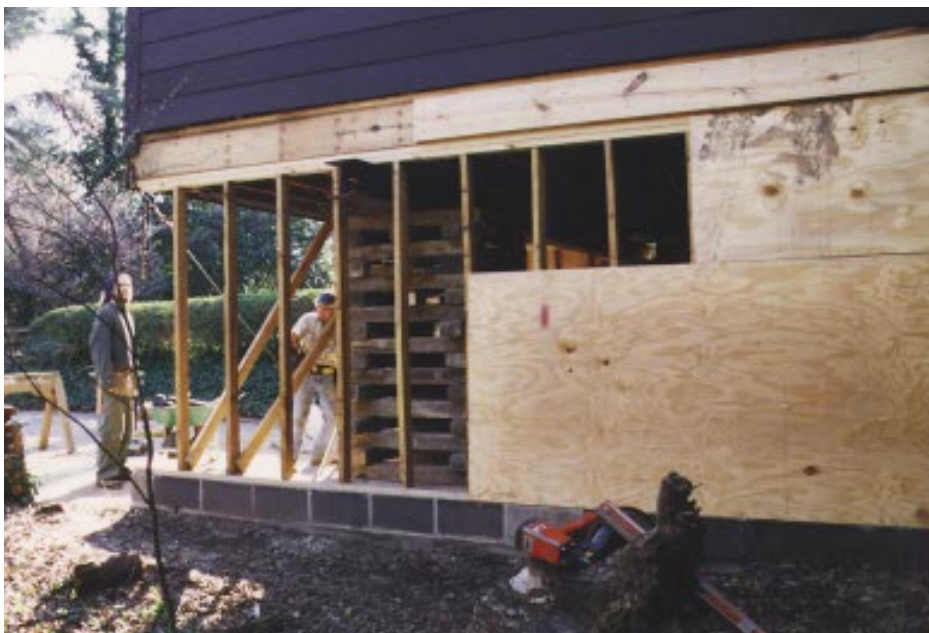
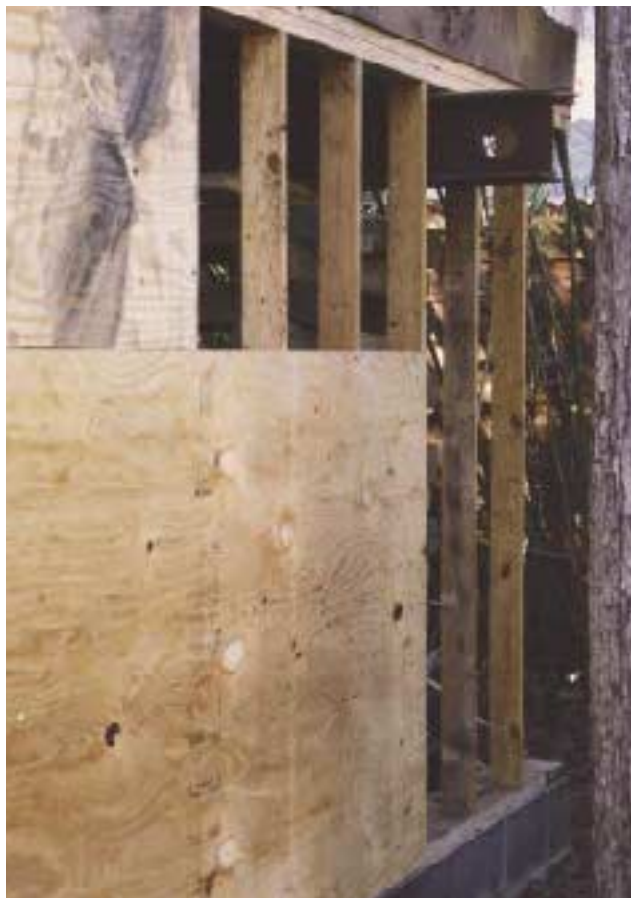
**Figure 8.** After some minor foundation repairs and the placement of new anchor bolts, new garage walls were framed and partially sheathed (above). At the last minute, the steel beams were eased out of their slots, shifting the second-story load onto the foundation (right).

Some block joints in the foundation had been damaged by the force of the blow, so those blocks were re-laid. The cores of the entire foundation wall were filled with concrete, and foundation bolts were set in and tightened to the bottom plate of the wall. We set the framing of the first-floor walls  $\frac{1}{2}$  inch in from the original in order to sheath the studs in plywood. Plumbing lines to the second-floor apartment had been ripped loose by the blow, and we repaired those. Once the structure was framed and mostly sheathed, we slid the steel beams out of their slots (Figure 8).

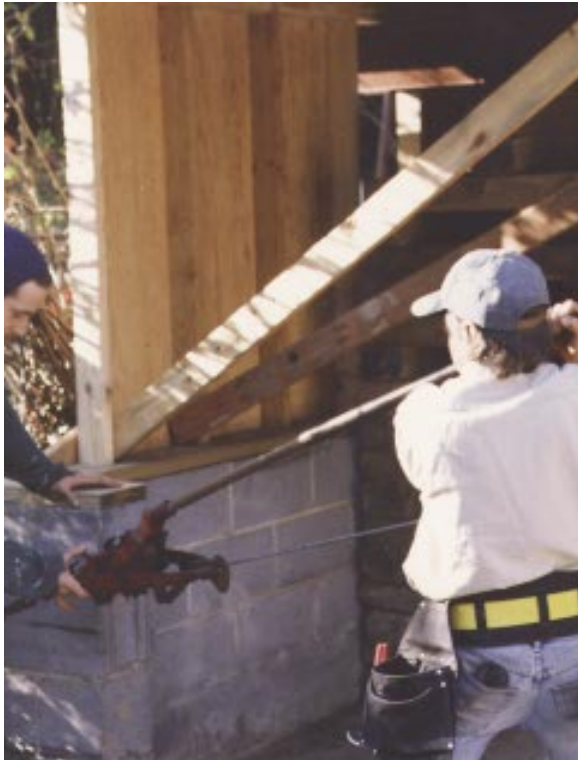
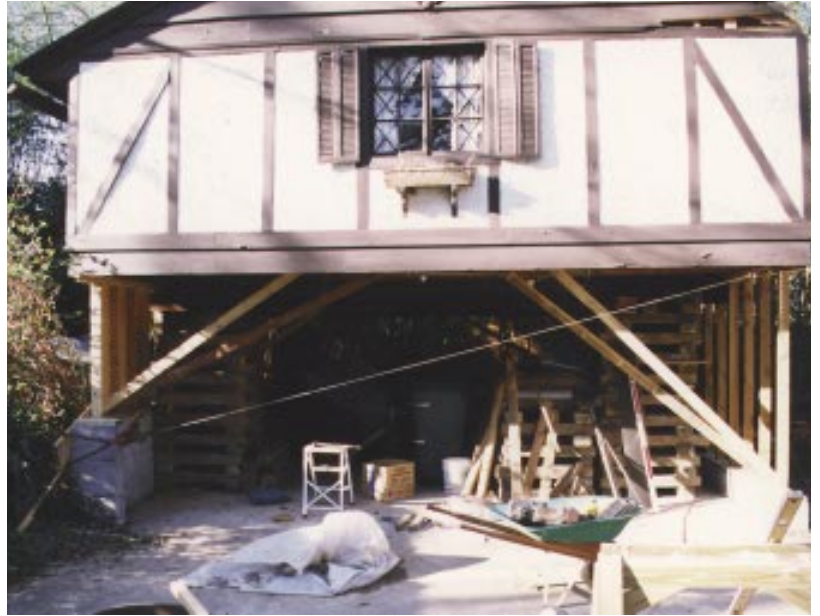
The only problem now was that the opening for the garage doors was slightly out of square. To fix it, we used a come-along to crank the opening

**Figure 9.** To square up the garage door opening, the completed frame was carefully racked with a come-along (left), and the temporary diagonal bracing shown above was replaced with shorter, permanent braces.

square and locked it into shape with short, permanent interior diagonal bracing (Figure 9).

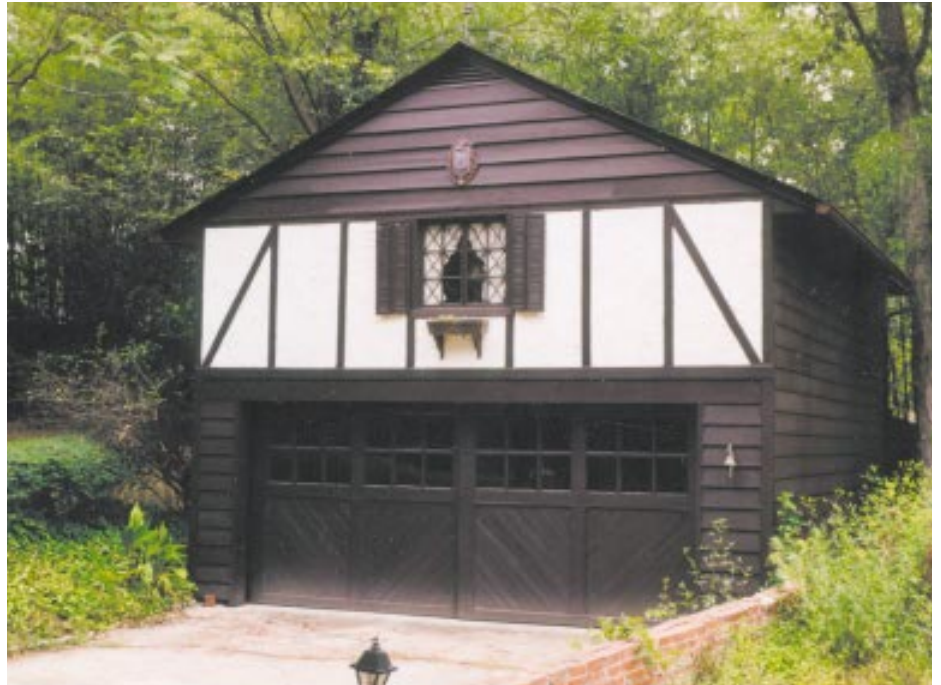
**Figure 10.** Better than new on its reworked underpinnings, the repaired structure came in well below the cost of razing and rebuilding.

This job was completed in six weeks and cost \$27,250 (Figure 10). The 535 carpenter hours included my time as contractor, because I work as a carpenter on my jobs. It also included the many non-carpenter things that carpenters do, such as laying a few blocks when the job is too small to call a mason. The price included the painting, electrical, and plumbing subcontractors, as well as the \$3,000 bill from the house mover.
