# Builder Blunders

It's always  
cheaper to  
learn from the  
other guy's mistakes

by Stephen Smulski

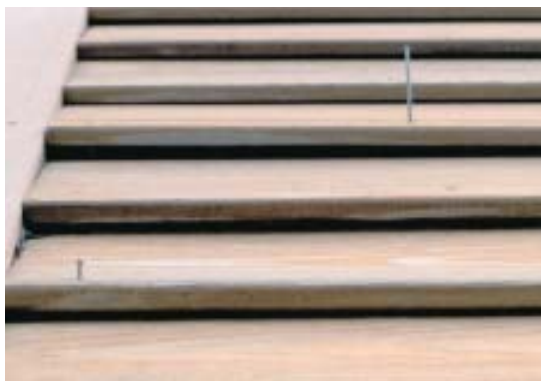
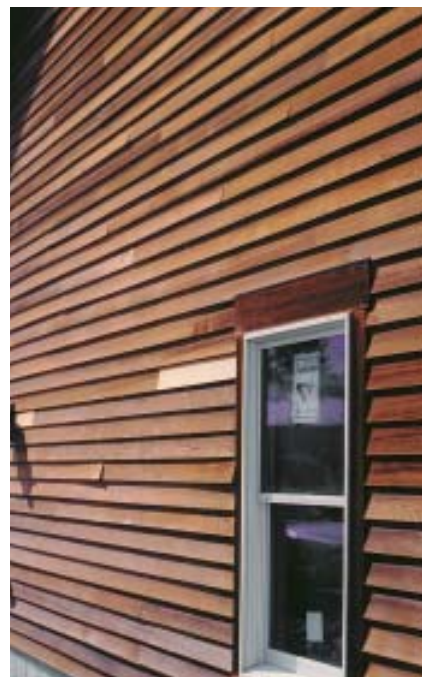
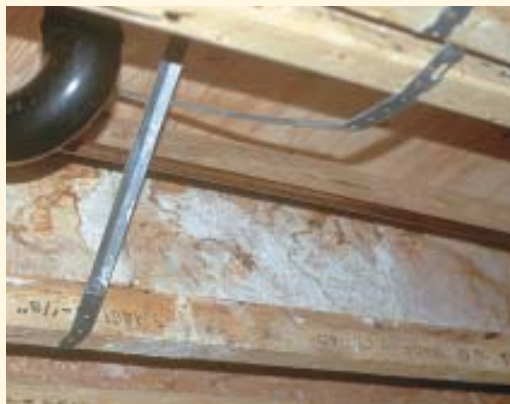
## The Finishing Touch

A homeowner complains that the cedar bevel siding is falling off her house less than a year after it was installed. Turns out the builder fastened it with pneumatically-driven finish nails. The nail heads are so small that they pull through the siding as the wood shrinks and swells in thickness and tries to cup. This occurs where the nails are sunk

into the framing — lots of nails missed the framing altogether. Where that happened, movement of the siding slowly ratchets their smooth shank out of the plywood sheathing. The only fix is to remove the siding and properly hand-nail new siding into the framing with ring-shank stainless-steel siding nails.

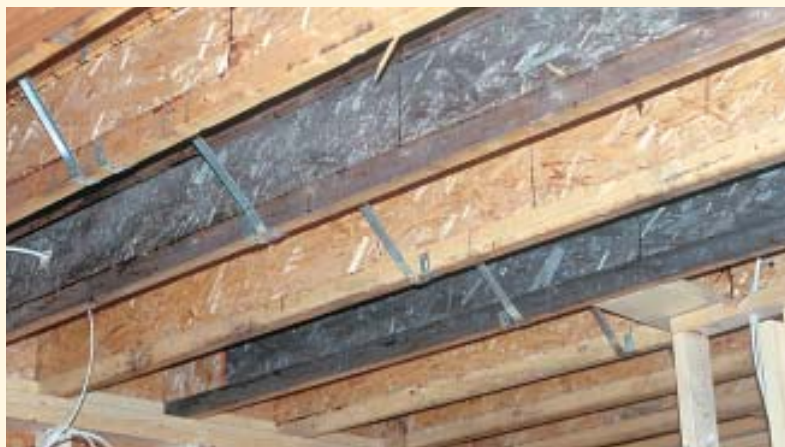
**Hear No Evil,  
See No Evil,  
Speak No Evil**

**A**n architect visits the house he's having built for himself and is stunned by the condition of the wood I-joists the contractor used to frame the floors. By now, the two-story building is weathertight, and pipes and wires have been roughed-in through the I-joists' webs. Amazingly, the contractor installed nearly two dozen I-joists with obviously rotted webs without blinking an eye or mentioning anything to anyone simply because that's

what was delivered to the job site. Equally astonishing is the apathetic silence of the plumber, electrician, and code officials who signed off on three separate inspections. One flange of every I-joint is weathered and gray, as is one side of the web of two I-joists. Clearly, these two I-joists were on the outside of a banded bundle that got wet and rotted while being improperly stored out in the open somewhere along the way. Whether the rotted I-joists are reinforced or removed, the utilities have to be pulled.

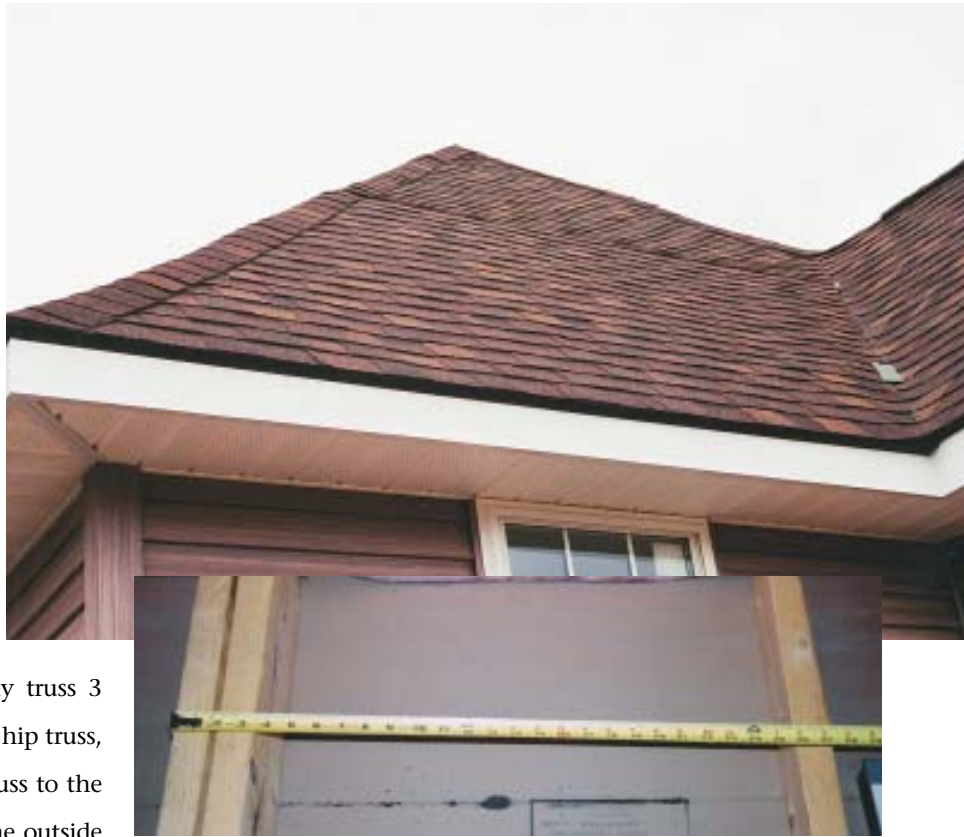
## On-Center Space-Out

A developer stops by one of the spec houses he's financing a few days after the roof is shingled. He notices that all three of the building's hip roofs have three slightly different planes instead of a single plane that rises smoothly from eaves to ridge. Turns out the builder consistently positioned the first hip truss in each roof too far from the girder truss. This happened because he incorrectly referenced his measurement for the location of the first hip truss. Instead of measuring from the outside face of the girder truss — a two-ply truss 3 inches thick — to the outside face of the first hip truss, he measured from the center of the girder truss to the outside face of the first hip truss. This put the outside face of the first hip truss 25½ inches from the outside face of the girder truss instead of the 24 inches called for. Consequently, the roof angle rose at the intended 45 degrees, dove to 43 degrees, then climbed back to 45 degrees. Although each plane sticks out like a sore thumb when the sun is low in the sky, the homeowner will have to learn to live with it.

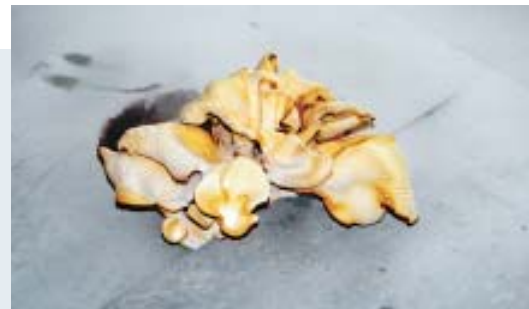
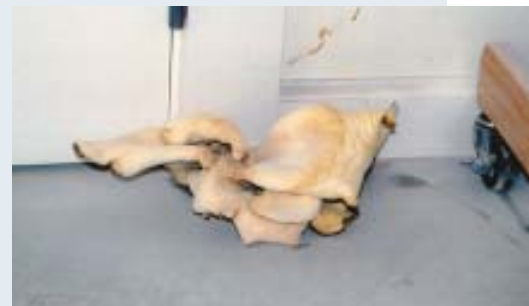
## School Daze

**Entering her classroom** one morning, a teacher at a one-year-old slab-on-grade elementary school is startled by huge mushrooms sprouting out of the vinyl-tiled floor. A scan of the plan reveals that the classroom floor slab is depressed below the level of the sidewalk leading to the entrance door. This was done so that the sidewalk and floor would be at the same elevation. The sidewalk, of course, slopes toward the door. Water puddled on the sidewalk runs under the threshold and pools on the slab, where it saturates the plywood subflooring under the vinyl, creating conditions ideal for rot. This predictable problem wouldn't have happened had the architect properly put an interceptor grate and drain outside the door.

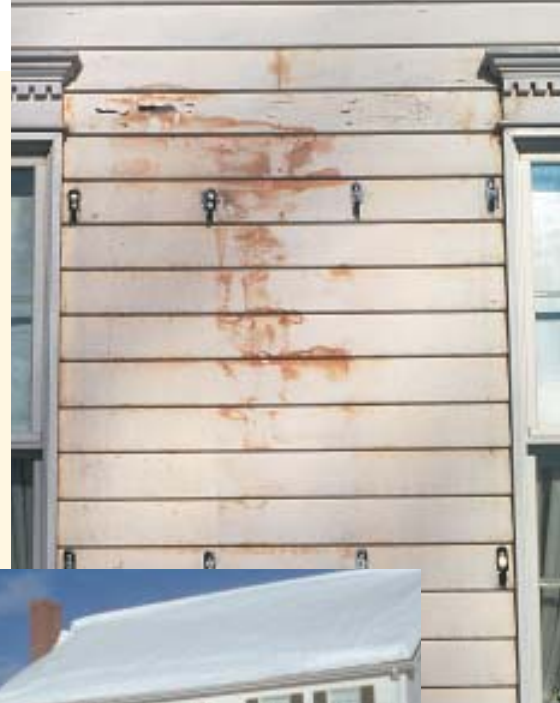
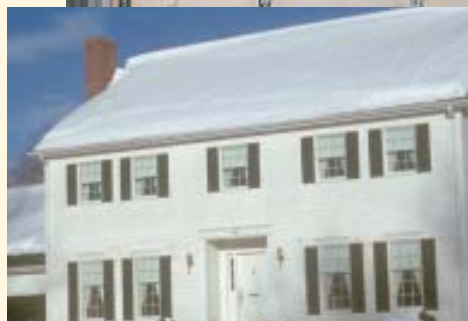
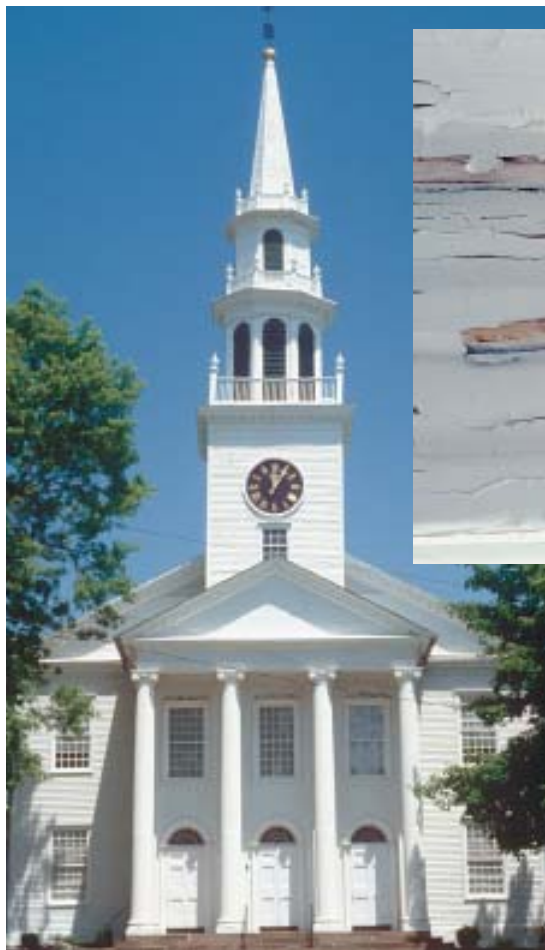
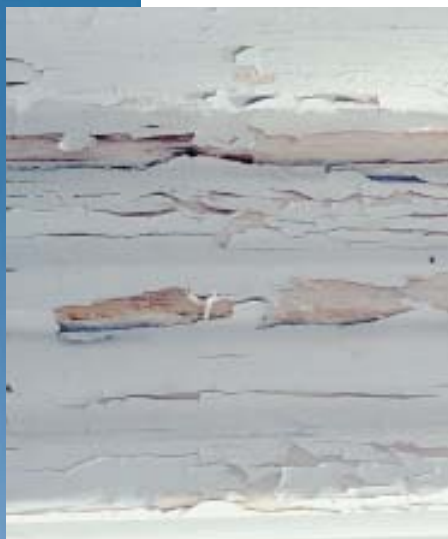
## Hot-Air Headache

### A homeowner complains of chronic peeling paint and red-brown stains on

the cedar bevel siding on his three-year-old two-story house, which is painted white. Most of the peeling and staining occurs between pairs of windows on the first floor beginning at the level of the rim joist between stories. Like many houses, this one has a forced-hot-air heating system with a humidifier. The hvac contractor, for reasons known only to him, routed the ductwork for the second floor up through the exterior walls instead of inside the interior partitions. The ductwork is uninsulated, joints between sections are not sealed, and the stud bays containing the ducts have virtually no insulation in them. Every time the heating system operates, it blows hot, humid air inside the walls. The resultant condensation wets the sheathing and siding, then discolors and pops the paint. No matter what correction is chosen, it will surely be expensive.

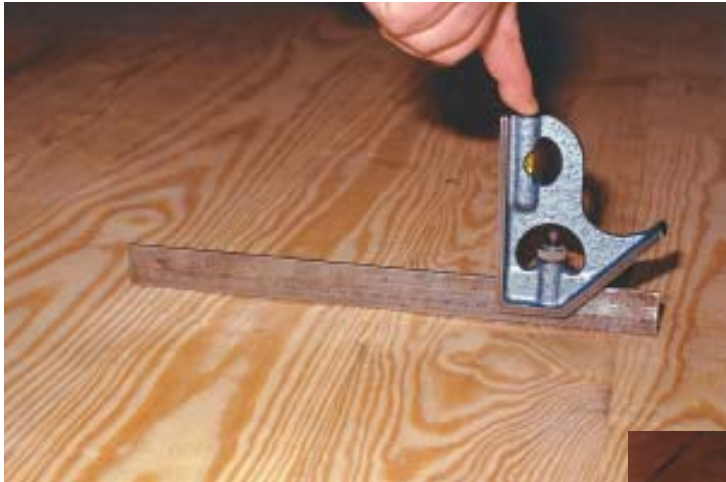
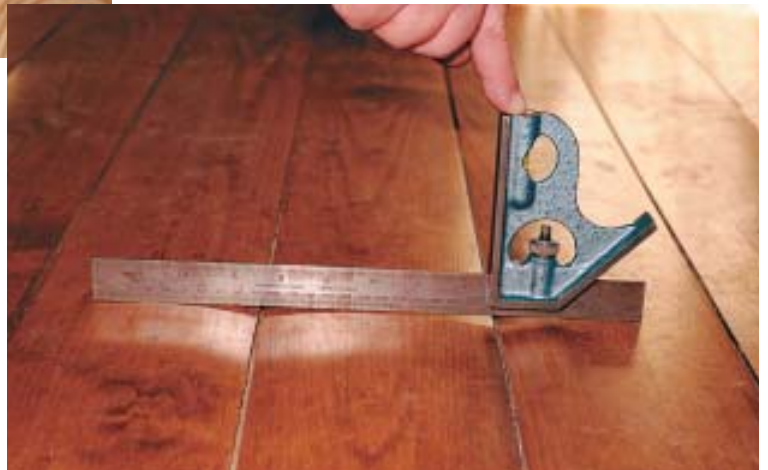
# Fast-Track Train Wreck

A contractor was converting several old wooden warehouses into retail shops and office space on a tight schedule. In early August he poured a cementitious leveling compound over the existing floors, then soon laid sleepers and southern pine plank flooring so that he could frame the interior partitions on a smooth,

even base. By mid-October the flooring had been sanded and finished. A few weeks after the heat was turned on, tenants complained that there were wide gaps between planks and that the planks had arched upward. Thousands of square feet of flooring went south on this project because its moisture content was too high when it was installed. After being laid, the bottom of the planks adsorbed water vapor evaporating from the still-drying leveling compound. This caused them to cup, with their edges raised above the centers. When the cupped planks were sanded flat, the raised edges were taken off. Once the heat was turned on, all hell broke loose. Gaps between the planks grew excessively wide as they shrank in width because their moisture content had been too high when they were laid. Though the planks seemed to arch upward, they actually reflattened as they dried out, revealing a condition known as crowning, in which the center is raised above the edges. Because sanding the planks when they were cupped left their edges thinner than their center, the edges ended up lower than the center when the planks reflattened. Most of the crowning was removed by careful sanding, but nothing could be done to narrow the gaps.
