RESISTING Tornado Damage

by Bryan Readling, P.E.

Wood-frame buildings can take the brunt of all but the biggest storms, but the connections have to be strong

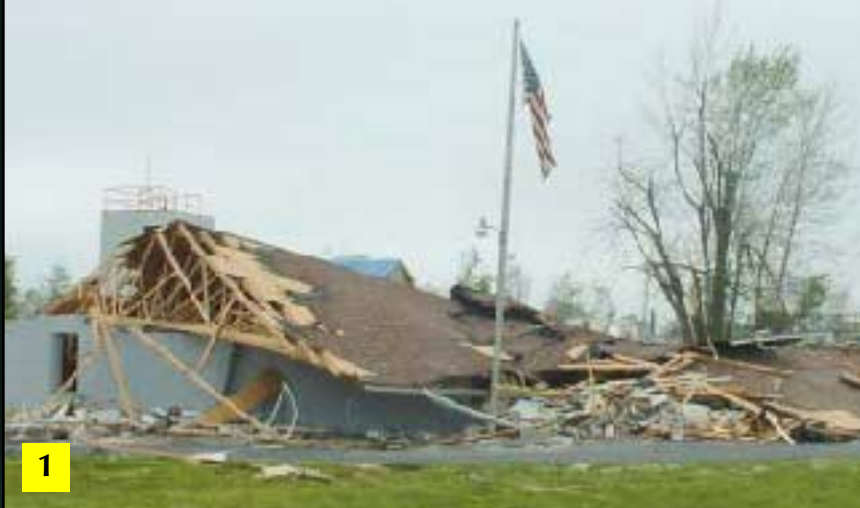
The masonry walls of this fire station (1) were inadequately reinforced to withstand the tornado forces. A lumber nailer bolted to the top of the walls supported open-web wood trusses that spanned 50 feet. Despite the enormous loads such large trusses could be subjected to in high winds, they were attached to the lumber plate with only toenails (2).

As a unit, the roof lifted off the building and shifted laterally. Many of the walls collapsed, covering emergency equipment and personnel. A worker reported that the building was 10 to 15 years old.

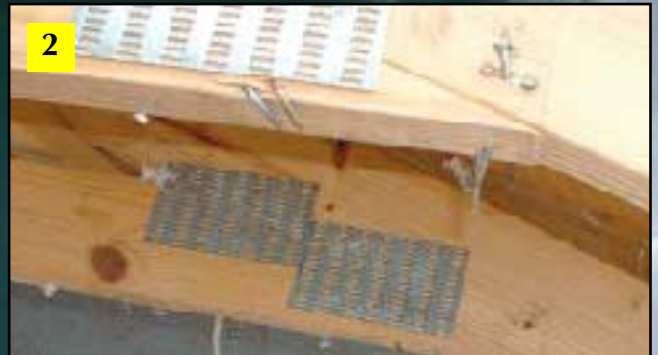
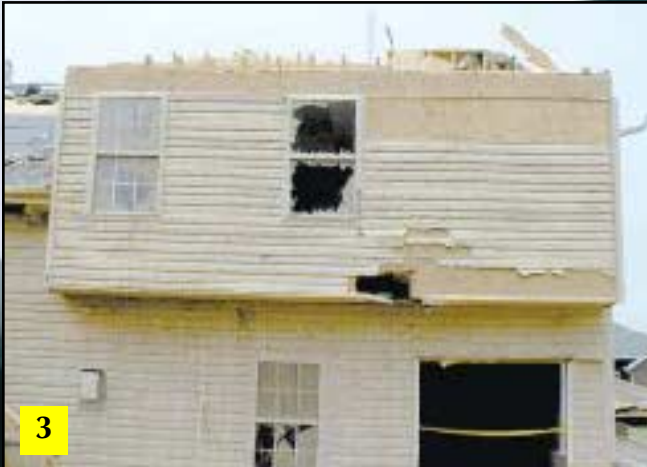
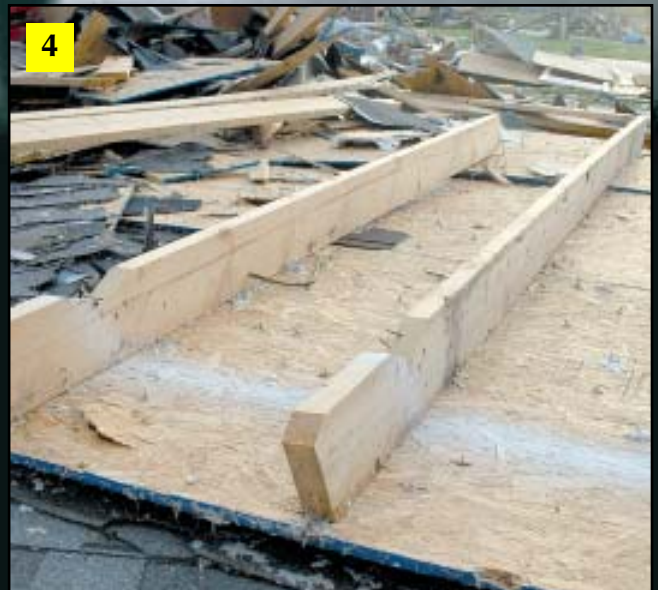
The severely damaged homes in the Missouri subdivision visited by the author commonly lost either all or a large portion of their roof framing. Most of the roofs were stick-built, with no light-gauge metal connectors tying the roof framing to the top of the walls. The home shown above (3) was under construction but completely dried-in at the time of the tornado. Throughout the subdivision, sections of roof lay scattered on the ground; most of the rafters had only a few toenails driven into the supporting wall top plates (4).

Use metal connectors to tie roof framing to the top of walls. Uplift performance of straps or clips is better and more reliable than toenails (illustration, previous page). A few more dollars spent on light-gauge metal connectors could make the difference between structural failure and good building performance.

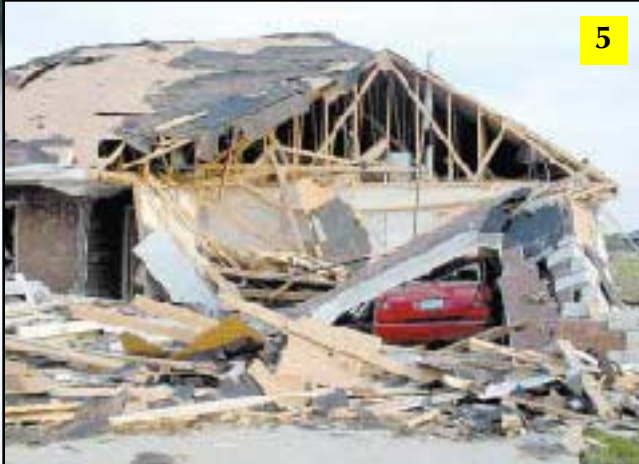
5

Nearly every home in the subdivision had a two-car garage (5). On about half the homes with major damage, the structural failure started with the garage. In some cases, weak garage doors were destroyed by wind and flying debris, exposing the interior of the homes to wind pressure. Inadequate wall bracing on either side of the garage opening and poor attachment between roofs, walls, and foundations also made garages vulnerable to internal pressurization.

Use APA-designed portal framing when narrow return walls are desired at garages. Such framing details improve the bracing performance of narrow walls (see *Practical Engineering*, “Building Strong Garage Door Walls,” 4/04; www.apawood.org/bracing).

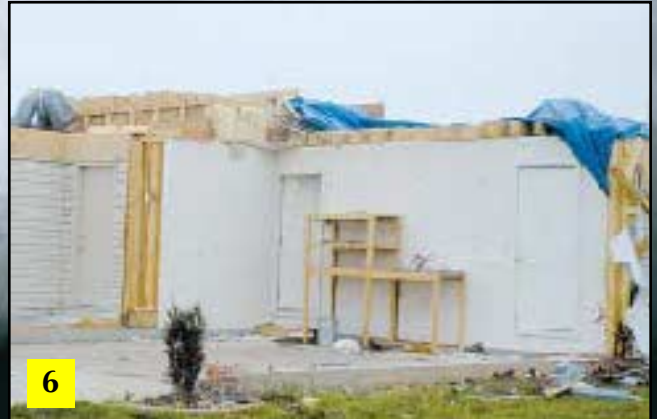
6

The garage walls and the entire roof are completely missing from this severely damaged home (6). Note the exposed garage slab and the drywall on the garage's rear wall, where a storage shelf still stands.

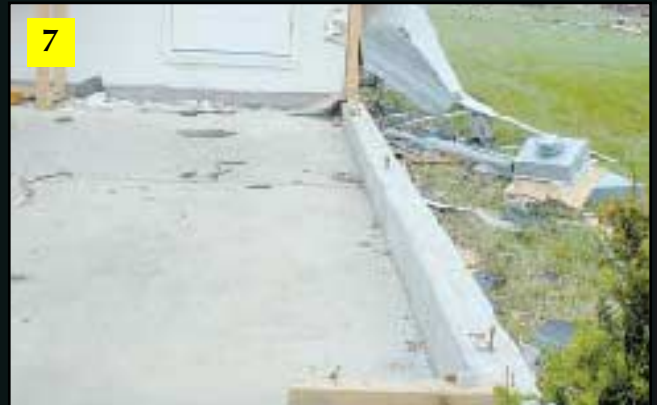
7

The garage walls were poorly braced and inadequately tied to the foundation. The bottom plate of the garage sidewall is missing, leaving anchor bolts jutting up on 8-foot centers (7). The bolts had been installed with standard round washers, which have proved inadequate to resist strong uplift forces.

In other heavily damaged garages, the bottom plate was no longer attached to the foundation. In these cases, anchor bolts either split or pulled through the bottom plate. In most instances, standard round washers had been used between the nut and the plate instead of stronger plate washers (illustration, page 8).

Use proper sill anchorage. Check local building codes for correct bolt diameter and maximum bolt spacing and placement. Larger washers between the sill plate and the nut improve performance. In high-seismic regions, for example, 2x2x3/16-inch washers are required. These could be adopted in tornado-prone regions as well. FEMA also recommends greater use of anchor bolts, in addition to properly fastened structural panel wall sheathing.

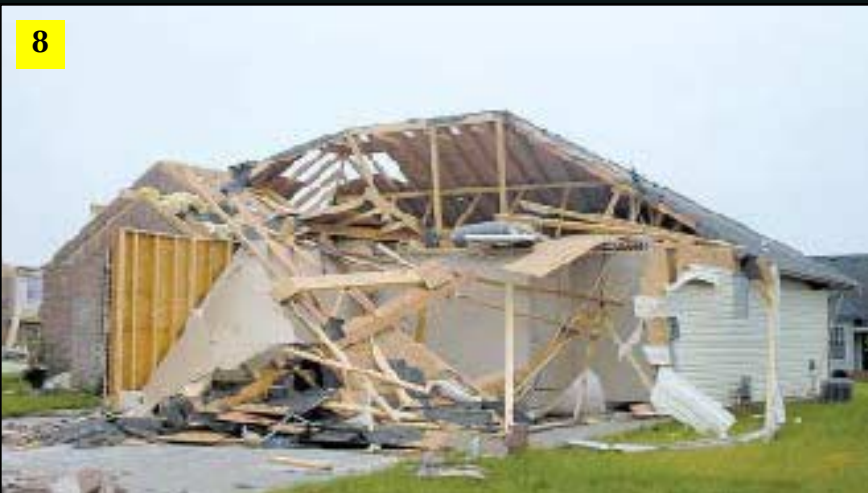
8

The bottom plate of this garage (8) was still in place, with the end nails into the studs sticking up every 16 inches (9). The brick veneer was peeled away.

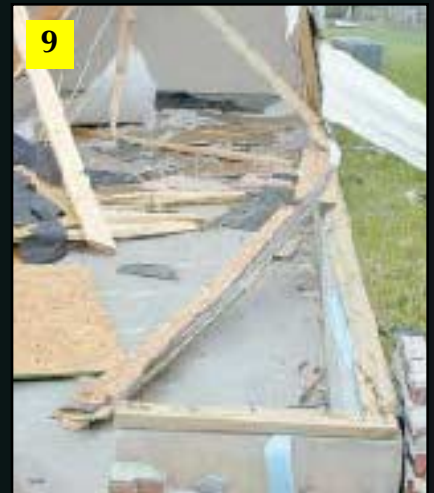
9

Connections between the garage walls and the concrete foundations were also weak. In several cases, we found the bottom plates of garage walls still attached to the concrete stem wall with the studs missing. Only the nails through the bottom plate and into the bottom of the studs remained. Properly lapped and fastened structural panel wall sheathing could have been an economical way to transfer the forces around the stud-to-plate joint and then into the foundation.

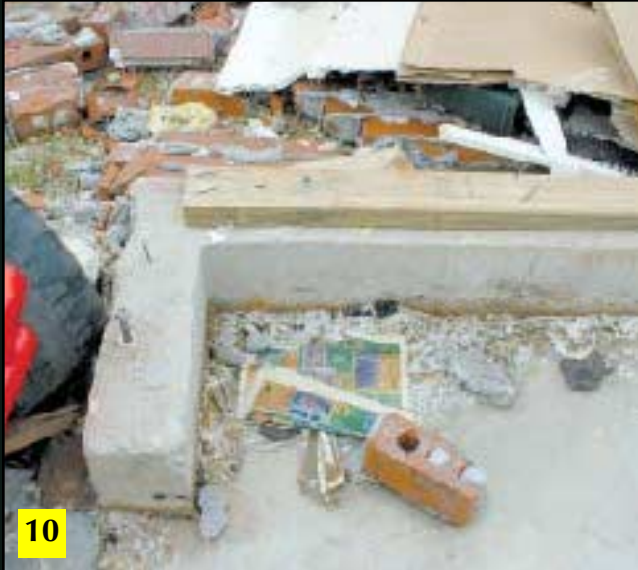
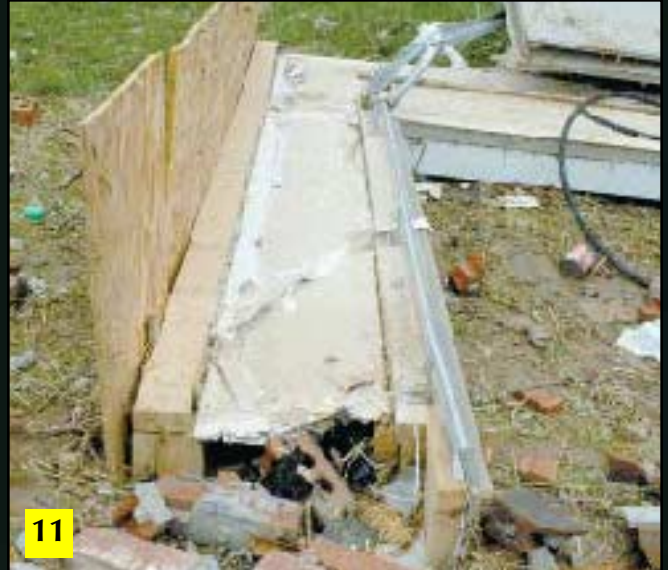
The return wall of this garage (10) was attached with only one anchor bolt. Though flat on the ground, the sheathed return wall was relatively intact, with the OSB sheathing still attached to the corner studs (11). Note the metal garage door track on the wall's inside face.

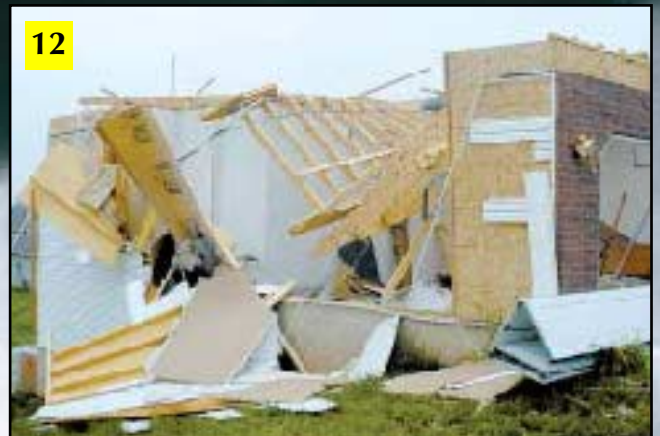
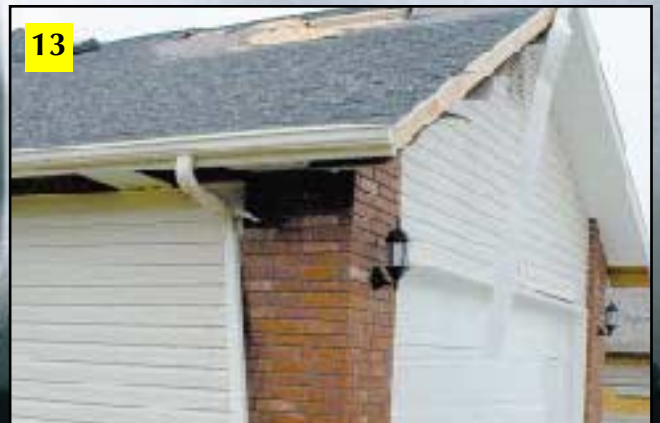
A breach in the garage door opening of this home (12) first pressurized the inside of the garage, resulting in devastating failure of the garage walls and the home's roof. In a similarly built home nearby (13), the garage door was bowed outward by the tornado's suction. The door held, preventing further damage to the home.

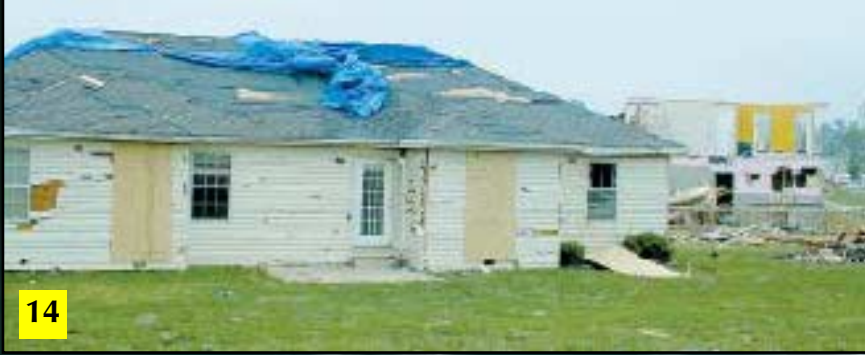
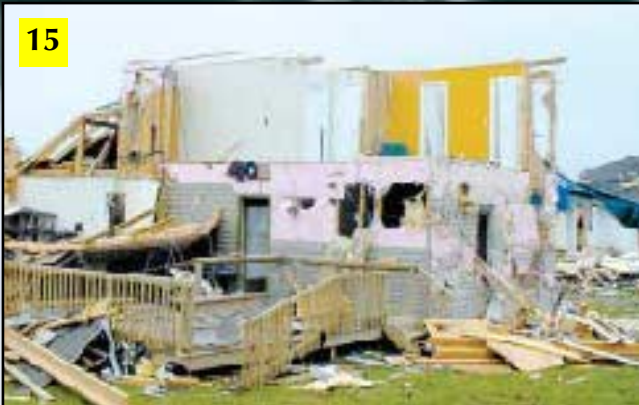
This plywood-sheathed house (14) fared much better than the home in the background (15), which was sheathed with non-structural rigid foam board. Rigid foam offers no racking resistance, and little resistance to damage from flying debris.

Fully sheathe houses. A house fully sheathed and properly fastened with

wood structural panels (plywood or OSB) has better racking resistance, greater structural redundancy, and can better resist flying debris.

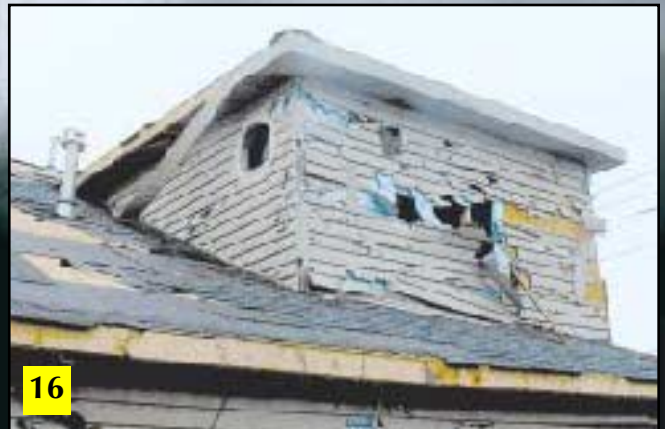
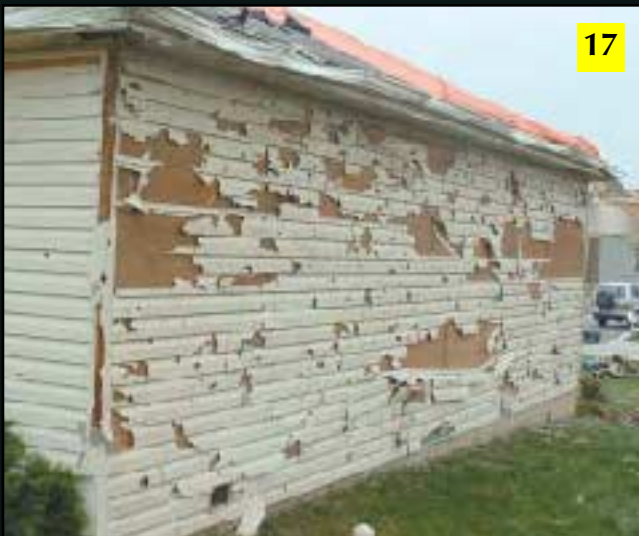
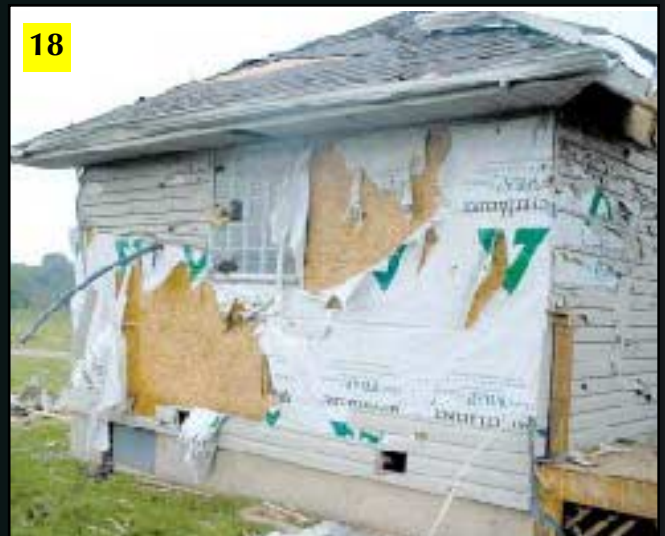
Vinyl siding and extruded polystyrene sheathing were no match for flying debris, which pierced holes in this dormer (16). By contrast, the plywood sheathing on this home remains intact (17), although the vinyl siding is in tatters. Though this OSB sheathing also fared well, it couldn't completely stop a flying pipe (18).

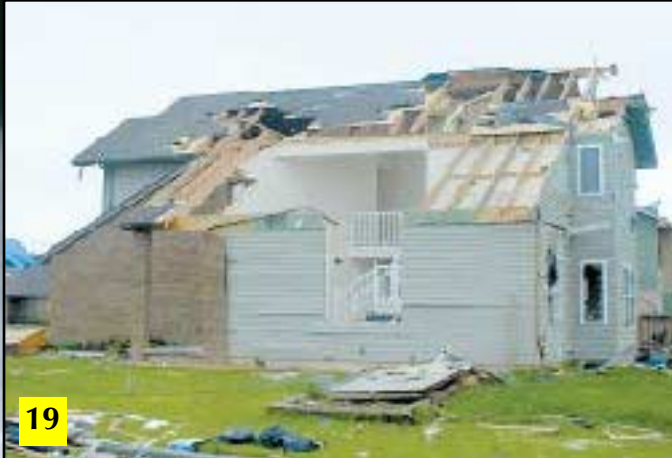
19

An initial breach at a large window resulted in internal pressurization and loss of the roof structure over the vaulted ceiling of this stairway. The rafters had been toenailed in place.

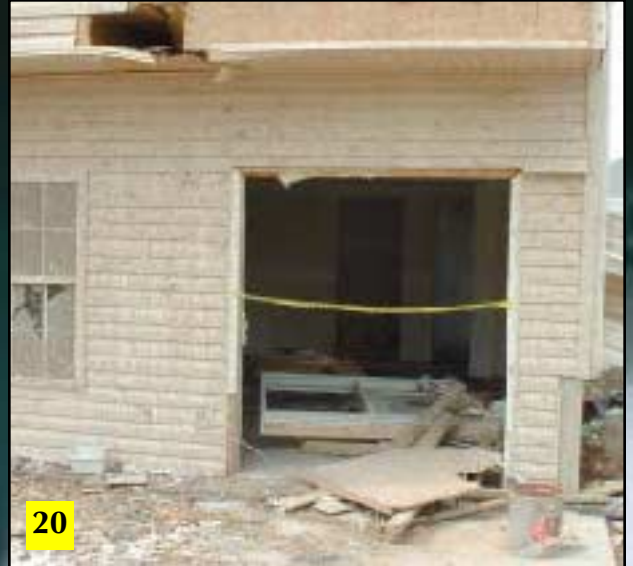
20

Here, in a home still under construction, a breach resulted because a pair of French doors were poorly fastened into the rough opening.

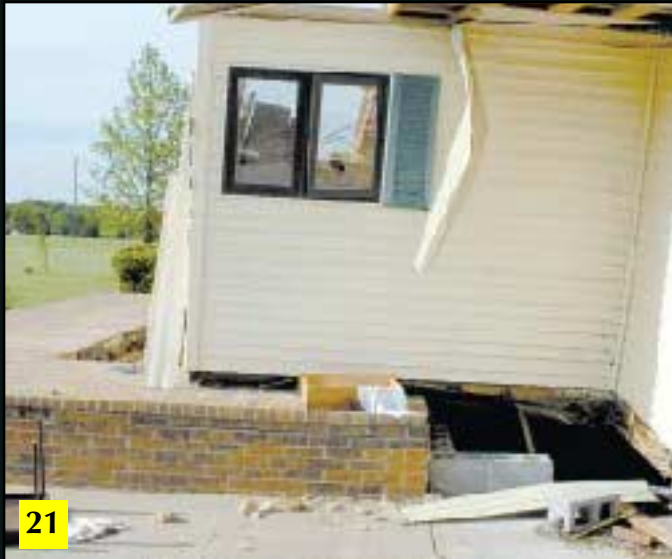
21

The hold-down anchors weren't adequate to keep this home from shifting 5 feet off its foundation.

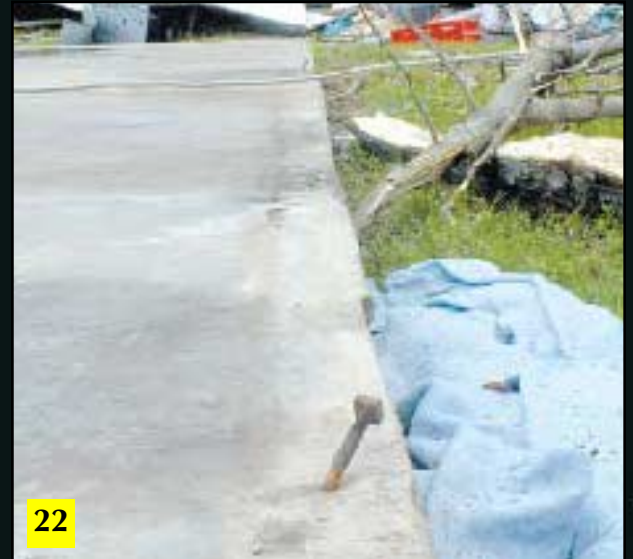
22

The anchor bolts in this slab-on-grade foundation were located 20 feet on-center and had no washers; none of the structure was left.
