Rainproofing Stucco Trim

Nailing trim through stucco without proper flashing is a recipe for disaster

by David Dobson

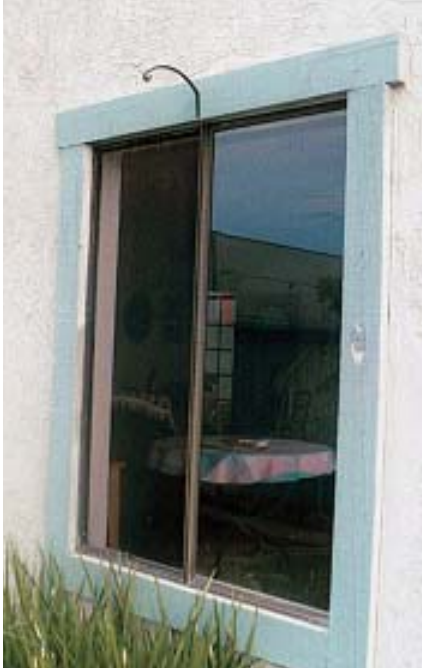
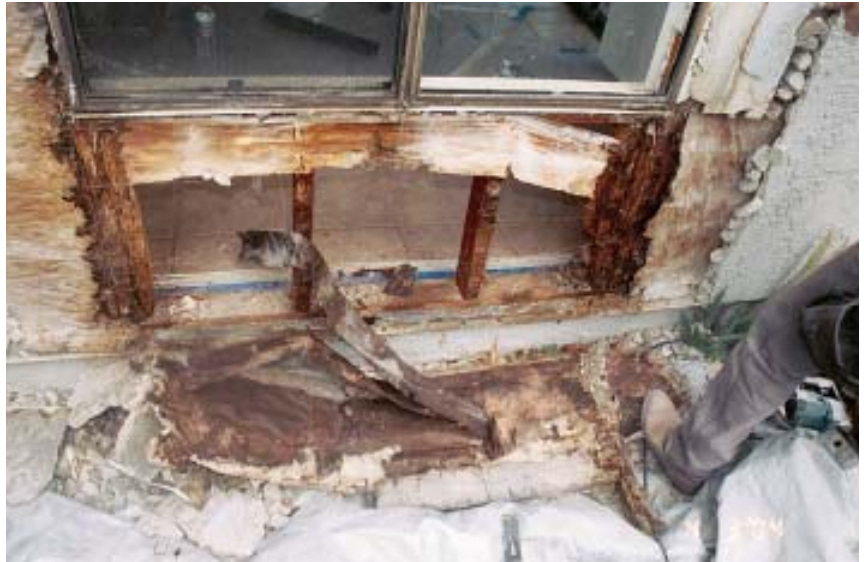
Every time it rained, water would soak the carpet under the windows of an acquaintance's Southern California condominium. Built about 20 years ago, this former apartment complex had a standard three-coat stucco and lath finish applied over building paper stapled directly to framing; 2x6 rough-sawn wood trim

was nailed through the stucco around the windows and horizontally around the entire building. Because the window, trim, and surrounding stucco appeared to be undamaged on the exterior, I suspected that water was probably following the trim's nails right through the stucco and into the walls (see Figure 1, next page).

Figure 1. Though there was no obvious damage, the window of this Southern California condominium complex leaked every time it rained (left). Underneath the traditional three-coat stucco exterior, water had caused severe rot (above).

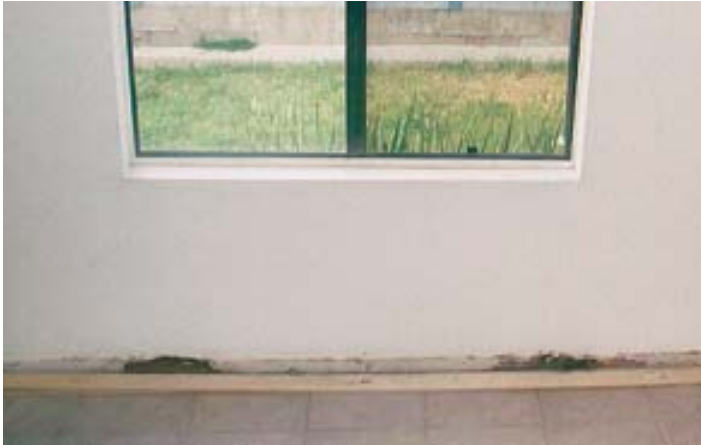
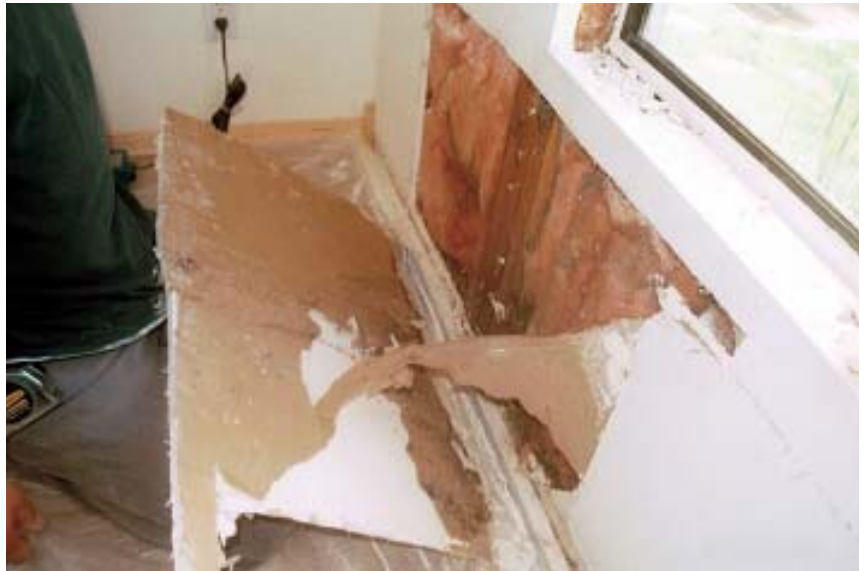
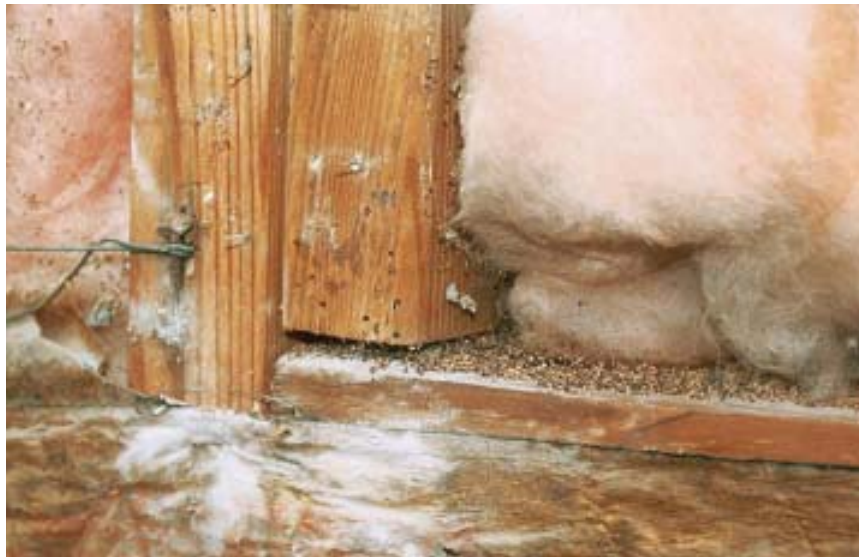
When we went inside the house and opened up the gypsum wallboard underneath the window to expose the wood framing and the building paper, we found an enormous amount of damage. Not only were the framing members water-stained and starting to rot, they were also damaged and infested with termites. The king, trimmer, and cripple studs underneath both window jambs were almost completely destroyed, robbing each member of virtually all load-bearing capacity. And water damage had completely worn away the building paper in several places, exposing the back of the stucco (Figure 2, next page).

The termites seem to have favored the wood that had been affected by water intrusion. We found the greatest termite

damage on wood that was already stained and that got wet during our spray test. With the stucco removed, that damage was even more evident.

Considering the damage to the framing around the window, it was a wonder the wall was still standing. The king, trimmer, and cripple studs had not only been completely eaten away — they were not even bearing on the mudsill. Fortunately, damage to the wood framing in this part of the building was limited to the window area, but we suspected that other walls in the complex — which have both the same window trim detail and an additional horizontal trim detail — had similar damage.

Figure 2. Water stains and mildew behind the baseboard underneath the window hint at the damage in the wall (above). Removing the drywall revealed the extent of the damage (right), including rotted framing and extensive termite infestation (below right).

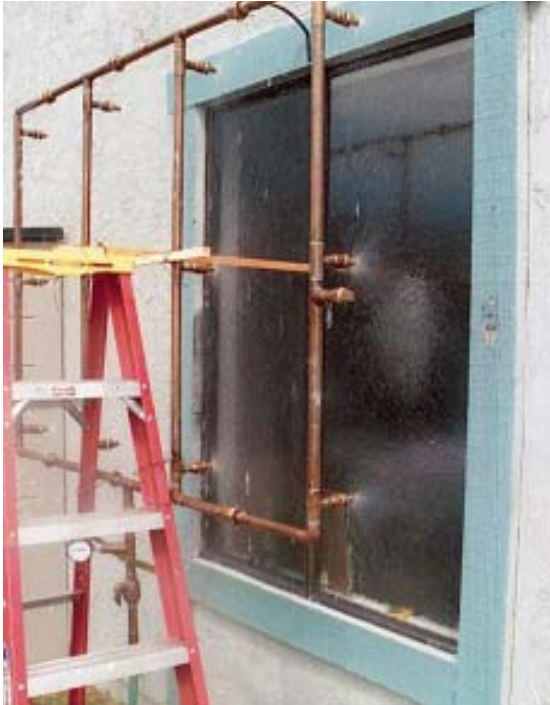
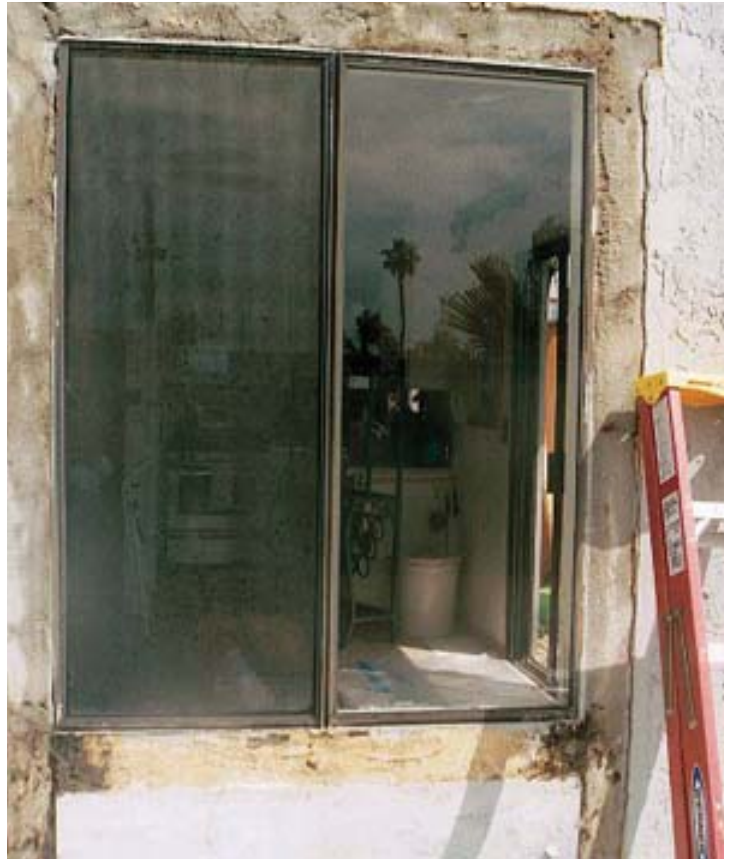
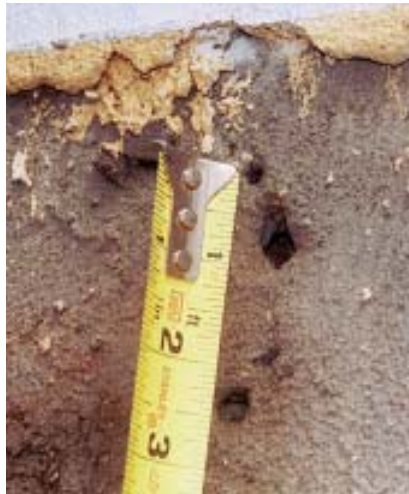
turned on our spray rack, water poured in around the window in several locations (Figure 3, page 4). Spray tests are normally conducted for 15 minutes, but we had to turn off the water after only a couple of minutes because so much water was pouring through the window and wall assembly.

When we removed the exterior trim from around the window, we found holes as big as 1/4 inch in diameter blown through the stucco where the nails attaching the wood trim had once been driven. We then removed the stucco 12 inches around the window, all the way down to the stucco screed. Our original hypothesis was correct: Everywhere there had been a trim nail driven through the stucco, there was corresponding water damage to the flashings, building paper, and wood framing.

Figure 3. When the author directed his firm's spray rack at the window, water began pouring into the interior (above left). Once the trim was removed (above), it became obvious that holes blown through the stucco by the trim nails were the path for the water intrusion; some were 1/4 inch or more in diameter (left).

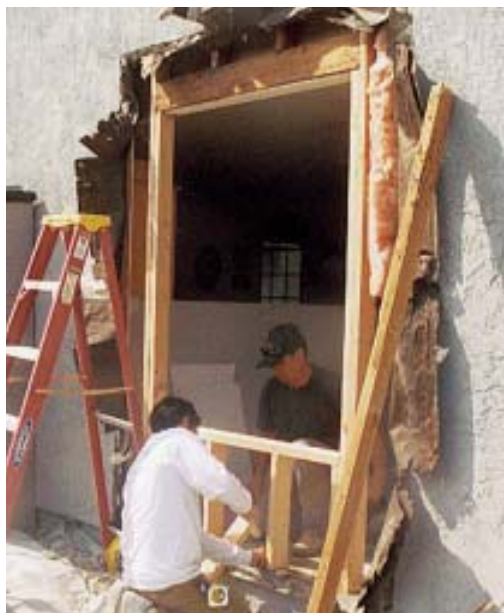
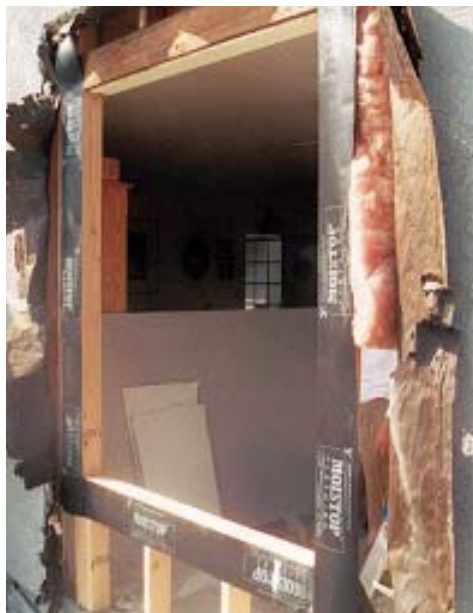
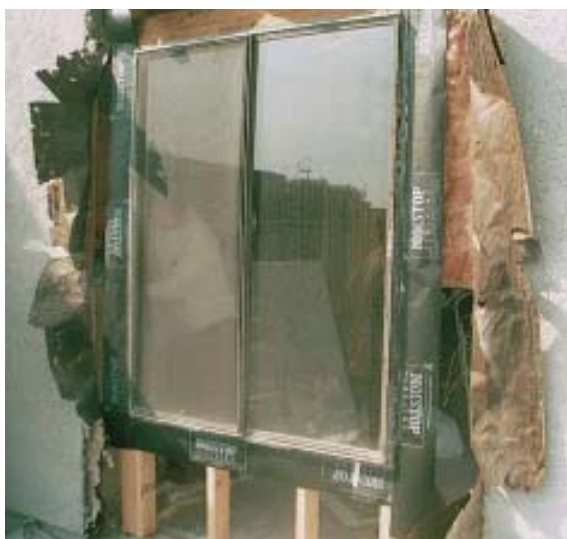
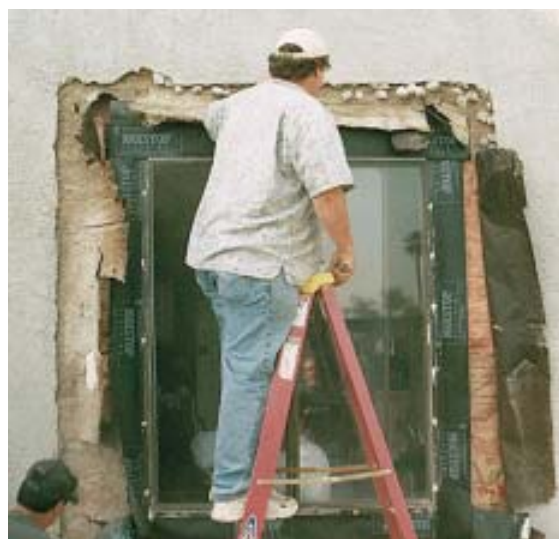
Figure 4. To repair the wall, the author replaced the damaged framing and added blocking (far left), which provided solid backing for Moistop waterproofing membrane. The Moistop was first applied to the sill and jambs (left); later, after applying sealant to the flanges, the crew installed the window (below left) and then applied Moistop over the head flange (below).

As we reframed the wall, we added 2-by blocking around the window; this would provide solid backing for the waterproofing membranes we planned to install, since there would be no wall sheathing (Figure 4, page 3). And before reinstalling the window, we covered the sill and jamb framing with Moistop flashing, a 12-mil-thick fiberglass-reinforced membrane covered on both sides with water-resistant polyethylene (Fortifiber Building Systems Group, 800/773-4777, www.fortifiber.com).

After applying sealant to the window flanges and installing the window, we lapped Moistop over the head flange. For an additional layer of protection, we taped the window flanges with 12-inch-wide strips of 40-mil Jiffy Seal Ice & Water Guard (Protecto Wrap Co., 800/759-9727, www.protectowrap.com), a self-adhering, rubberized waterproof membrane. Besides sealing the joint against water leakage, this thicker mem-

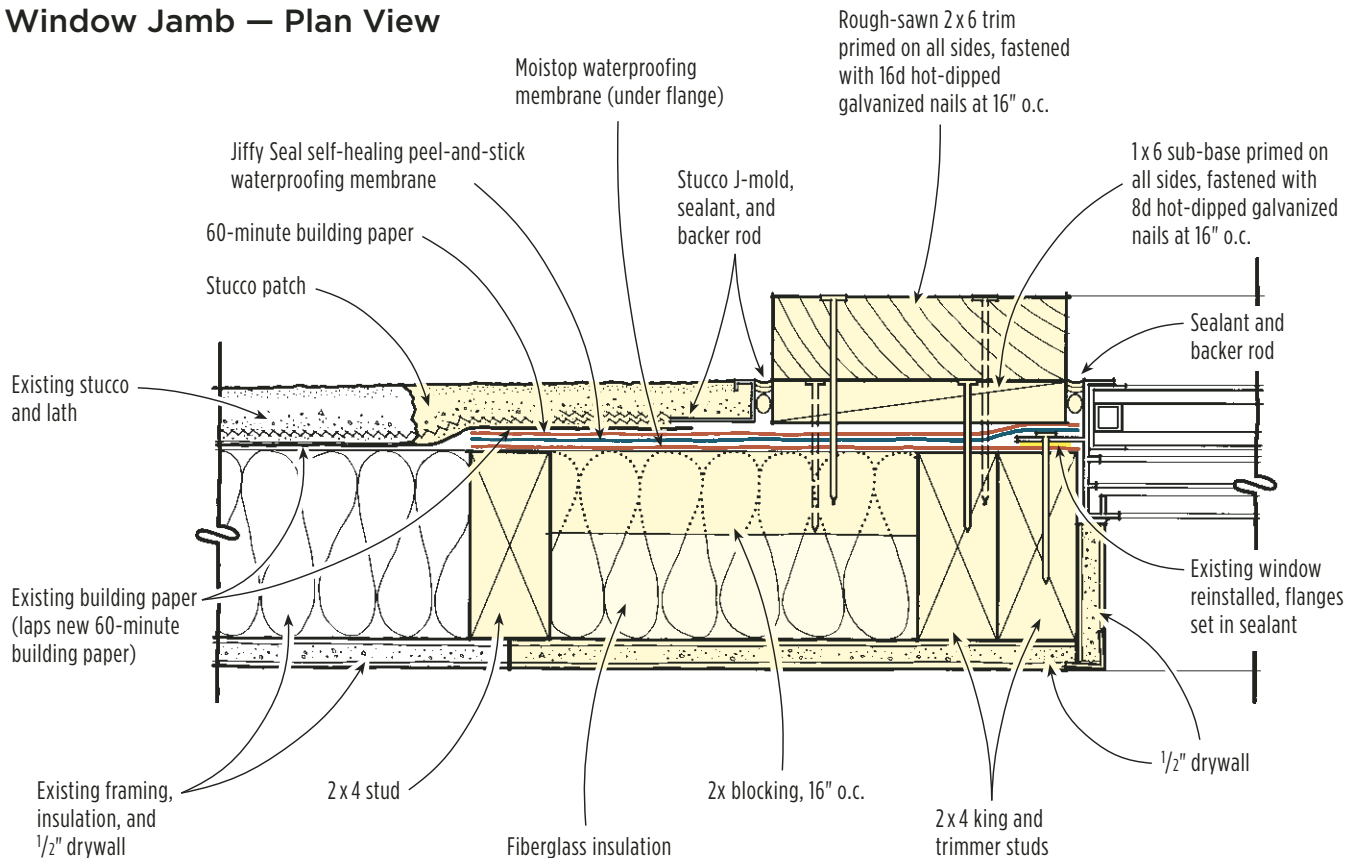
Window Jamb — Plan View

Figure 5. The reinstalled window trim relies on self-healing peel-and stick membrane to prevent water from entering around the nail holes.

brane does a good job of sealing around fasteners that penetrate it, helping to prevent the kind of damage we were repairing from recurring. In preparation for the stucco patch, we stapled 60-minute building paper to the framing, lapping it over onto the Jiffy Seal.

Next, we nailed primed 1x6s directly to the framing around the window, as a kind of sub-base for the window trim. With these in place, we could avoid having to nail the 2x6 trim directly through the stucco; also, they made it easier to create sealant joints between

We left one 3/8-inch-wide gap between the window and the 1x6, and another between the 1x6 and the stucco J-mold surrounding the window. And we installed a primed G90 galvanized steel drip edge over the trim at the head of the window. (If the original assembly had included drip metal over the trim at the head, it may have kept some of the

water from getting into the wall assembly.) Then, after the 7/8-inch-thick three-coat stucco was applied, we inserted 1/2-inch-diameter closed-cell backer rod into the gaps.

Finally, we primed all surfaces of the new rough-sawn 2x6 Douglas fir trim and nailed it on over the 1x6s (Figure 5, page 6). (Because the original trim had not been back-primed before being installed, it had warped and twisted and couldn't be reused.)
