Rain-Screen Retrofit

Improper flashing, unprimed cedar, and a southern exposure had all contributed to a moldy mess

by Mike Goldfield

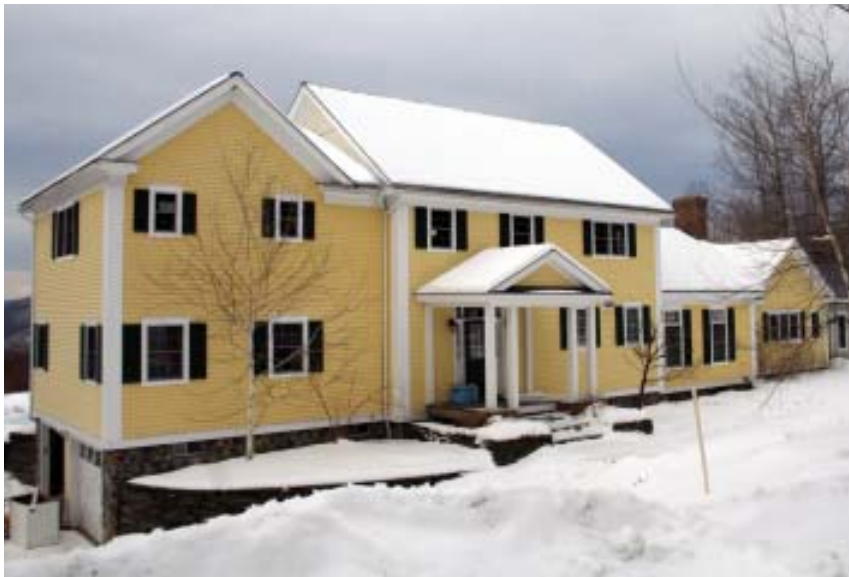
Figure 1. Judging by the exterior, one would never imagine what was going on behind the siding of this 10-year-old house. The north elevation (before the siding was removed) is shown here.

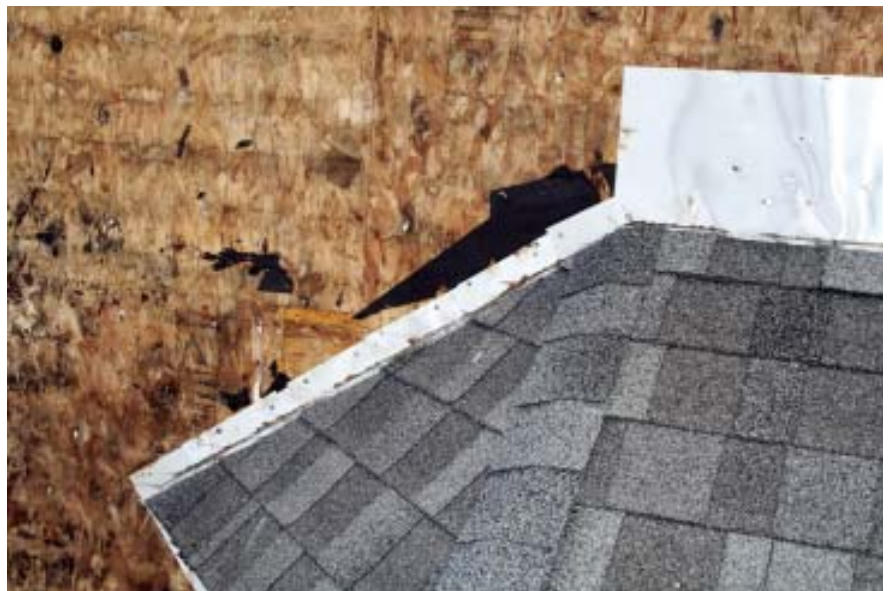
Figure 2. Incorrect and sloppy flashing contributed to water damage behind the siding. The step flashing over this bay window, for example, was installed on top of the house-wrap rather than being tucked beneath it.

Incorrect flashing. To begin with, step flashings and window head flashings had been installed incorrectly — they were on top of the housewrap instead of tucked underneath (**Figure 2**, page 2). Also, at door and window openings, the housewrap had been cut out in a big X, with little effort made to seal the corners — a typical method when the house was built.

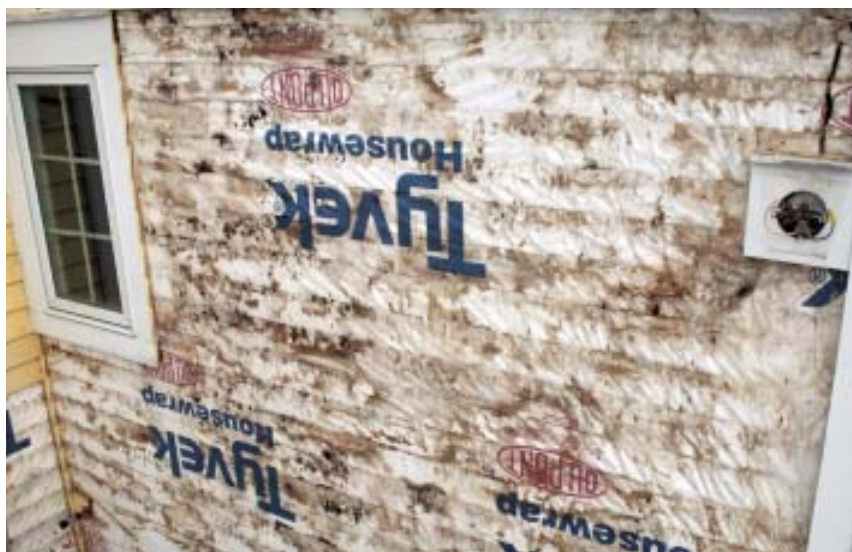
No back-priming. In addition, the 6-inch cedar bevel siding wasn't back-primed (**Figure 3**). It's possible that, at the time of construction, back-priming wasn't specified in housewrap installation instructions. Later, after researchers had shown that the tannins in cedar could break down housewrap's water

Solar vapor drive. Another factor in the failure was the home's southern exposure. Although we repaired and re-sided the entire home, we found that damage

to the OSB sheathing was limited largely to the southern side. This, according to architect Doug Viehmann, who designed the repair details for the job, was the result of solar vapor drive. Liquid water and water vapor always move from a warmer to a cooler surface, so when the sun heats the siding, it causes moisture to

Figure 3. Brown stains from water-soluble extractives in the unprimed clapboards clearly indicate the movement of water. The damage was much worse on the southern exposure, where solar vapor drive played a role.

move upward in the capillary spaces — where the siding overlaps — toward the cooler sheathing. Because the tannins in the cedar allowed the water to move through the housewrap, the sheathing became soaked and began to rot.

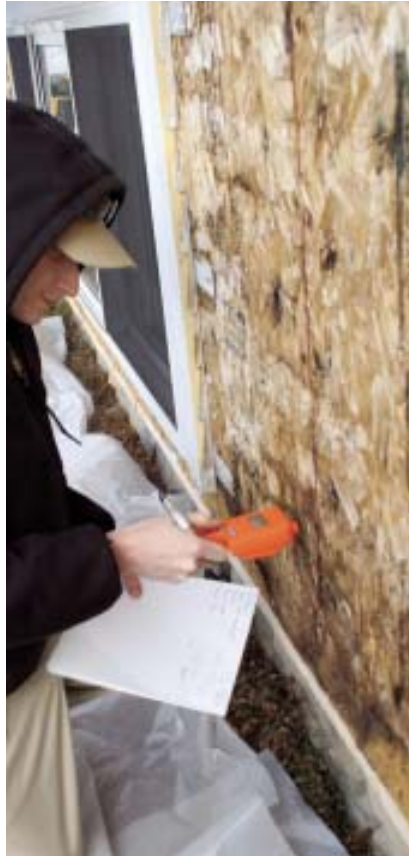
Figure 5. The author's crew used a hand-held moisture meter to measure the moisture levels in the OSB-covered SIP panels. Readings were highest around windows — which had been poorly flashed — and closer to grade, where water leaking in from above would have accumulated. Levels were lowest on the second floor under the eaves overhang.

In retrospect, despite daytime high temperatures in the teens and one of the largest snowfalls on record, winter was not a bad time to tackle this project (see sidebar, next page). Overall, conditions were dry and windy, which helped the shell air out. We started in mid-November, stripping off all the siding on the south side and measuring moisture levels in numerous locations with a Delmhorst J-2000 moisture meter (Figure 5, page 4).

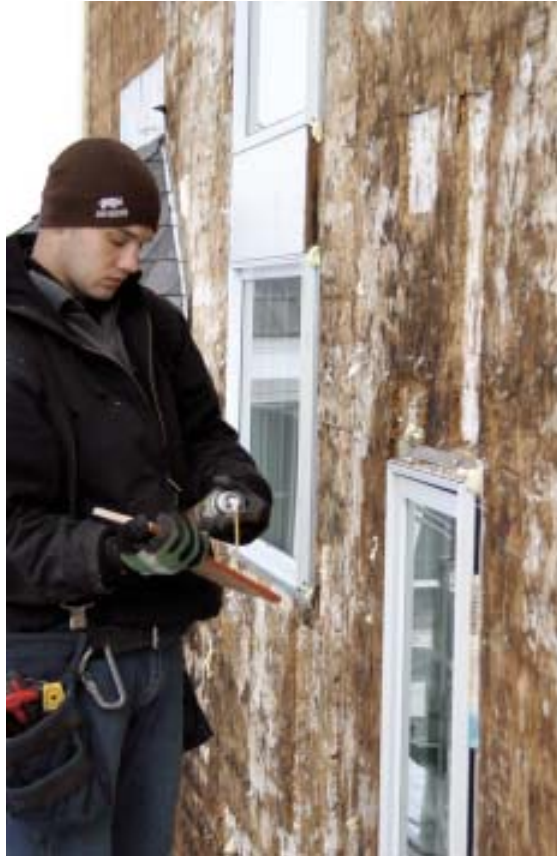
Patching the panels. Some sections of the OSB looked more like compost than lumber. It's fortunate that the home was built with a structural timber frame and wasn't relying on the SIPs panels as the

Figure 7. Heavily damaged sections of the SIPs panels were patched with OSB inserts secured with polyurethane foam.

made patches from new OSB, gluing them in place with polyurethane spray foam (Figure 7, page 5). We also filled in any gaps around windows.
