Framing Flaws

These common errors could lead to expensive callbacks later on

by Donald Cohen

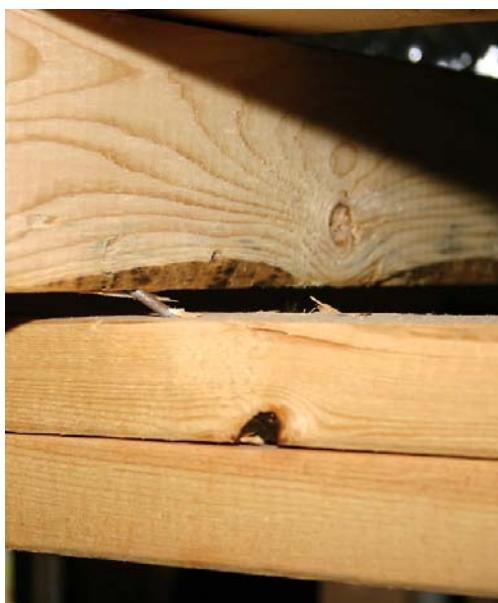
Truss framing isn't difficult, but it has to be done right for the engineering to work correctly. A common error is to toenail the bottom chords of trusses to partition wall framing (below left); truss clips should be used instead. Otherwise, truss uplift — which occurs when cold upper-truss chords gain moisture while warm lower-truss chords dry out, making the whole truss curve like a bow — can lift the interior wall off the floor and cause problems with the drywall. It can even lead to a split in the bottom chord, creating the potential for truss failure under snow loading.

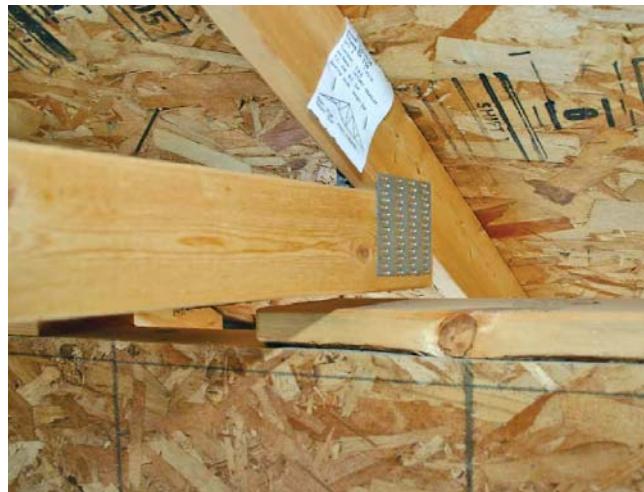
The framing carpenter on this job also failed to provide adequate bearing under the ends of a couple of trusses (below right). Instead, the trusses bear on an interior partition wall, resulting in cantilevered truss ends that "float" above the wall plate. Unfortunately, they won't float for long.

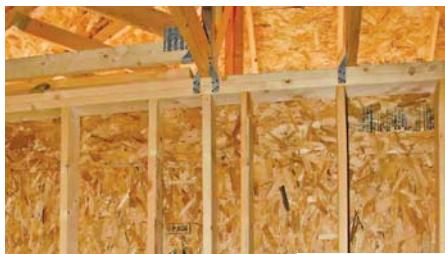
A girder truss is engineered to support heavy roof loads and carry them to the points where the girder bears on the wall plates. These significant point loads need to be directly supported by columns with sufficient strength and stiffness to transfer the loads to the foundation wall. In this project, the point loads should have been borne by—at the very least—doubled 2-by posts properly nailed to both the top and bottom plates, not by a single loose stud propped into place (far left).

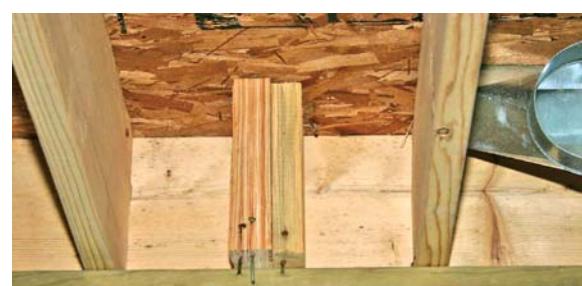
Adding to the problem, load-transfer blocks below the girder truss support on the upper floor hadn't been cut to fit properly (left). Because they are too short and not tight to the subfloor, they will allow the wall plates and truss support columns to settle, which can result in cracked drywall and possible structural damage.

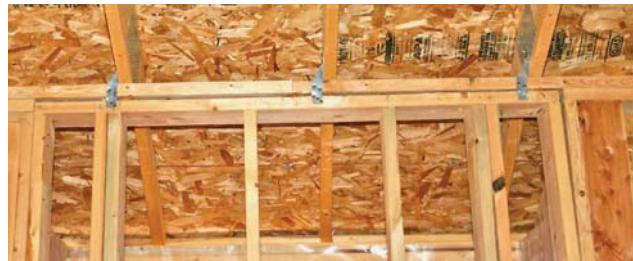
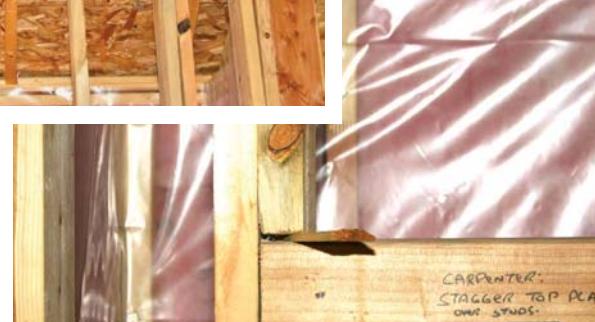
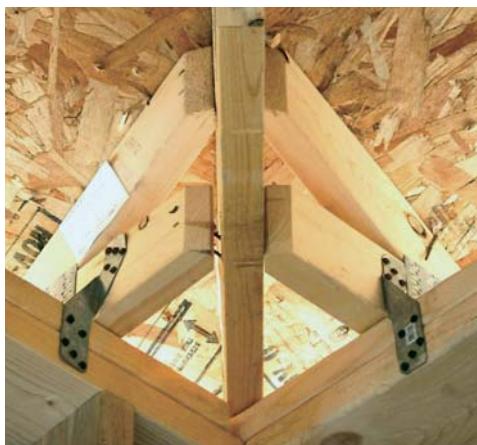
Wood is strongest when loads are applied parallel—rather than perpendicular—to grain. White cedar shims, of course, are made from a light and porous wood and are cut with the grain; they simply don't have enough compressive strength to be used in structural applications. On this house, the framing carpenter improperly used them to fill in gaps between the top plate and a header wall for a fireplace (top), and between load-bearing studs and the lintel header (bottom; note the state building inspector's drawing indicating the proper framing for this wall). Under normal roof loads, the fibers in these cedar shims will be crushed.

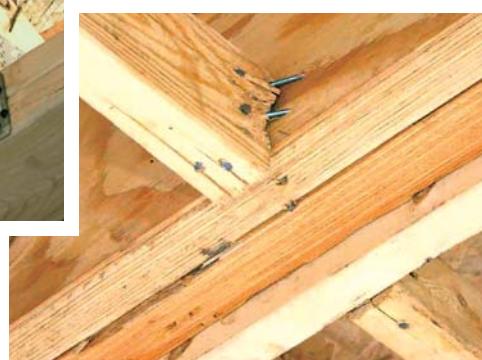
An important part of the framer's job is to install proper blocking. On this house, none of the rough openings for bath fixtures had any blocking, and some of the ceiling blocking was either missing or loosely nailed in place (top). Such gaps can lead to movement, and then cracking of the drywall.

It's also important not to over nail a framing member. For example, this porch ceiling joist (bottom) has about 10 toenails shot into it, which shredded the end of the 2x4. Without a joist hanger to hold the pieces together, there's no way this joist end will be able to support the weight of the ceiling.
