Rebuilding on the Gulf Coast

A combination of engineered lumber, steel, and structural insulated panels provides protection against the next hurricane

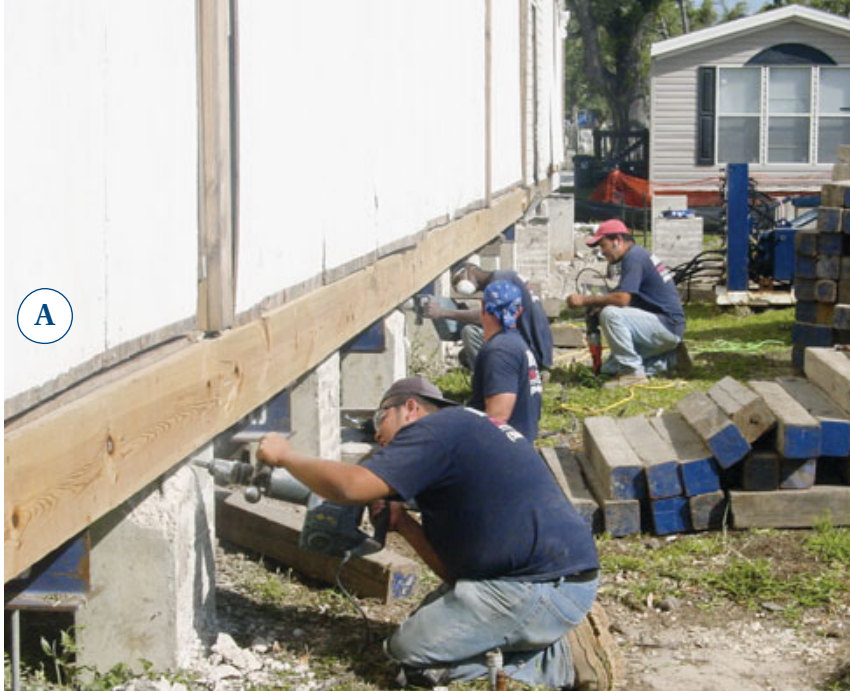
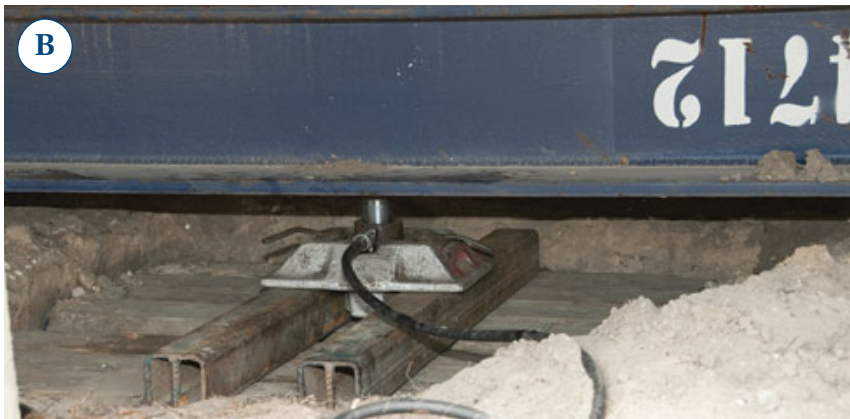
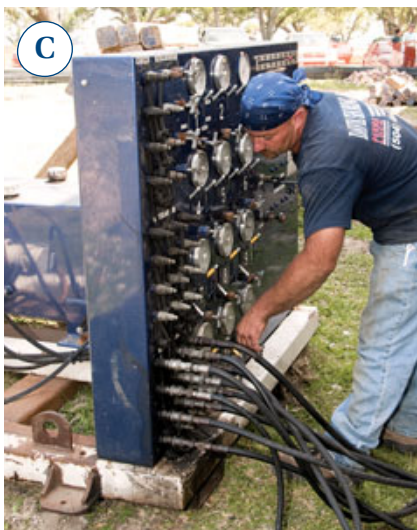
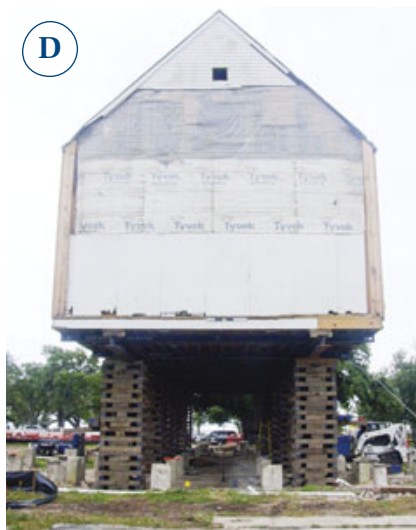
Figure 1. The shoring crew first disconnected the floor framing from the foundation by cutting the steel bolts embedded in the short concrete piers (A), then installed cribbing and hydraulic jacks for lifting the building (B). Each jack was connected to a hydraulic manifold powered by a diesel engine (C), which was able to lift the 3,000-square-foot structure more than 10 feet with less than $\frac{3}{8}$ -inch difference in elevation between any of the 10 lifting points (D).

Raising a 3,000-square-foot, 66-ton building more than 10 feet was a terrifying prospect, but I was reassured when I learned that the lifting contractor — Davie Shoring of New Orleans — had 150 other buildings in the air at the same time. It took the shoring crew only a couple of days to place the two 100-foot-long main steel I-beams and ten 30-foot-long cross beams, install cribbing for the hydraulic jacks, and break the building loose from the old foundation (see Figure 1).

The actual lift took about 11 hours, spread out over the course of two days in May 2009. The 10 jacks were connected to a diesel-powered hydraulic pump, which raised them simultaneously at a rate of 10 seconds per 6-inch lift. Then the crew would take about an hour to install more cribbing, lower the building onto the new cribbing, reposition the jacks, and repeat the process. By the time the building reached its final position, movement over

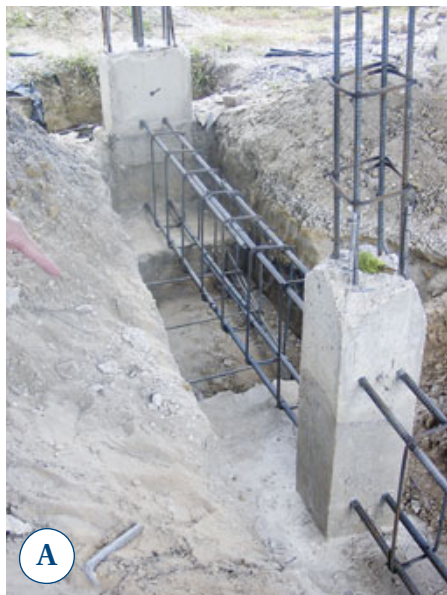
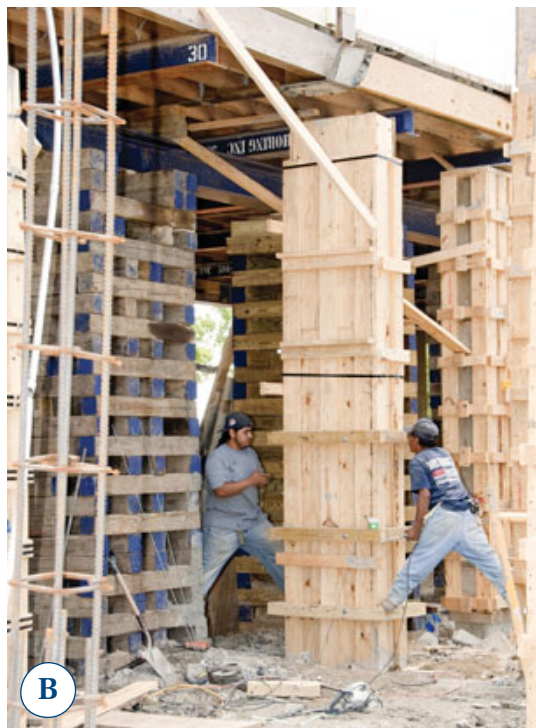
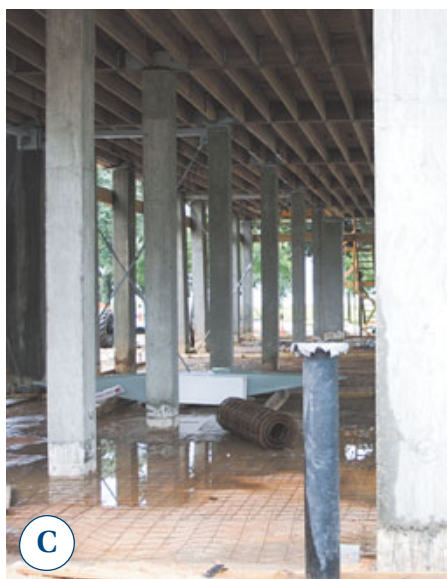
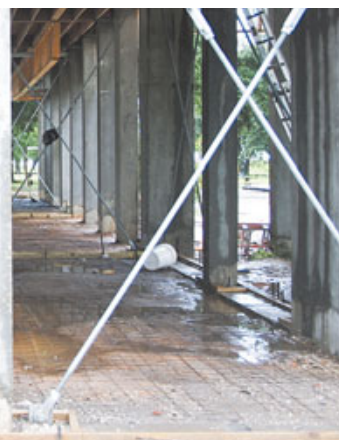
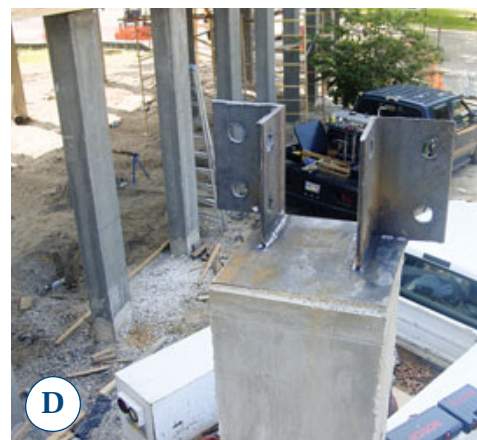
Figure 2. The rebar for new grade beams and pier extensions was epoxied to the original piers (A). Formwork for the pier extensions stopped a foot shy of the raised building to allow for setting the anchor bolt-studded cap plates and pumping the concrete (B). Diagonal steel rods provide lateral bracing for the exposed portions of the piers (C); note the cold joint at the base of each pier between the old pier and the pier extensions. Steel brackets welded to the cap plates anchor the transept framing to the foundation (D).

While the lift was quick, we had to wait two months for the foundation contractor to complete the iron and concrete work needed to build the new pier foundation. Needless to say, I was anxious to get the building bolted down before the next storm season started. The shoring company reinforced the existing piers with grade beams and extended them with new rebar dowelled and epoxied into the old concrete (Figure 2). The crew also built new concrete piers for the two

Steel work. To anchor the building to the piers, workers embedded $\frac{1}{2}$ -inch-thick steel plates into the concrete at the top of each pier during the pour. Each plate had four $\frac{3}{4}$ -inch by 12-inch J-bolts welded to it to strengthen the connection between the concrete and the steel.

We also bored holes through the forms and inserted short lengths of conduit so that later we could through-bolt steel brackets to the piers. These brackets accommodate $1\frac{1}{8}$ -inch-diameter diagonal steel rods and steel tubing that reinforce the tall piers.

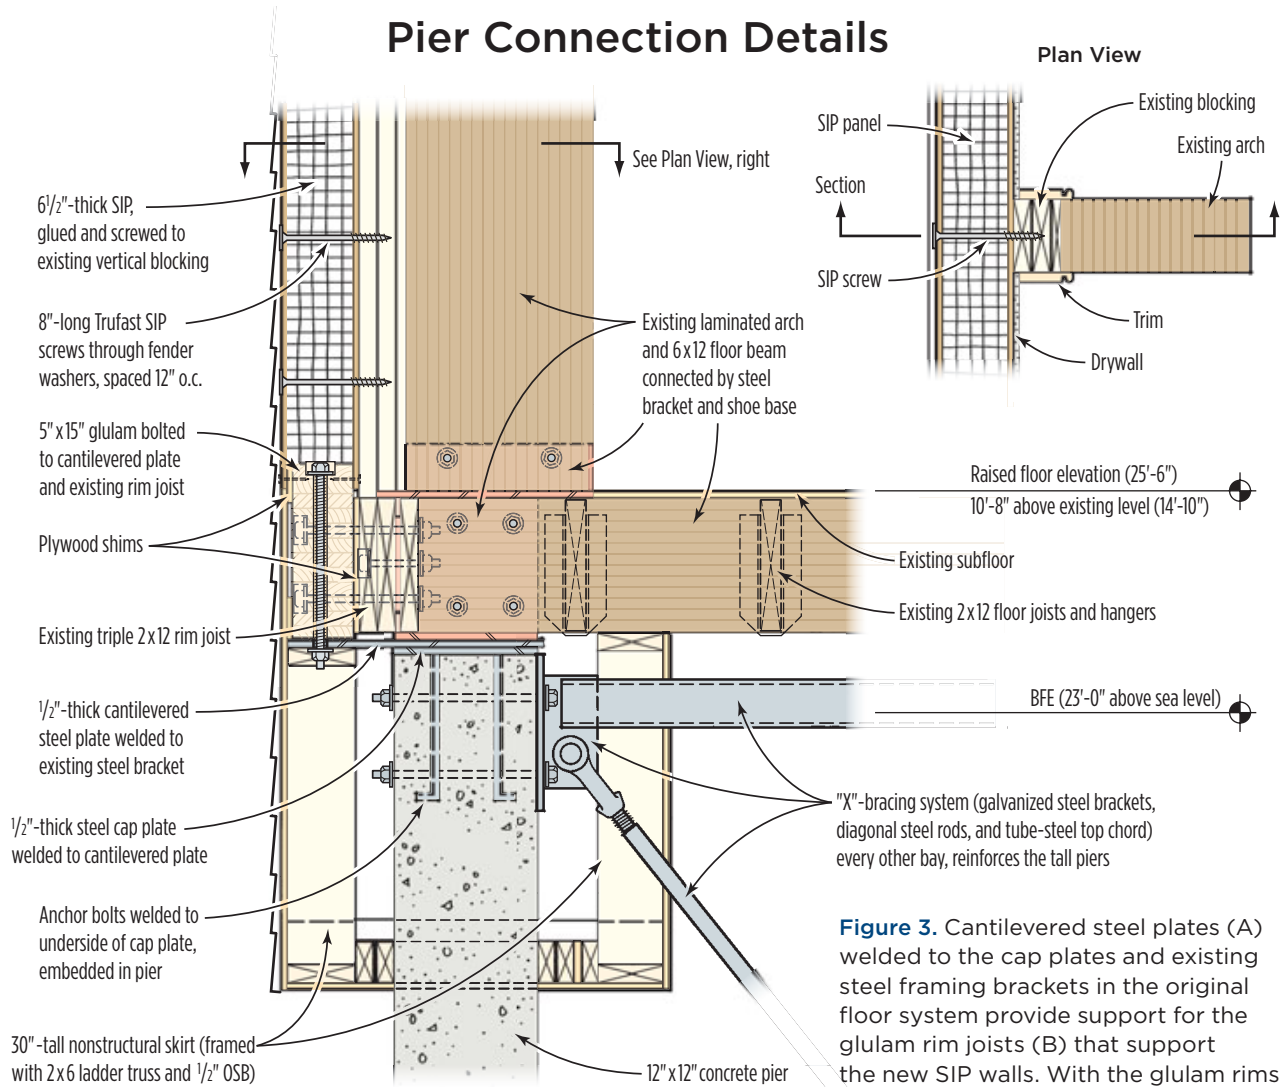
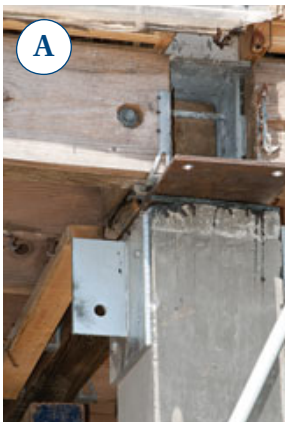
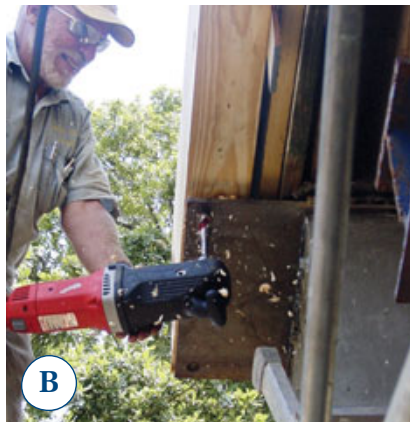
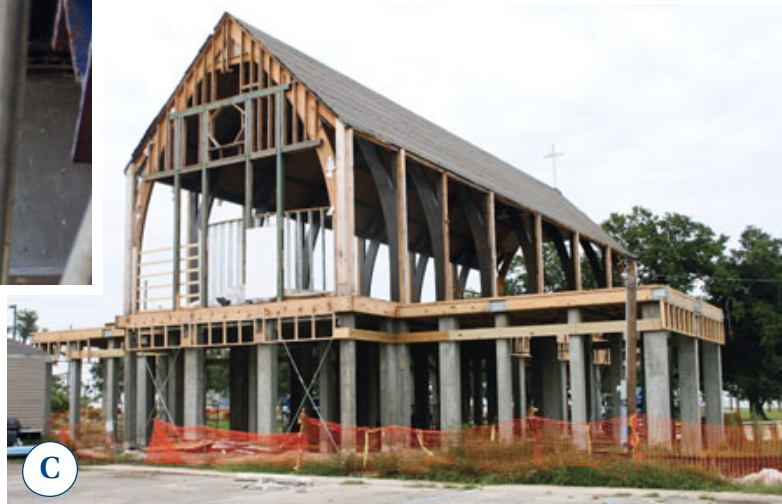
Pier Connection Details

Figure 3. Cantilevered steel plates (A) welded to the cap plates and existing steel framing brackets in the original floor system provide support for the glulam rim joists (B) that support the new SIP walls. With the glulam rims secured to the original structure and the new transept floor framing completed, the building is ready for wall and roof panels (C).

ing, ironsmith Craig Campbell welded $\frac{1}{2}$ -inch-thick steel plates to the steel framing brackets that the shoring company had cut loose from the old piers. These new plates extend out over the tops of the piers 5 inches from the original wall plane, and help support the 5-inch by 15-inch glulams that hold up the SIP walls.

Then we bolted the big perimeter glulams to the steel plates with 1-inch all-thread rod and to the framework of the church with $\frac{3}{4}$ -inch bolts 16 inches on-center (**Figure 3**, page 4). To account for the thickness of the panels' inner OSB skins, we shimmed the glulams out from the framing with $\frac{5}{8}$ -inch plywood shims.

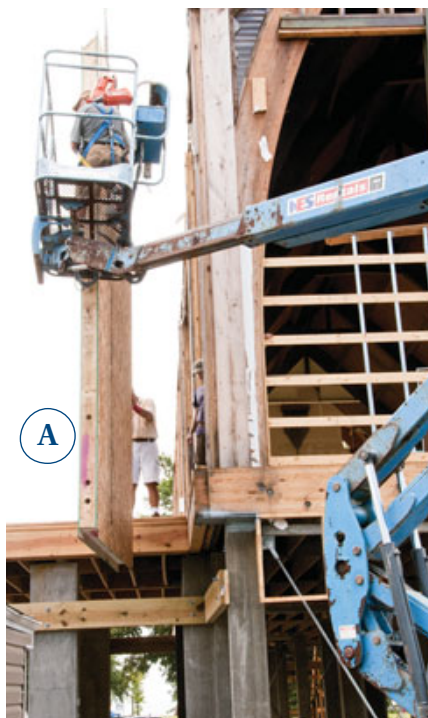
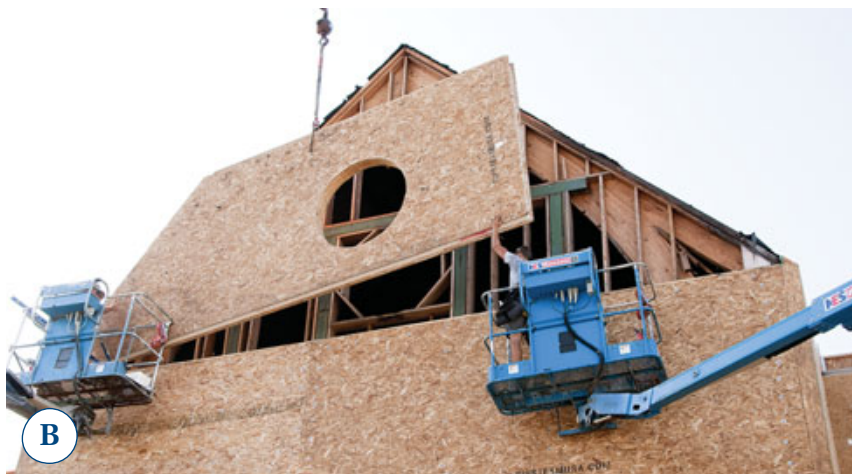
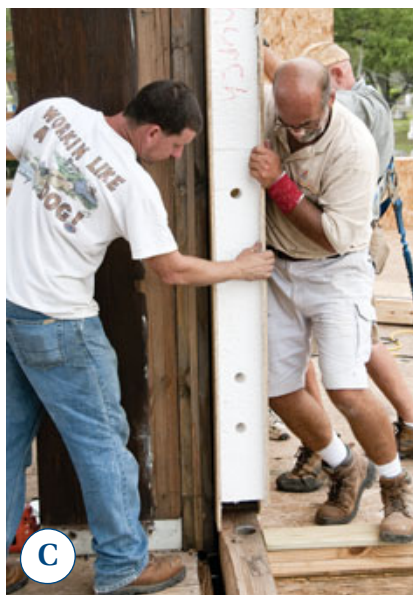
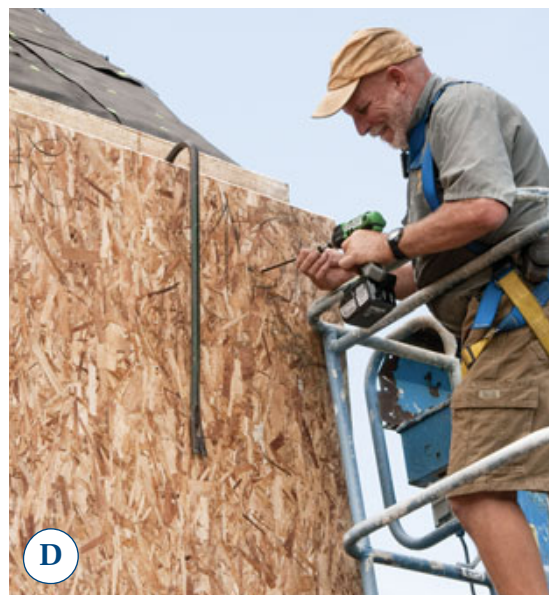
Figure 4. The floor was 14 feet above grade, so man lifts were essential for safe handling of the large panels (A, B). Panel edges were relieved at the bottom to fit over the glulam rim joist, and at the sides and top for the 2-by connecting splines (C). The wall panels were first glued and nailed to the glulam band and splines, then fastened to each other and to existing framing with structural screws (D).

The T&G-style wall panels have EPS foam cores and $\frac{7}{16}$ -inch-thick OSB skins on both faces and range in size from 8 feet by 2 feet to 8 feet by 24 feet. They connect by way of 2-by full-width LVL or sawn-lumber splines, which fit into $\frac{3}{4}$ -inch-deep recesses in adjacent panels' edges (**Figure 4**). We oriented panels both vertically and horizontally, depending on door and window openings and wall sizes. According to the manufacturer, each SIP acts as a shear panel, and screwing and

Before setting the first wall panel in place, we applied plenty of low-VOC adhesive to the glulam and laminated arch framing. Then we nailed through the OSB skins into the glulams 6 inches on-center in a staggered pattern on both sides, creating an uplift-resistant connection between the panel, glulam, and foundation. The panels are fastened to the arch framing with Trufast $\frac{1}{4}$ -inch by 8-inch structural screws supplied by the SIP

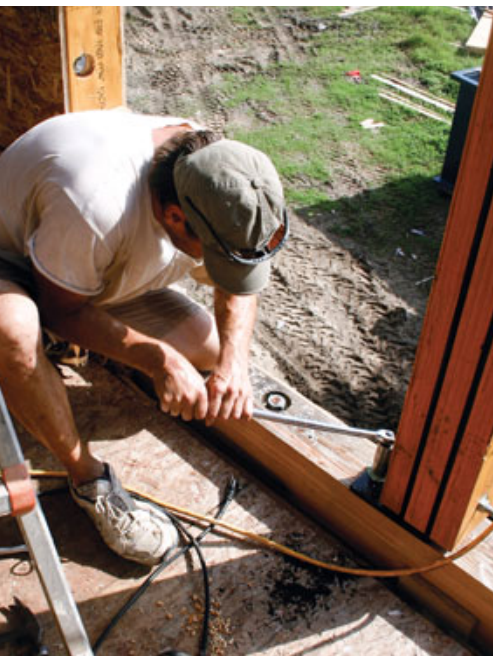
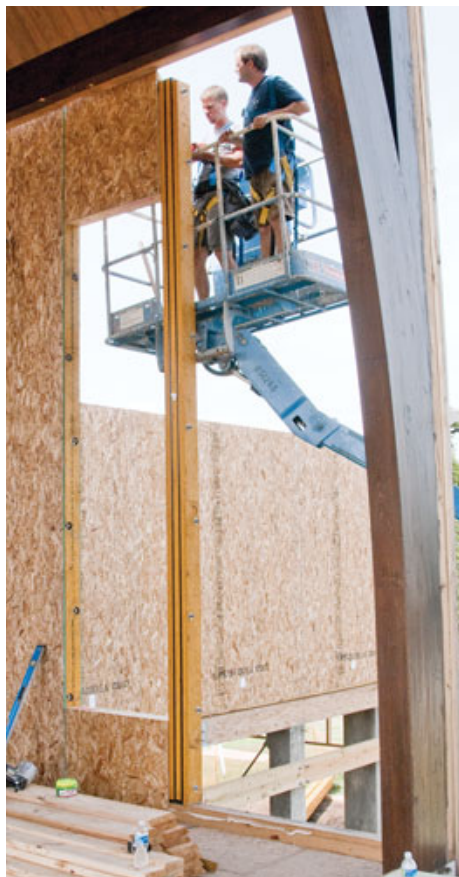
Figure 5. To prevent wind deflection, the tall window walls were reinforced with full-length flitch-beam stiffeners (right), which were bolted to the glulam rim joists (above) and recessed into the wall panels.

To reinforce the 16-foot-tall sanctuary walls to meet local wind-code requirements, we installed flitch beam stiffeners on both sides of each window (Figure 5). The stiffeners consist of three 1 $\frac{3}{4}$ -inch by 5 $\frac{1}{2}$ -inch by 16-foot LVLs sandwiched around a pair of $\frac{1}{2}$ -inch by 5-inch by 16-foot steel plates; each one weighs 650 pounds. We bolted them to the glulams with 1-inch-diameter bolts, then glued and nailed the SIPs to the stiffeners.

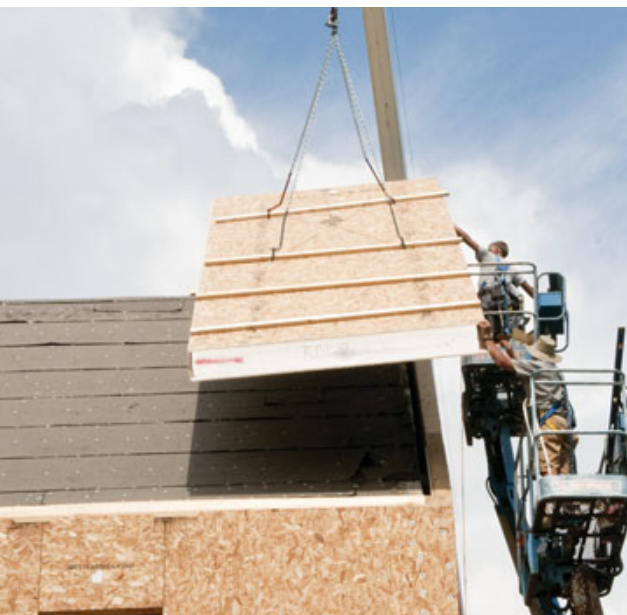
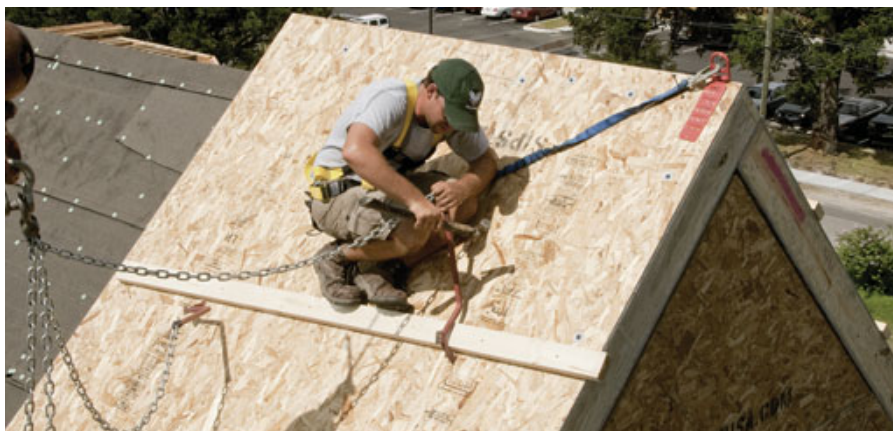
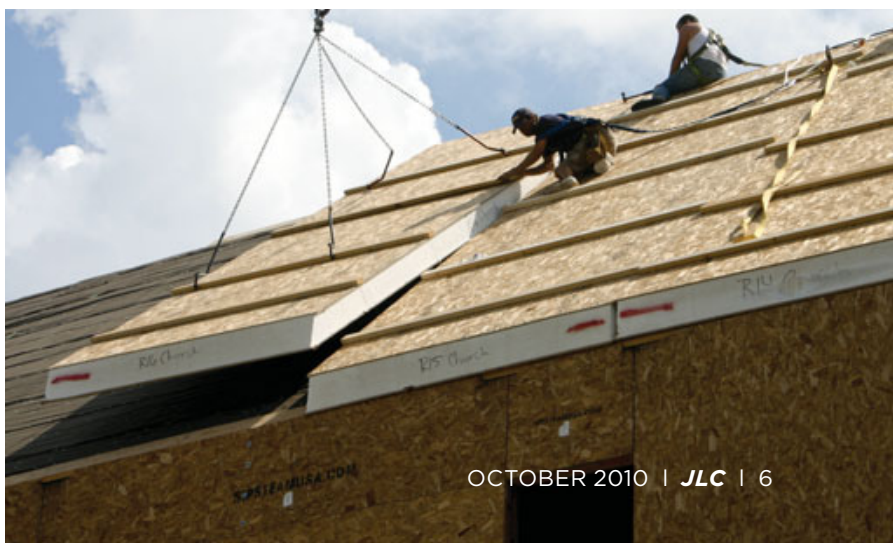
Figure 6. Preinstalled 2-by walk boards reinforced the connection between the lifting hooks and the OSB skins of the roof panels (above, above right). Placing the hooks slightly off-center eliminated camber in the panel, making it easier to slide the edge over the spline of the previous panel (right).

Most of the roof panels were 8-foot by 24-foot SIPs weighing 900 pounds each. Since they were set on top of an existing roof deck, we couldn't have attachment points for the lifting straps. Instead, we used what we called hay-hooks: four iron hooks (provided by the SIP manufacturer) driven through the top skin of the panels

(Figure 6, page 6). Since we needed walk boards on the panels anyway, we placed them so that they would reinforce the OSB where it was penetrated by the hay-hooks.

We quickly found that installing the hooks somewhat off-center — so that the heavy panels hung from the crane at a slight angle — helped take the crown out. This allowed the tongue-side to slide into the groove side much more easily.

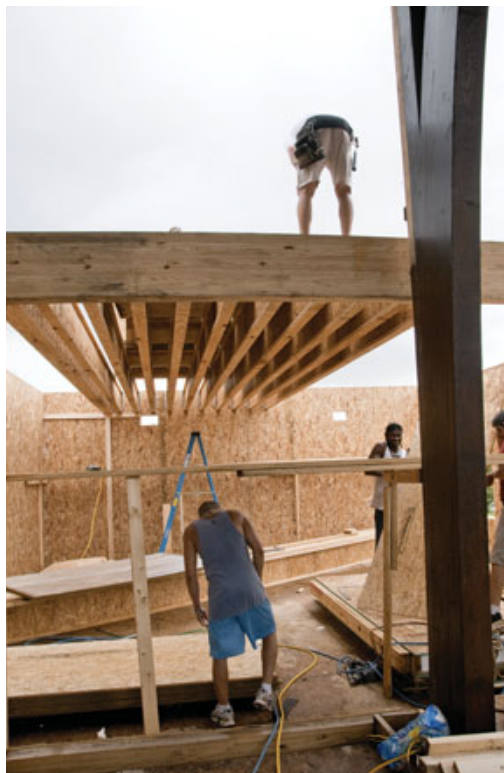
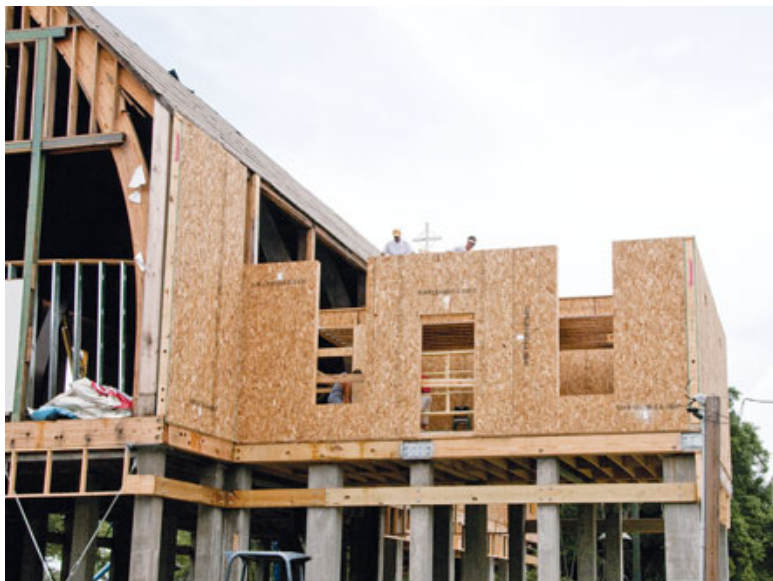
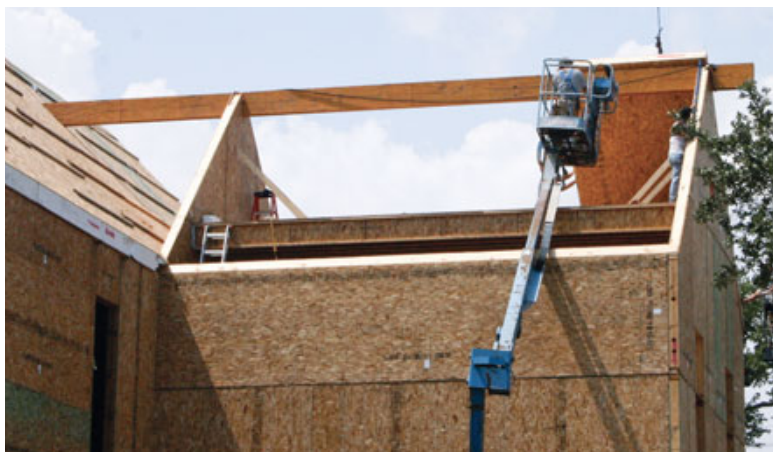
Figure 7. The second-story floor system in the transept addition (above right) hangs between the top of the first-floor wall panels and 6x16 glulam beams that span the openings between the arches of the old structure (above). The 32-foot-long structural ridge beam fit into reinforced pockets in the gable SIPs (right).

The transept wings on each side of the main sanctuary were essentially new construction and went together smoothly. After framing and sheathing the first floor on top of the piers, we glued and screwed doubled 2x6s around the perimeter and slipped the wall panels into place (Figure 7).

We hung the second-floor I-joists from the tops of the first-floor wall panels with top-mount joist hangers. Where the transepts intersect the main sanctuary, the

joists hang from recessed 6x16 glulam beams that carry the floor loads and stiffen the main walls. Then we sheathed the floor, and repeated the process with the second-story wall panels. At the gables, panels were notched and reinforced to receive the 32-foot-long structural ridge beams that support the roof panels.

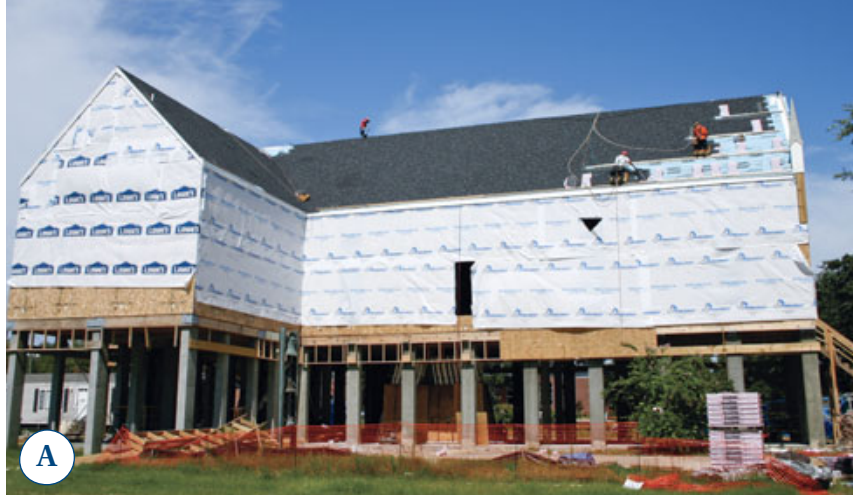
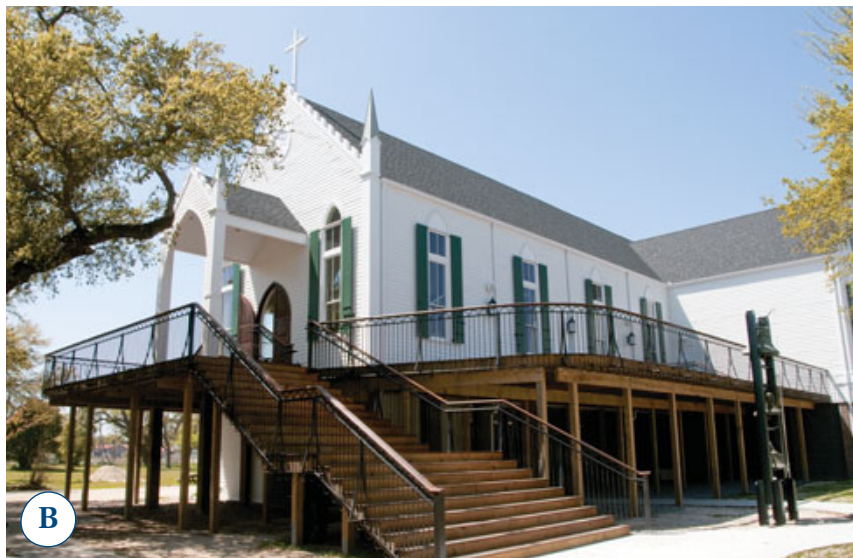
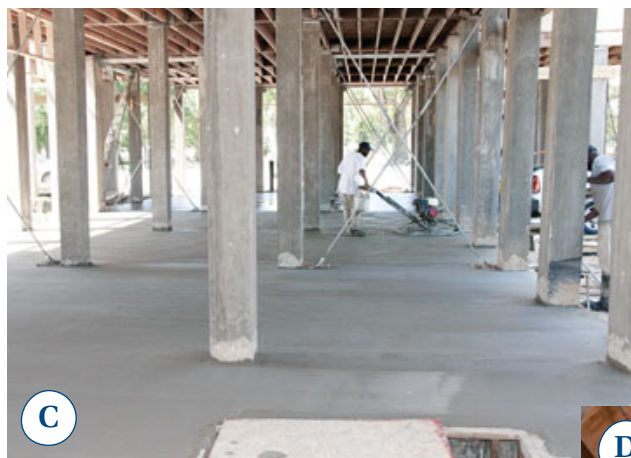
Figure 8. The nonstructural skirt wall (A) and lowered entry deck (B) make the church appear lower to the ground than it actually is, but there’s also elevator access from the finished slab underneath the building (C). With the arches and finish ceiling intact — and the original stained-glass window back in place — the interior looks almost unchanged (D).

Since the bottoms of the SIPs were 14 feet above grade, we wanted to disguise the overall height of the church with a conventionally framed “skirt.” To satisfy FEMA requirements, this skirt had to be non-structural and somewhat less substantial than the SIPs so that it would break away in the event of flooding. Therefore, we framed 30-inch-tall wall sections with 2x6s underneath the glulams. Where the deck, stairs, and hvac platforms would be attached, we bolted PT 2x12 ledgers to the piers at the same elevation, helping to create the illusion that the church is only 10 feet above grade (Figure 8).
