# Solving Moisture Mysteries With an Infrared Camera

Water leaks aren't always where you think they are

by Peter Hopkins

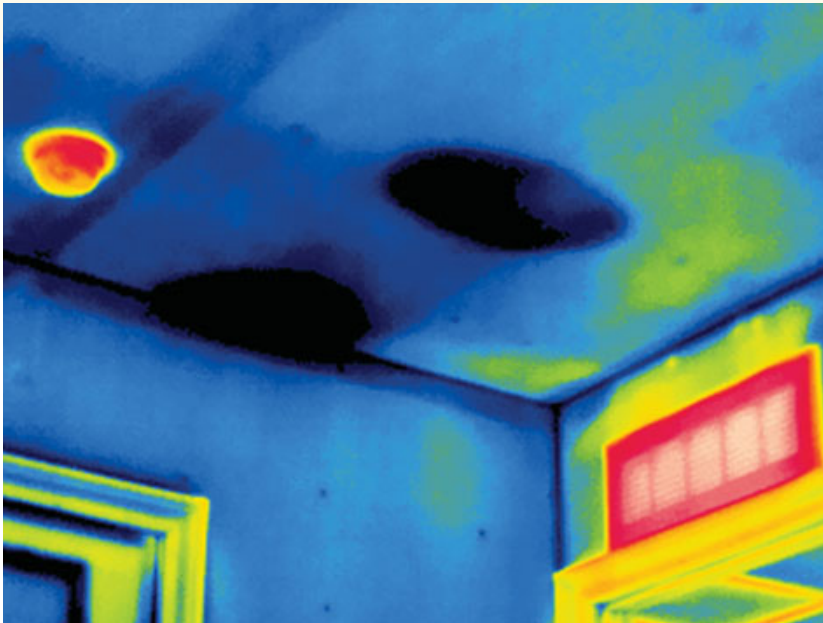
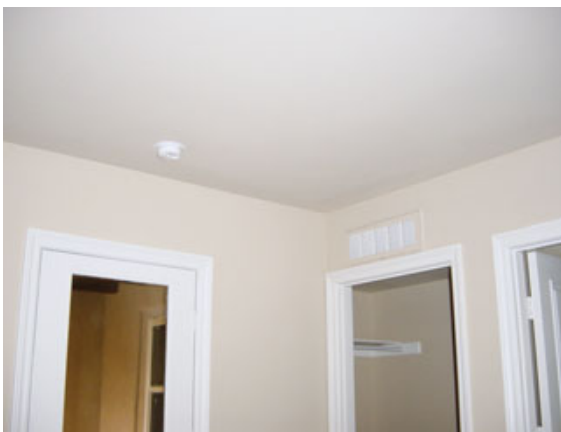
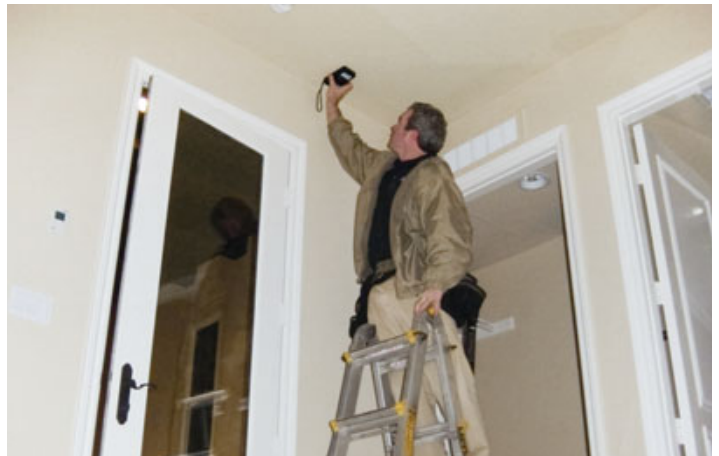
During an energy survey of a new home, the author's IR camera recorded this image (top) showing spots in the ceiling that were not visible on the drywall (above), and which did not look like voids in the insulation. A hand-held moisture meter confirmed the presence of moisture (right); the culprit was a leaky roof flashing.

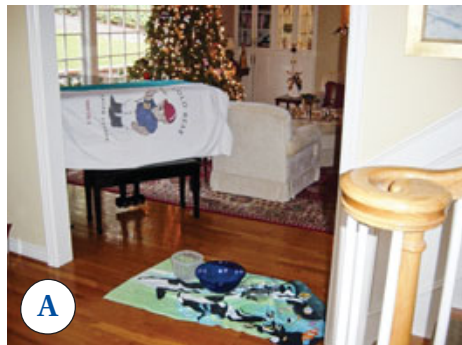
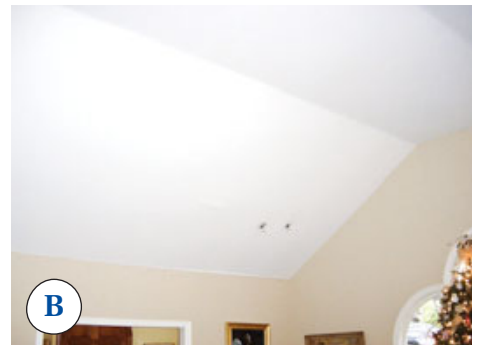
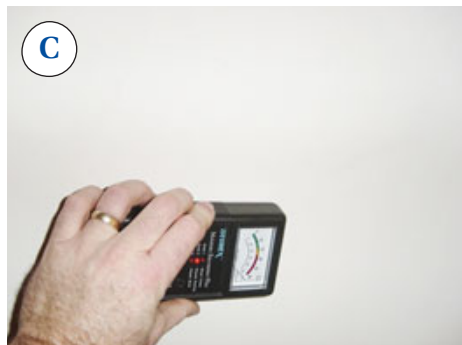
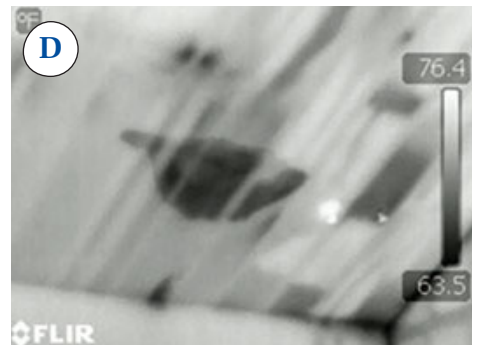
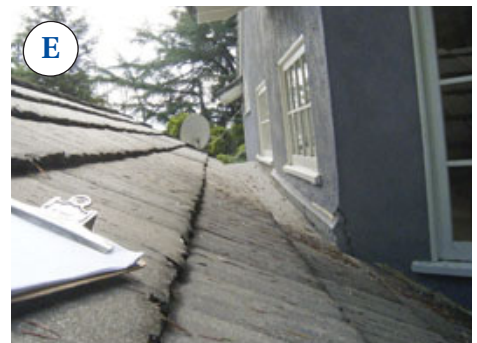
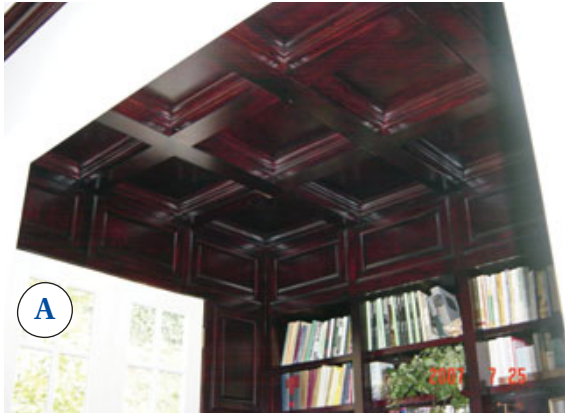
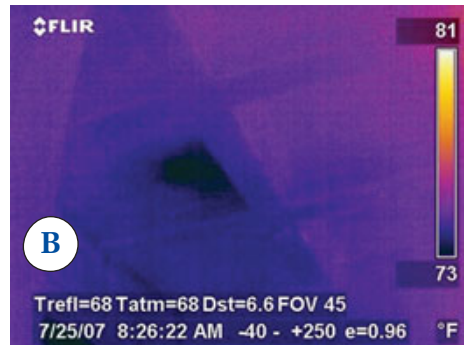
In this case, the homeowner had already replaced the roof three times, seeking to cure an ongoing leak. The roofing contractor was now insisting that replacing an upper section of the roofing would fix the leak, but the owner wanted to try our services first. When we arrived, we found the usual assortment of buckets on the floor (A). After talking to the owner about the problem, we turned on our camera and went to work. Though you may not be able to see it in the photograph (B), there was a slight bulge in the drywall ceiling but no other signs of moisture. The moisture meter, however, read off the scale when placed on this spot (C), and an IR image (D) showed

a concentration of moisture. (Note also the dark square areas to the right of the moisture spot; these indicate voids in the cathedral ceiling's insulation.)

The root of the problem turned out to be poor roof design (E). In heavy rains, water from an upper roof cascaded onto the lower steep-slope roof, where it was directed back against the building and in around the poorly executed counterflashing on the wall, eventually finding its way into the living room ceiling. Our recommendation was to install a new wide cricket flashing, taller counterflashing, and gutters on the upper roof to redirect the bulk of the water.

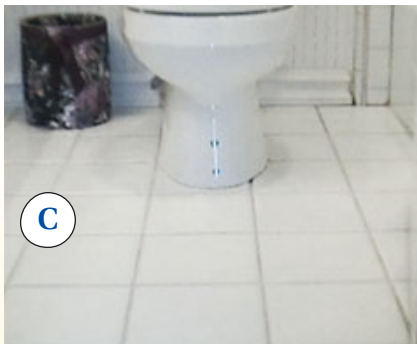
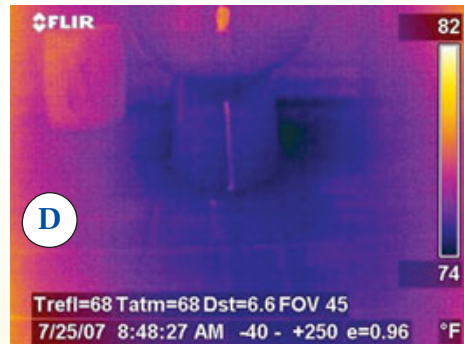
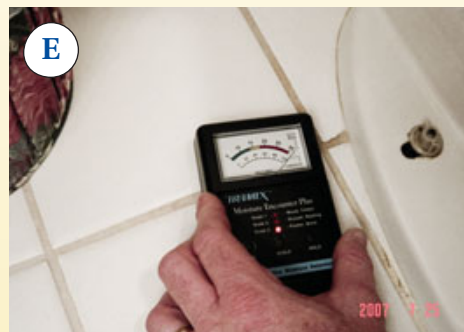
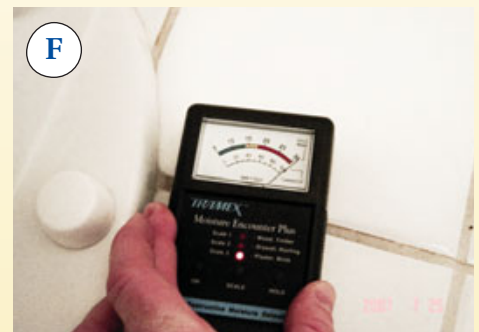
For seven years, the homeowner had tried various repairs to fix a leak that showed up in his library ceiling (A). The bathroom above seemed the obvious source, even though it was never used. One contractor had opened up the drywall around the tub and replaced all the plumbing, but that didn't stop the leak. Another contractor replaced the angle stops on the fixtures, but — again — to no avail. The owner began to suspect the bathroom window and called me in to set up my spray apparatus and do some water testing. But first, we pulled out the camera.

The dark spot in the infrared scan of the ceiling (B) helped to pinpoint the source of the water. Upstairs, we found that this coincided with the location of the toilet (C). As you can see in the thermal image (D), there's a darker area on right side of the toilet. A moisture meter confirmed that the floor around the toilet was soaked (E, F). We made some measurements downstairs and found that the wet spot in the office was 55 inches from the outside wall — the same distance as the right-hand toilet bolt. In questioning the owner about use of the bathroom, we learned that in fact the house cleaner flushed this toilet as part of her weekly cleaning — a seven-year mystery solved.

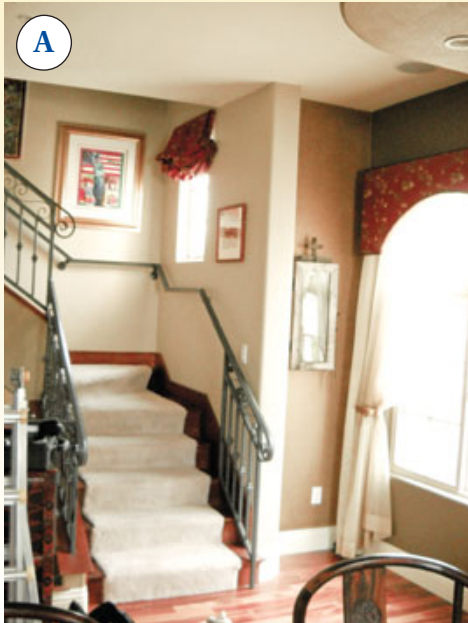
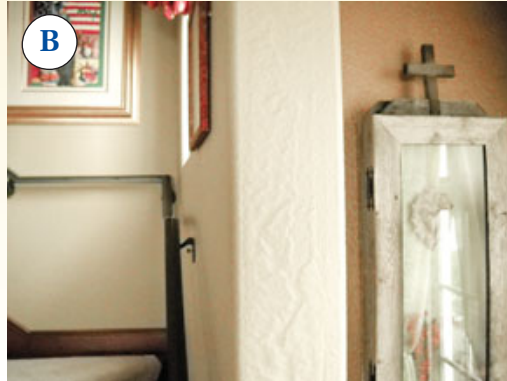
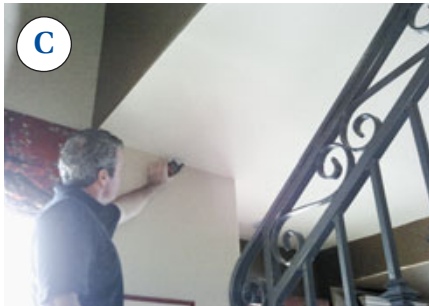
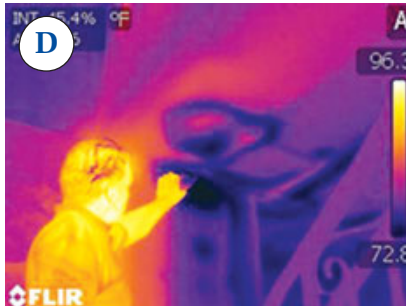
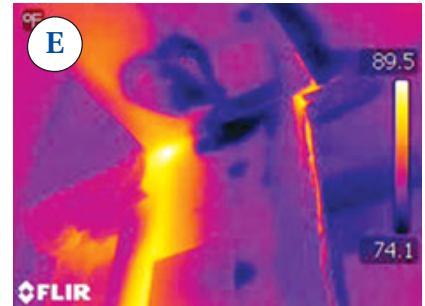
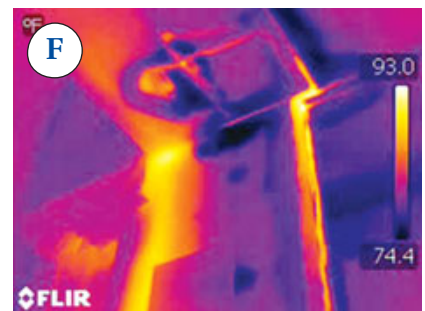
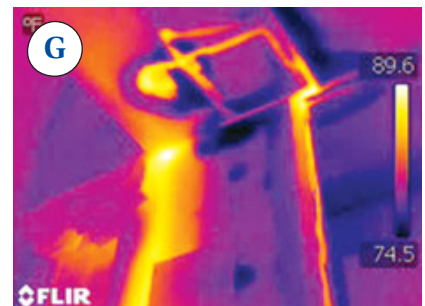
A general contractor called, saying he believed he had a roof leak in a house he had built and asking me to take a look. I found a patch of blistered paint on the return wall of the home's main staircase (A, B). Moisture readings confirmed that the wallboard in the area was damp (C). A bathroom upstairs might have been the likely culprit, but the builder had already repaired leaky supply pipes a few months earlier, so now he suspected the roof. However, the initial IR scan (D) showed a pattern of water under the bathtub, so we figured we'd start there.

We turned on the hot water and let it run, then set the camera on time-lapse mode and began scanning. In a couple of minutes, the water began to show up as a bright yellow streak coming down the corner of the wall (E). (You can also see the hot-water supply pipe running up through the wall to the left.) Then gradually, as the wall was saturated, the hot water filled in beneath the tub (F, G), which turned out to be the source of the leak.

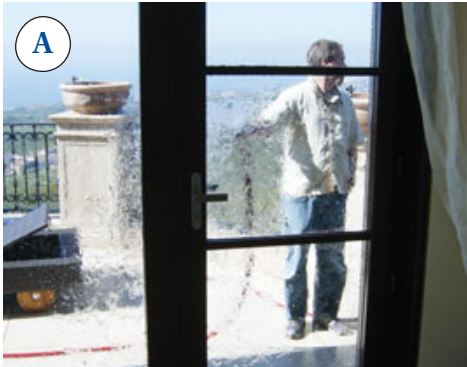
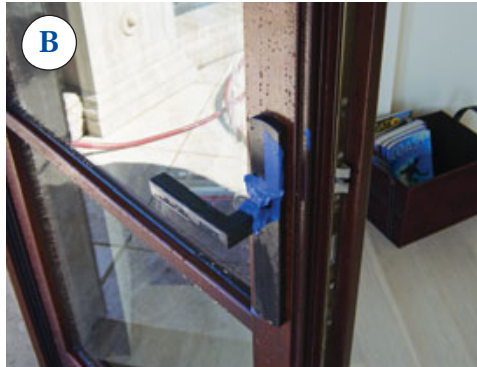
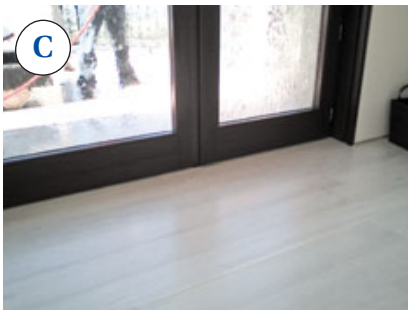
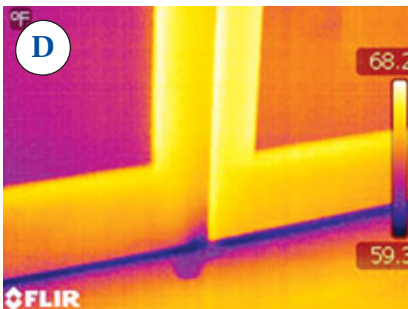
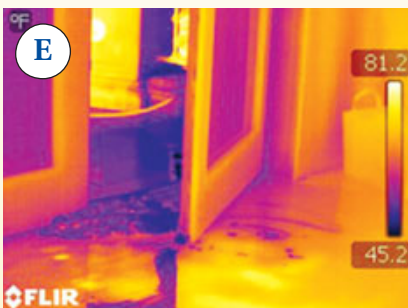
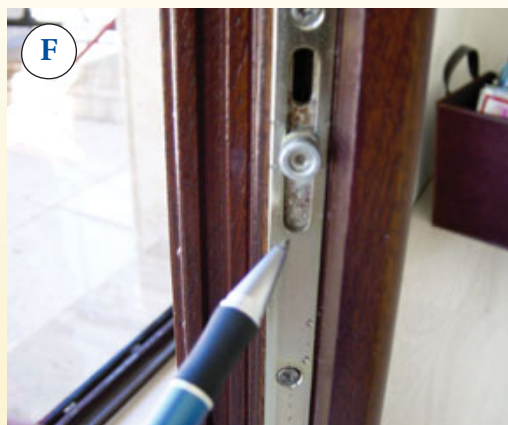
After getting up to speed on what had been done, we used a hose to perform a water test (A), which would help us figure out where the water was getting in. We taped off obvious points of entry, like the keyhole (B), to rule those out. Before long, water was coming in under the door, as both the visual and infrared photos show (C, D). When we opened the door, the IR scanner quickly picked up something that might not have been obvious — the water was flowing out from inside the bottom corner of the door (E). The problem wasn't the caulking or weatherstripping, but

simply a small gap between the door handle and the faceplate, which allowed water to enter and run down through the three-point locking mechanism. Note the rust spot on the hardware (F) where the water came in. We recommended adding a rubber washer between the handle and the plate — an inexpensive fix, considering how much money had been invested in trying to solve the problem.

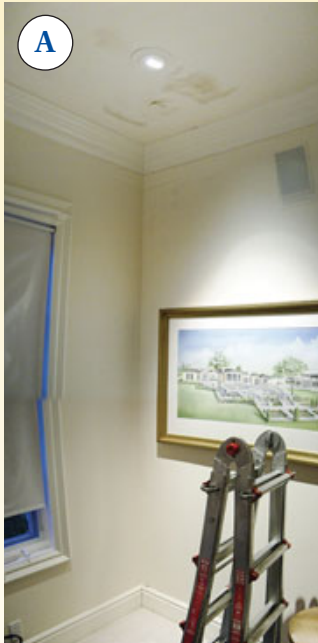
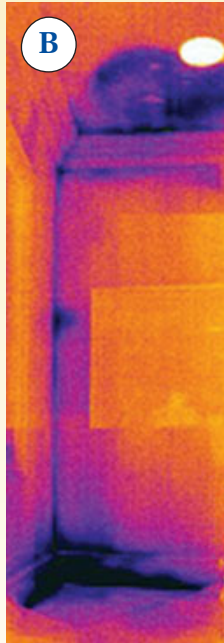
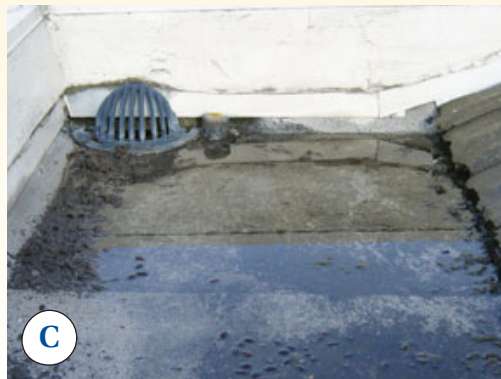
As you can see from the visual image (A), there was some moisture damage on the ceiling, but it seemed to be limited to that one location. But in the thermal image (B), it's obvious from the darker areas that the water had in fact traveled all the way to the floor. When we went up on the roof, we found that ponding was occurring because an overflow drain at the parapet wall was improperly installed (C). This was a leak waiting to happen.

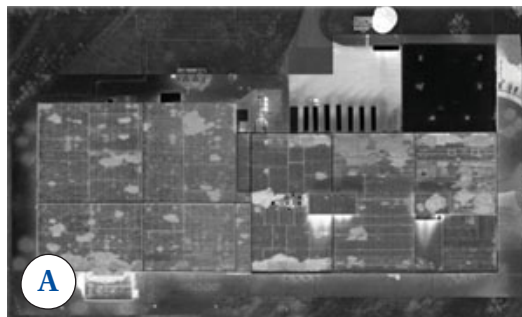
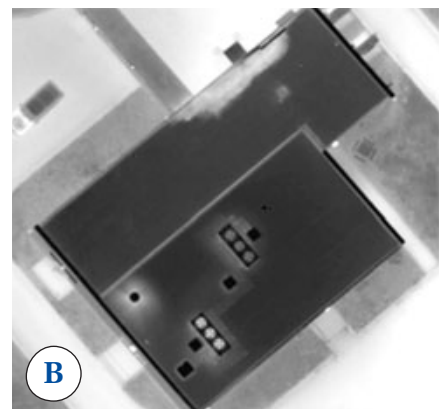
The white lines in this scan of a large low-slope roof (A) indicate moisture trapped along the edges of the rigid insulation panels. The other light-colored irregularly shaped areas show places where the insulation is wet. In the image of a flat roof (B), the light-colored area at the top indicates moisture in the roof substrate.
