# In the Path of the Storm

A firsthand look at the damage inflicted on new wood-frame homes by the April 2011 tornados in North Carolina and Alabama

by Bryan Reading, P.E.

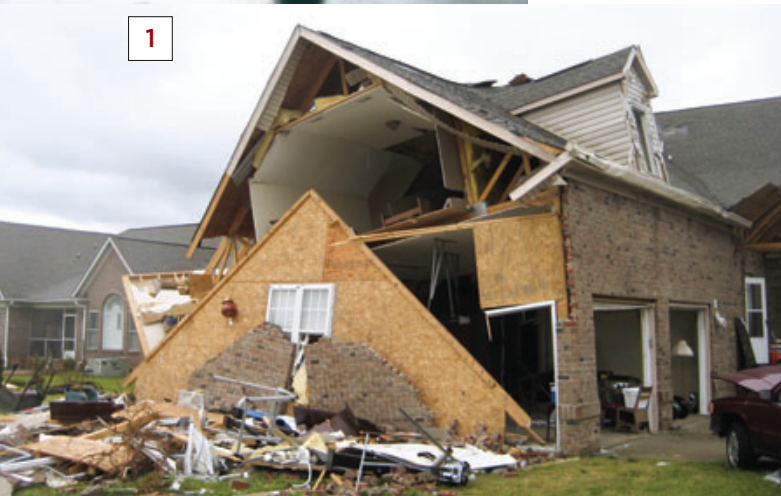
Damage to this home (1) most likely started with the failure of the garage doors. Subsequent pressurization of the garage blew out the sidewall and pushed out the back wall. A close look showed inadequate nailing of the drywall ceiling and the bonus-room floor sheathing (2) to the bottom chord of the gable-end truss, seen here from behind (3). The gable triangle was intact, with the OSB sheathing still in place — it's the connections that failed.

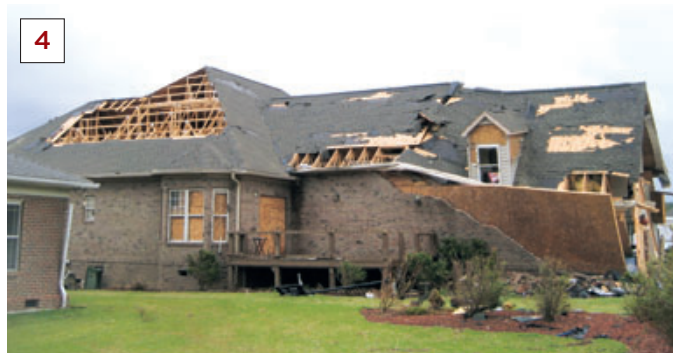
The same home, seen from the rear (4), also lost sheathing at the step-down trusses of the hip roof, a type of failure I observed several times. Top-chord nailing surfaces on step-down trusses do not neatly align with the roof sheathing, which makes it more difficult to attach the sheathing adequately.

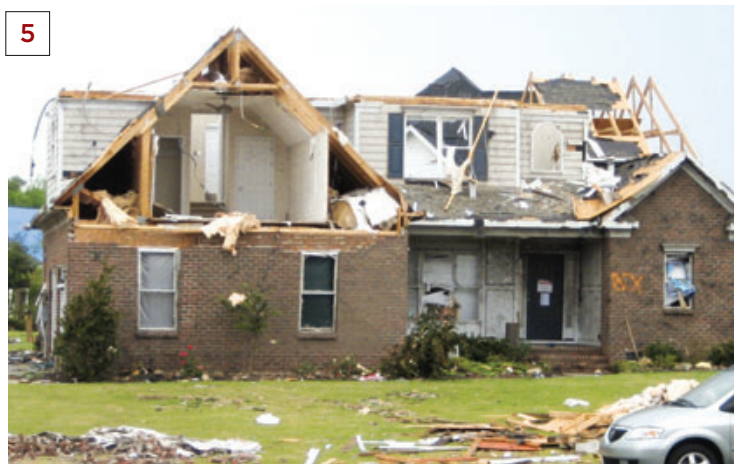
A nearby home (5) also lost gable-end attic trusses in two places. The garage doors (barely visible at the left end of the house) were breached, allowing the gable wall and roof to be blown off.

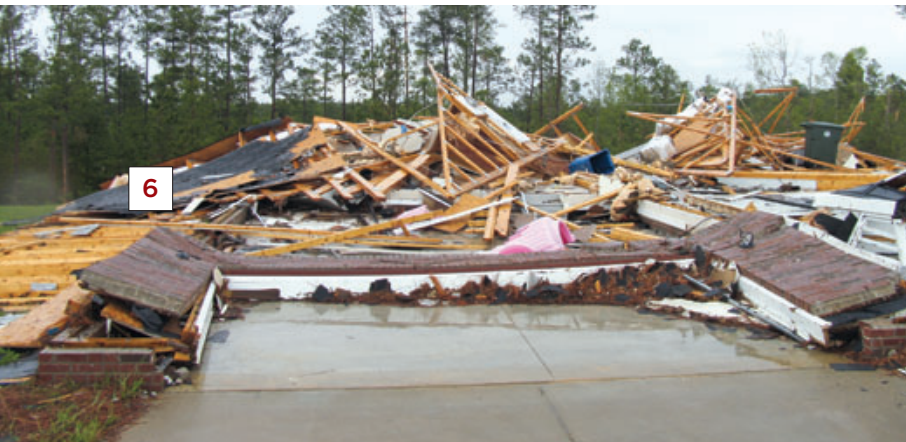
Another home in the same subdivision fared much worse (6); most likely the garage walls were blown out due to pressurization through the large garage-door opening, seen in the foreground. A closer look at the left-hand garage wall (7) shows that the OSB sheathing was poorly attached to the bottom plate with 8-penny nails 16 inches on-center. Foundation anchor bolts with round washers were spaced 48 inches on-center along the sill plate. The home's roof trusses had been attached with toenails (8).

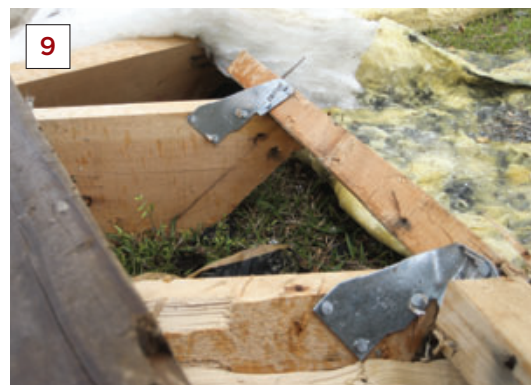
The rafters on another house in the neighborhood were attached with metal connectors (9); note, however, that the metal ties were nailed to the inside of the top plate. They should have been installed on the outside of the wall, in alignment with the load path through the plywood sheathing.

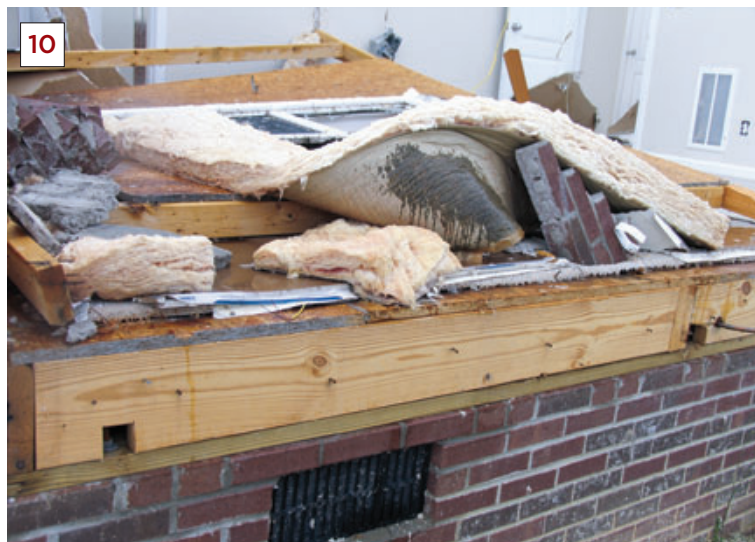
Another collapsed home (10) was fully sheathed with OSB, which lapped the rim board and sill plate but was fastened only to the rim board with 16-penny nails at approximately 16 inches on-center. I could see no nails through the sheathing into the sill plate.

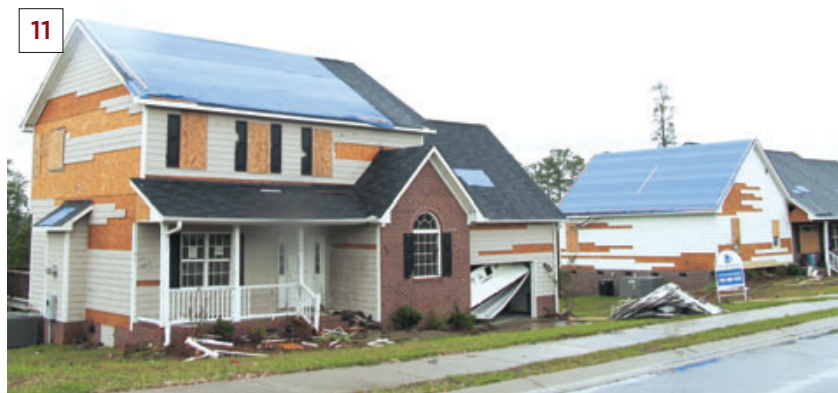
These two homes (11) lost much of their fiber-cement siding, but there were no breaches in the OSB sheathing.

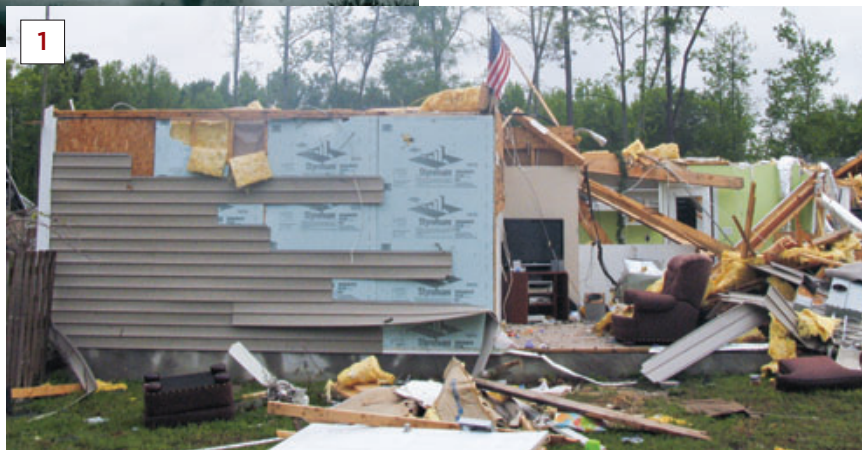
The homes I studied in Wilson were all built between 2004 and 2009. This home was almost completely destroyed (1); shown here is an end wall, which was braced at the corners with OSB and had nonstructural extruded polystyrene as infill sheathing. The home's bottom plate — shown with bits of the foam sheathing still attached — was intact (2); structural wall sheathing would have greatly strengthened this connection between the wall studs and the bottom plate.

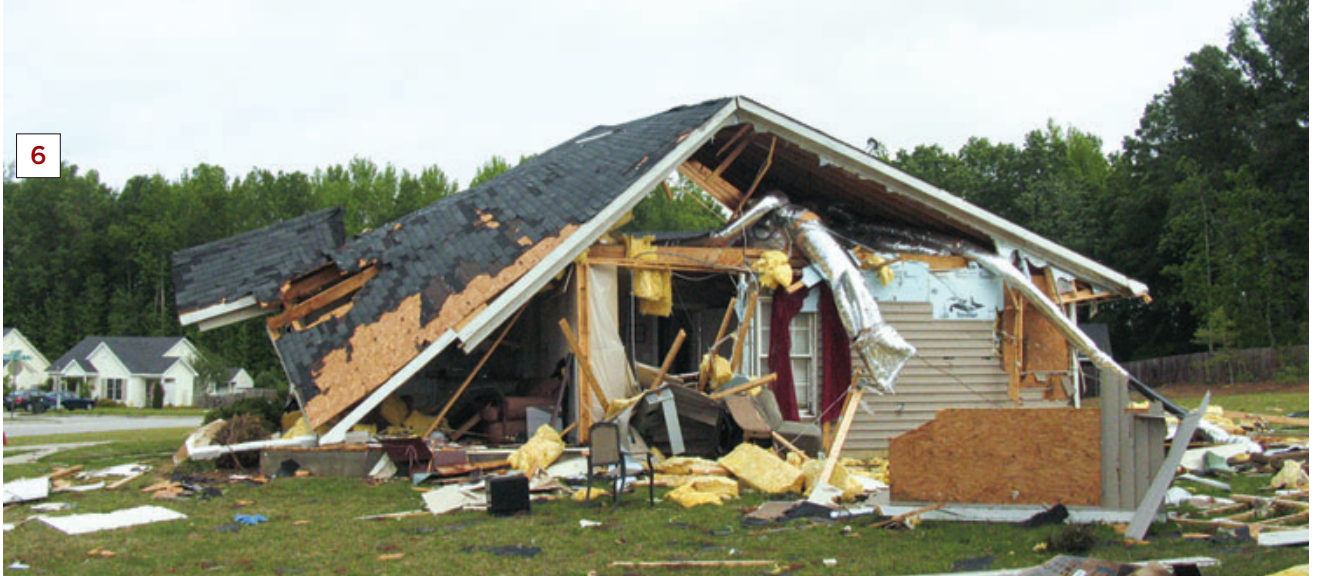
Though this home's roof remained largely intact (6), several of the exterior walls were blown out — a testament to both the tornado's lack of strength and the inability of poorly executed framing connections to maintain integrity of the

building envelope. The back corner is still supported by the OSB corner bracing panel (7). A braced corner in front was pulled off when its connection to the bottom plate failed (8). On the opposite side of the house, the foam sheathing at the gable truss is almost completely stripped from the framing (9). Below, the foam-sheathed portion of the wall was lost, though the OSB corner bracing is still in place.

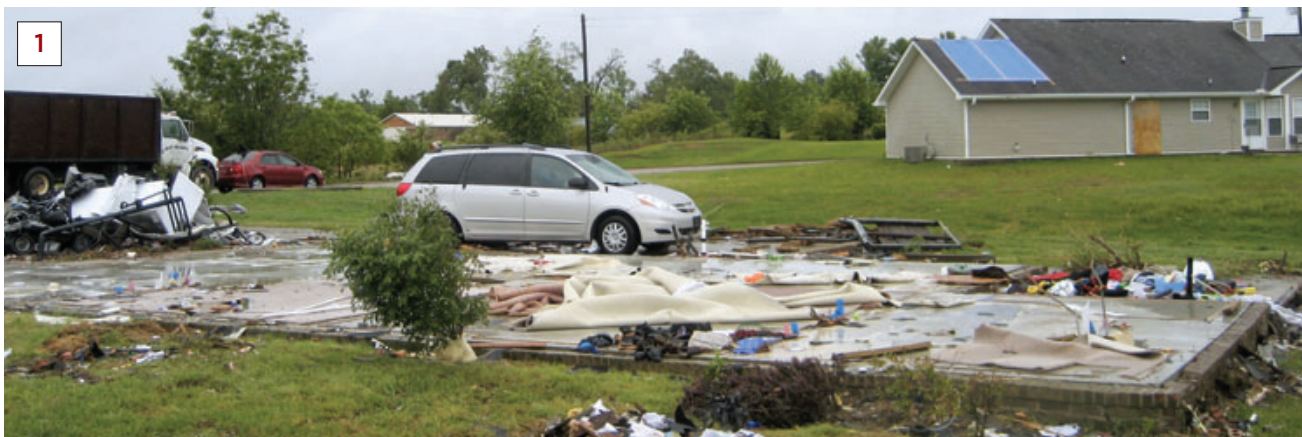
This home in western Alabama (1) was completely blown off its foundation by a tornado that came through the area around 5:30 a.m. on April 27. Remarkably, the family inside the home was swept away from the building, though no one was seriously injured. A length of sill plate was

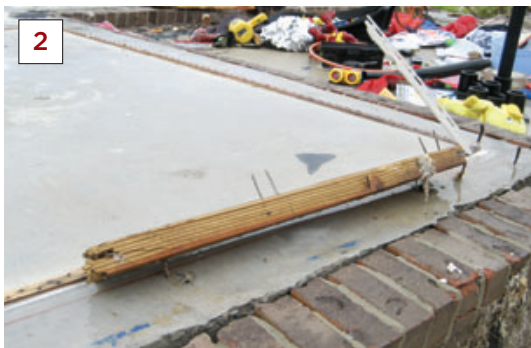
the only piece of the exterior walls that remained on the slab (2); the sills had been attached with rectangular cut nails.

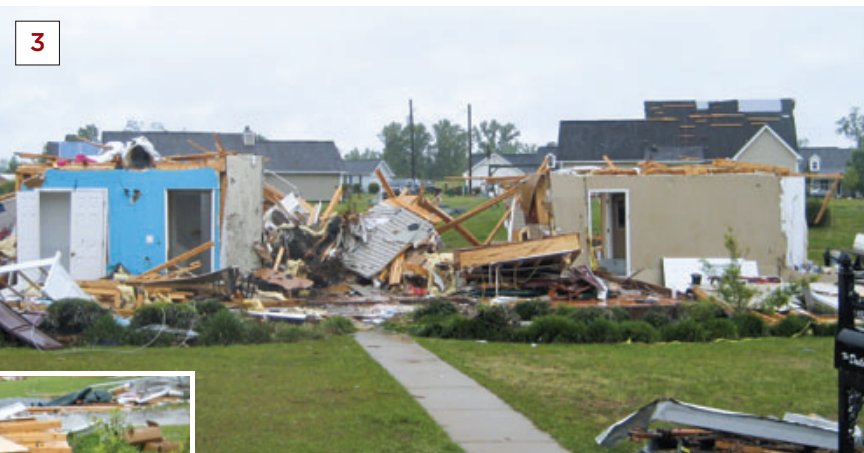
A nearby home lost all its exterior walls (3); its sill plates had been fastened with spiral shank nails 24 to 48 inches on-center (4, 5).

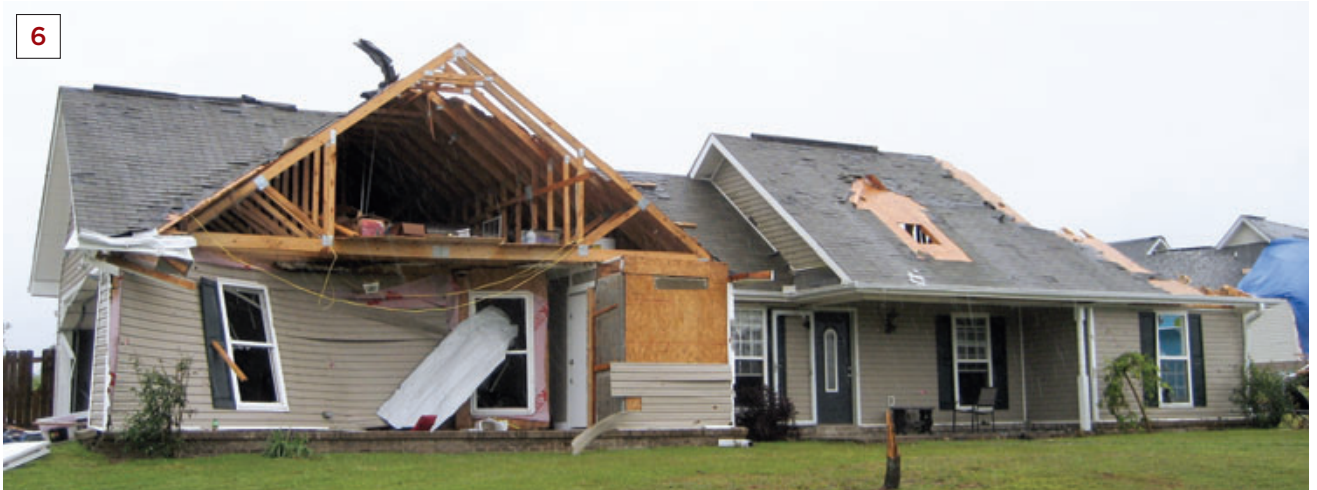
6

Another home in the same neighborhood lost its garage door and had its front garage wall pushed in — apparently by wind pressure, as there was no sign of impact. Gable-end failures occurred on the front and right side of the house (6). The home's masonry safe room, at the front center (7), was undamaged, and may have helped strengthen the home against the tornado's forces.

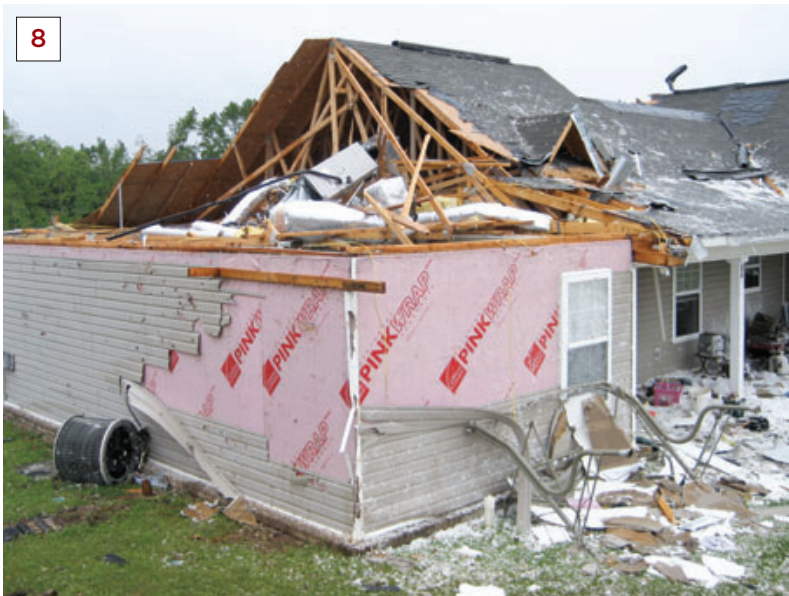
8

Seen here (8) is the back right corner, where the gable roof over the children's bedrooms was lost. Like most of the homes in the neighborhood, this one was fully sheathed with OSB; pink housewrap and vinyl siding covered the sheathing. A closeup (9) shows a typical truss-to-top-plate connection; the four toenails, placed in opposing pairs, caused the bottom chord to split.

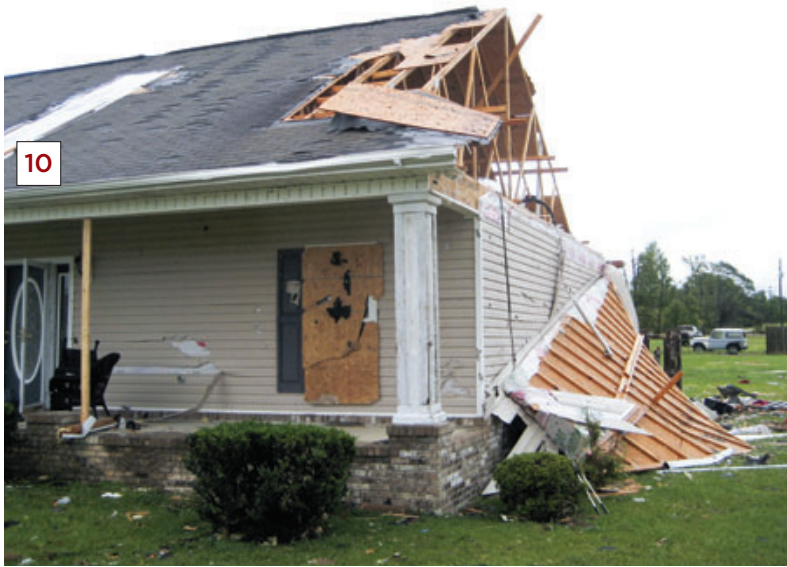
The gable end was stripped from this

home (10). The bottom chord of the gable truss had been attached to the plate below with 16-penny toenails more than 2 feet on-center (11); the roof sheathing was secured with nails every 48 inches and staples every 12 inches between the nails (12).

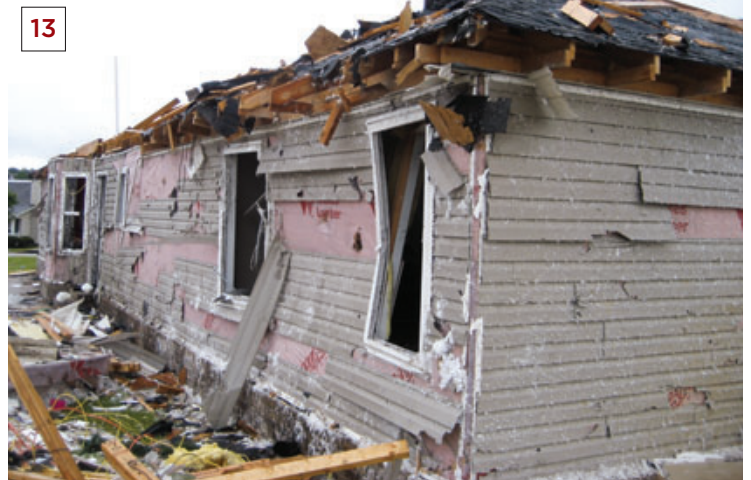
Though heavily damaged, this house (13) may have fared better than nearby homes because it has a hip roof, which is better than a gable roof at resisting high winds. The wall seen here was knocked in by an impact that occurred between the two windows in the middle of the photo. Though the wall was sheathed with OSB — which helped hold the framing together — the connection at the top plate failed.

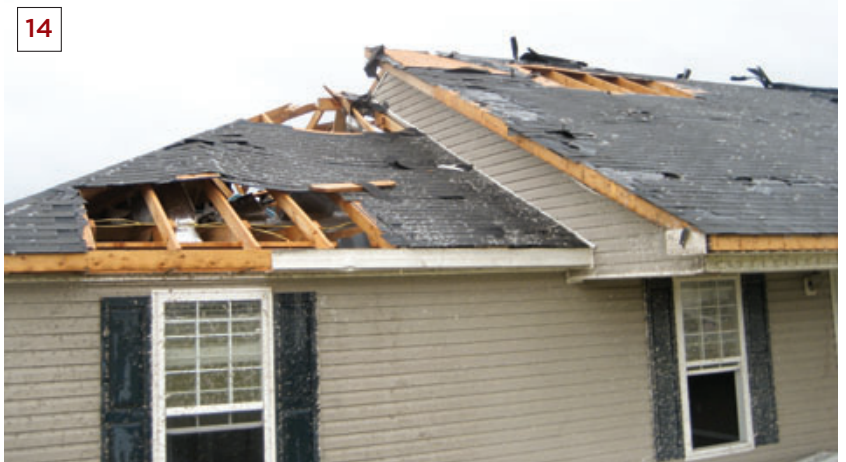
Another view of the same home shows missing sheathing on one section of the roof, probably related to loss of the lightweight vinyl soffit directly below (14).
