Troubleshooting Brick Veneer

Missing through-wall flashing and clogged cavities spell disaster

by Harrison McCampbell

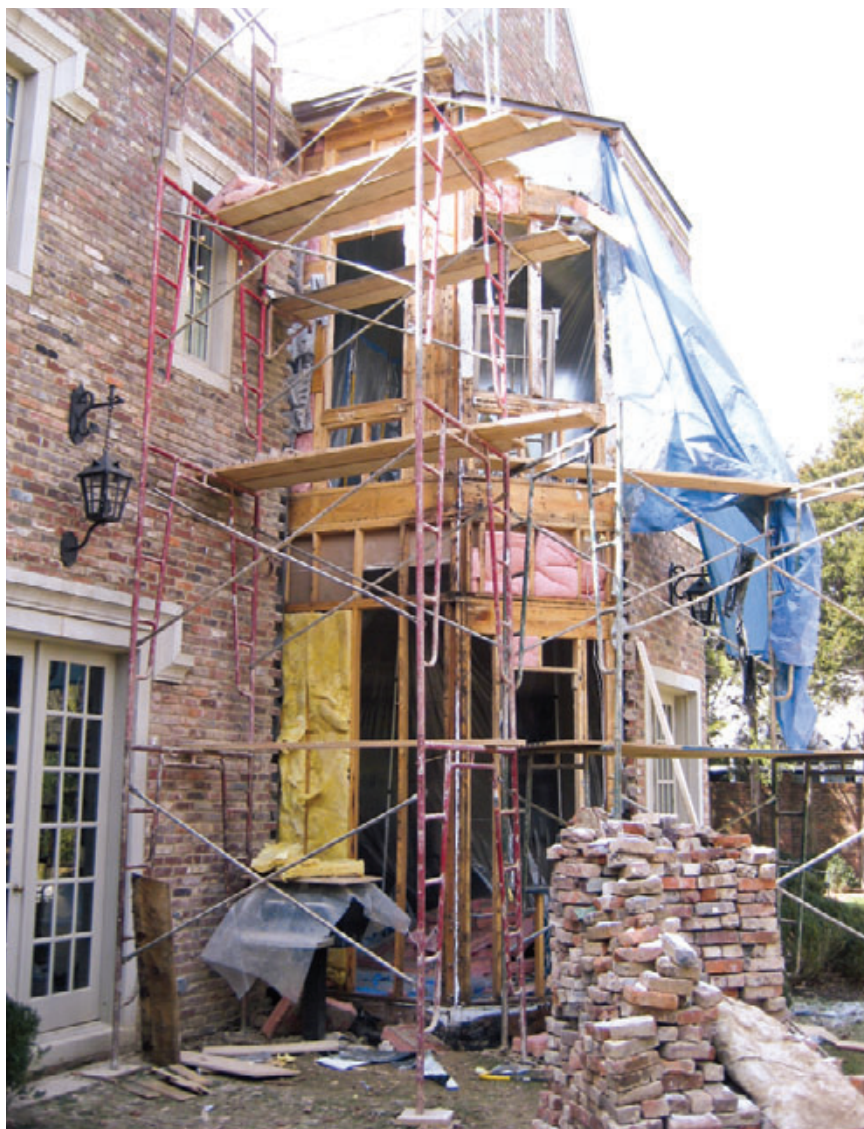
Take the house in the photo at right. The owners reported recurring leaks and damage to pricey custom finishes inside. By the time I was called in, they were understandably upset at the many failed attempts to fix the problem. Typically in a case like this, the “repair” consists of applying tubes of caulk or mastic around windows and flashings — inevitably a waste of time. As you can see from the photo, getting to the root of this house's problem was a little more involved than that.

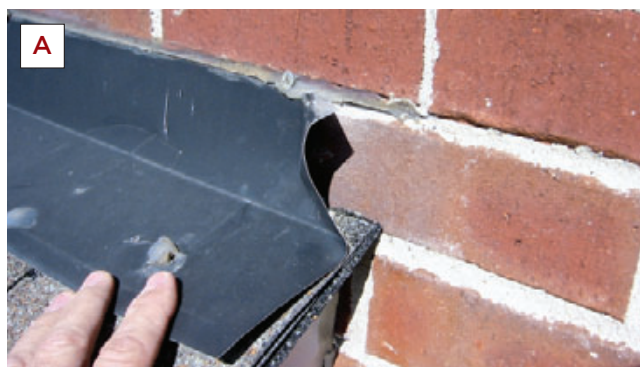
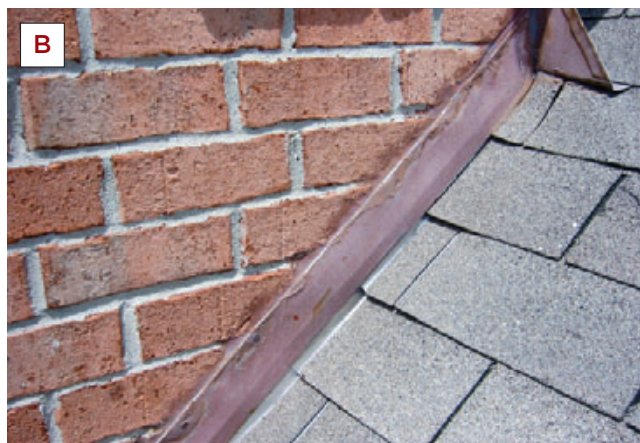
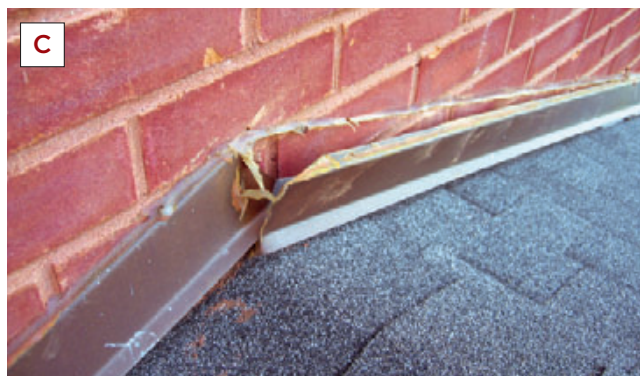
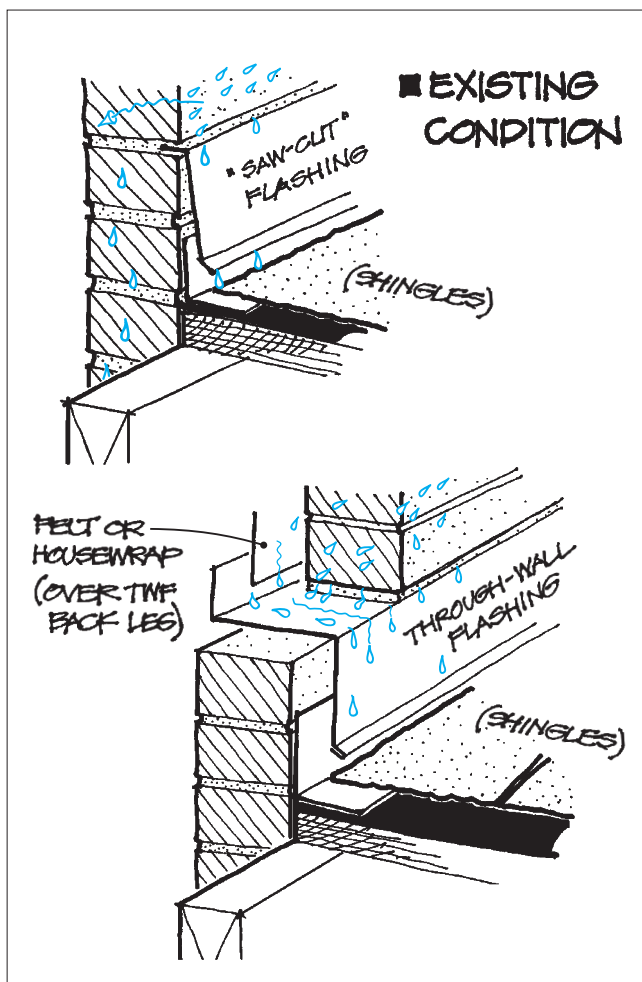
The main cause of moisture problems in the brick homes I investigate is the lack of proper through-wall flashings (see Figure 1). For example, one common source of leaks is the counterflashing installed where a sloped shingle roof abuts a brick wall. The metal is usually 4 or 5 inches high, follows the shingles in a straight line parallel with the roof, and may have an occasional fastener

Figure 1. Counterflashings installed in saw-cut kerfs, whether at shed roofs (A) or sloped roofs (B, C), do nothing to divert water from the cavity behind the brick. These installations have a high rate of failure; copious amounts of caulk and the presence of nails or screws are dead giveaways that the flashing is useless. The sketch above, made by the author during a site visit, explains to the client the difference between a kerfed-in and a through-wall flashing.

through its face into a mortar joint. Typically, the suspect flashing is turned in about $\frac{1}{4}$ inch to $\frac{1}{2}$ inch along the top and simply let into a kerf cut in the mortar or brick with a masonry blade. But the biggest warning signs are the nails and the copious amounts of caulk along the top edge. Even when I find the metal installed in stair-step fashion down a brick wall, it's still most likely a saw-cut job, where the counterflashing was installed after the brick had been laid (**Figure 2**).

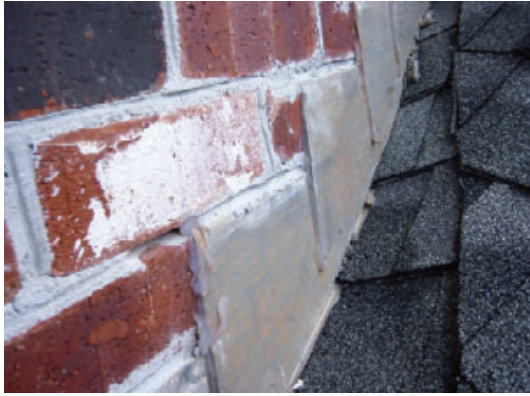
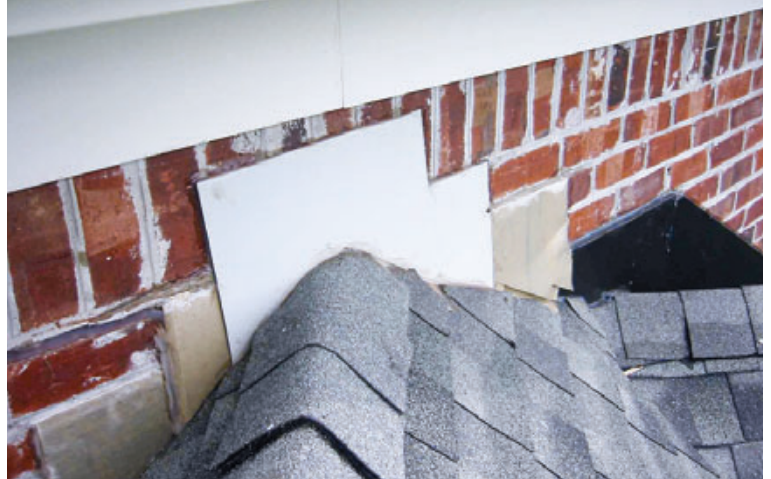
Figure 2. Stepped counterflashings installed in mortar joints (above) are no better than saw-cut flashings at diverting water from the cavity — unless they happen to run through to the sheathing and tuck under the building paper, which is rare. The work often gets sloppier where the installer thinks no one will see it, as in this bungled mishmash of surface-applied metal (right).

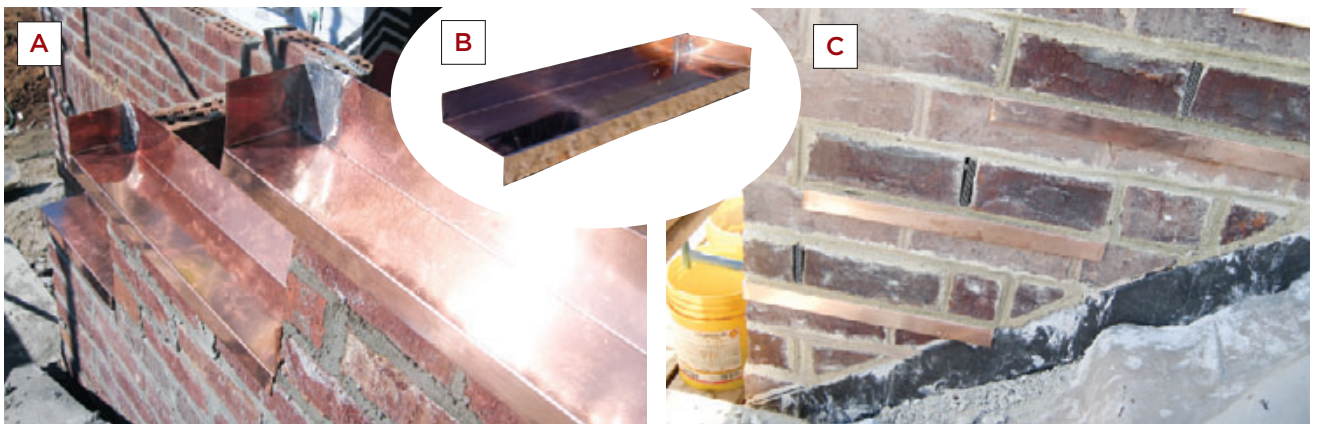
Figure 3. A properly flashed sidewall uses through-wall pans with soldered end dams (A, B), installed in stepped fashion as the brick is laid. Once the through-wall flashings are mortared into place (C), the roofer will install step flashings, followed by copper counterflashings that are secured to the through-wall hems with pop rivets. Note the wasp screens on the weep joints.

Unfortunately, the kerf method appears to have totally replaced use of proper through-wall flashings at roof-to-wall intersections. Admittedly, doing the job correctly is a detailed process that requires coordination between the roofer and the mason (**Figure 3**). But it's the only way to guarantee that water entering the brick

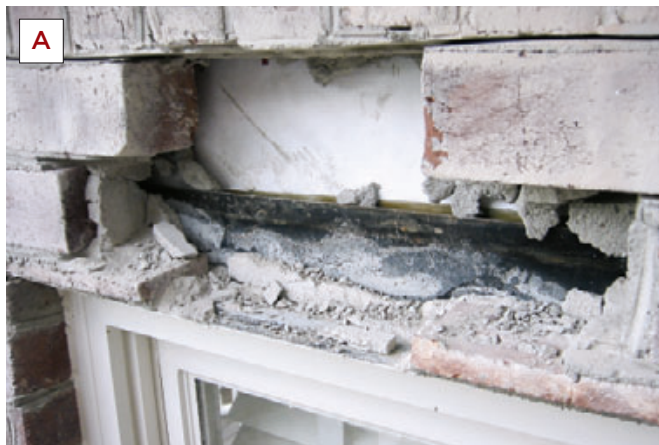
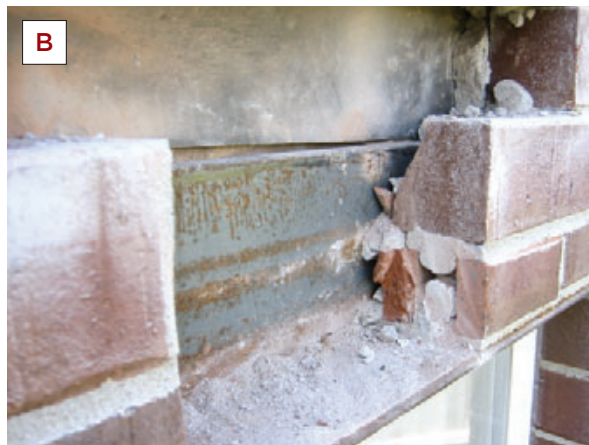
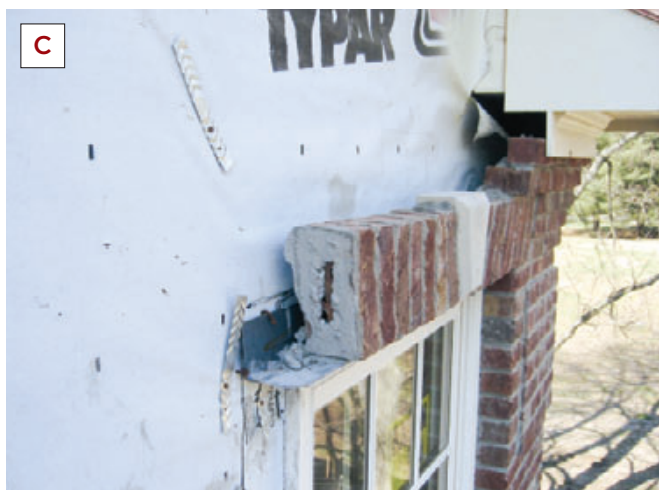
Figure 4. The rubber flashing tape intended to direct water onto the steel lintel (A) has pulled away from the housewrap and is instead directing water into the framing. Here (B), a metal flashing above the window just misses the lintel. Note the amount of mortar clogging the cavities in both cases. At left (C), a failed job required all the brick to be removed, revealing improperly flashed lintels at the windows, as well as ties that were never used.

Window and door heads. There should be through-wall flashings below the first course of brick along the top of windows and doors. The steel angle is for structural support only; it should not be used for flashing. For example, some contractors will lap the felt or housewrap over the top leg and rely on the angle to keep water out. More often, though, there's no flashing anyway, and the steel is installed on top of the housewrap (**Figure 4**).

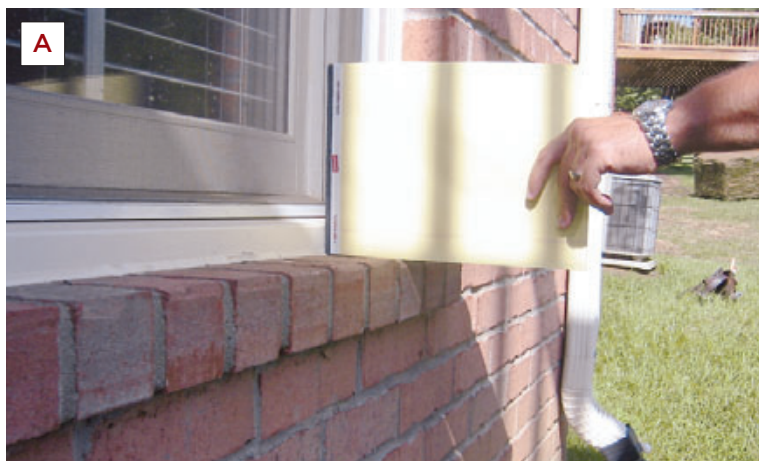
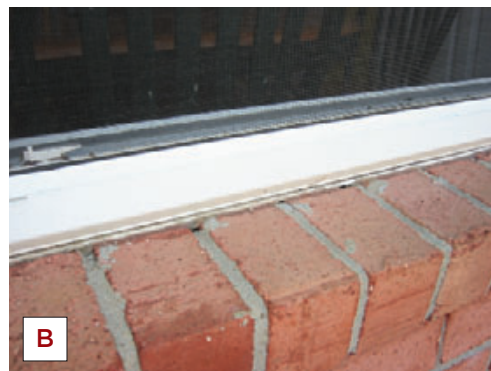
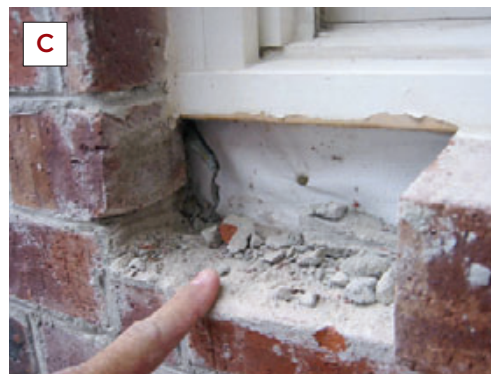
Figure 5. Unlike this one (A), window sills should be sloped 15 degrees. A close inspection reveals potential leak spots along this window frame (B); because there's no through-wall flashing, water will get into the framing. Instead of flashing below this window (C), there's a cavity clogged with mortar and compromised torn housewrap.

Window sills. Through-wall flashing should also be placed under the sloped course of brick (typically rowlock) immediately below the window. This is meant to catch any water that makes it into the wall cavity through or around the window. Sills should always be sloped at least 15 degrees, per BIA standards (**Figure 5**).

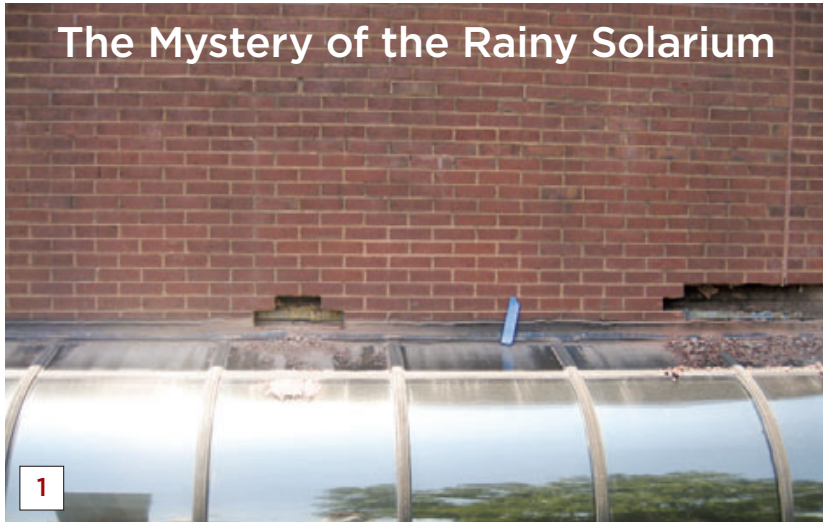
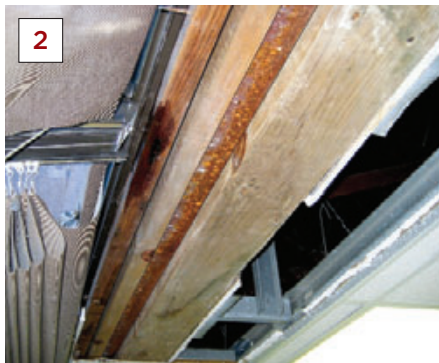
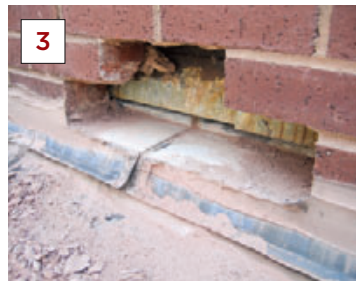
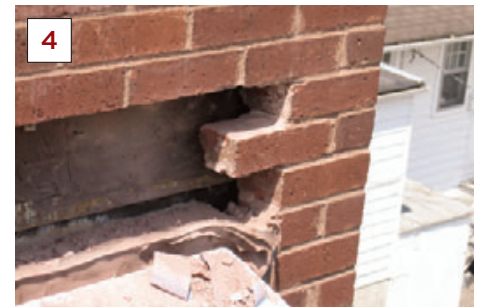
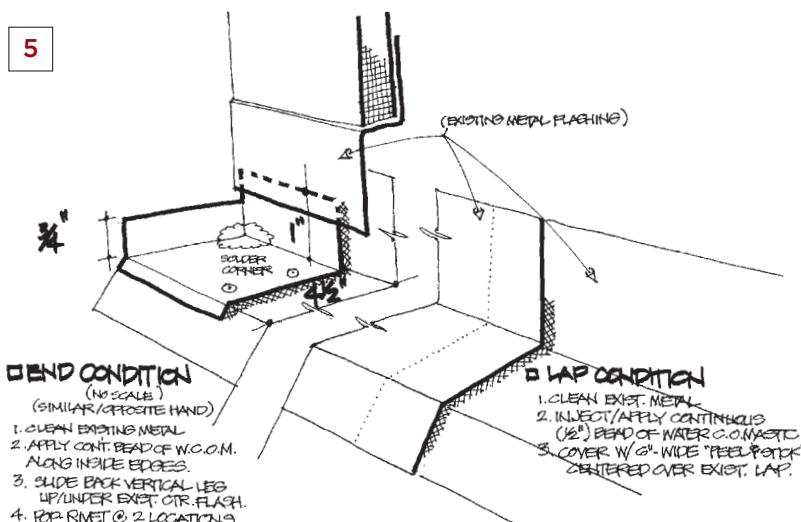
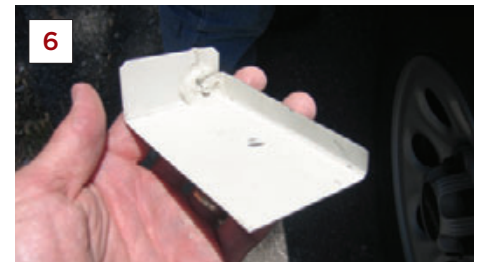
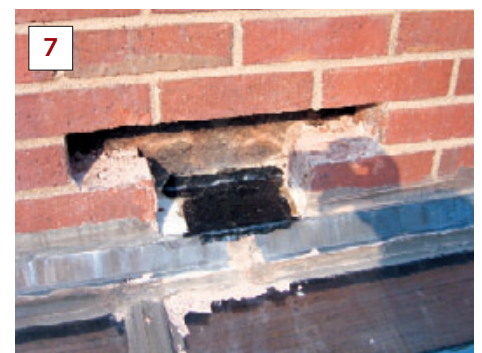
The offices under this curved glass roof (1) had been getting wet for years. The drops of water usually came down days after the rain — not surprising, given the height of the brick wall above, a likely water reservoir. I started with some controlled testing and discovered that water was showing up inside about 10 feet away from an area where I could see a lap in the metal through-wall flashing outside. Next I called for removal of the dry-wall ceiling (2) to further narrow the possible entry location. From what

I could see inside, I suspected that the laps in the flashing had failed, if they ever worked in the first place. We had no choice but to rent a bucket truck and — very carefully, considering the glass below — start deconstruction. We first uncovered the suspect lap joint, which — sure enough — was not sealed (3). I also pulled off the brick at the end of the solarium, pretty sure that I would find no end dam in the flashing there (4). Without dams, water would eventually make its way down into the walls at each end.

My recommended repair (5) called for all laps to be soldered and sealed, and for the installation of new end-dam flashings that would extend several inches past the glass roof. I made a mockup to show what I had in mind (6). When the roofing contractor did the repair, he soldered the new copper flashings wherever he could, and sealed them with Carlisle's Water Cut-Off Mastic, a clay-based caulk that effectively stops water as long as it's in compression and out of direct sunlight. For good measure, we also added a layer of uncured rubber membrane (7, 8). It's been years now and they've not had any leaks since. — H.M.

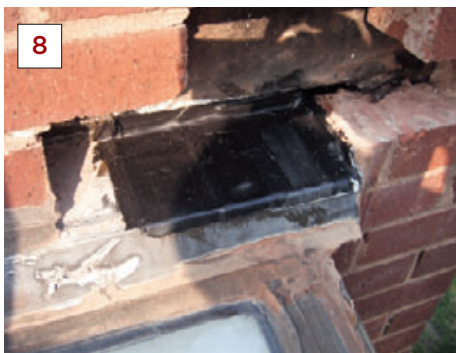
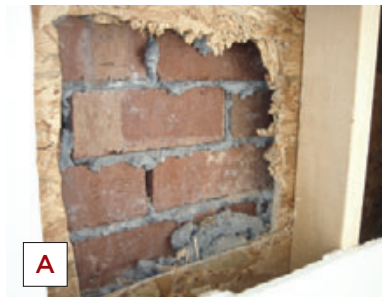
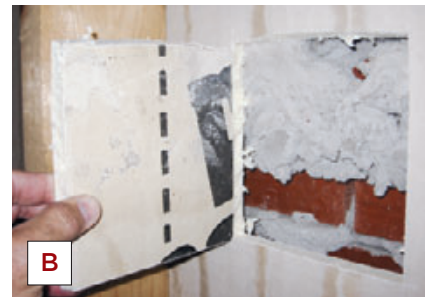
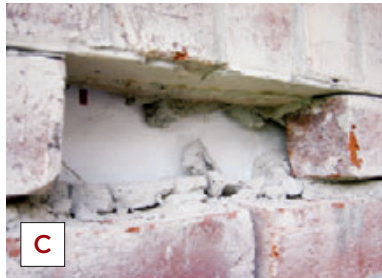
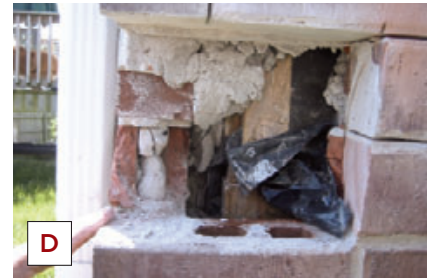
Figure 6. Destructive inspections from inside (A, B) and out (C, D) often reveal the cause of moisture, stains, and mold on interior finishes: The cavity is clogged with mortar, which holds water that eventually soaks the sheathing, framing, insulation, and drywall.

If wall cavities were created in a perfect world, they would be just that — cavities. The mortar, and any water it holds, would stay completely away from the felt or housewrap that guards the wall sheathing (Figure 6). But since masons are usually pressed to do their jobs as quickly as possible, excess mortar on the back

of the brick will naturally collect along the bottom of this cavity. As a precaution, always make sure that the back leg of the through-wall flashing at the base of the wall reaches above the likely level of the mortar droppings — 8 inches is good for a single-story house, more for additional stories.

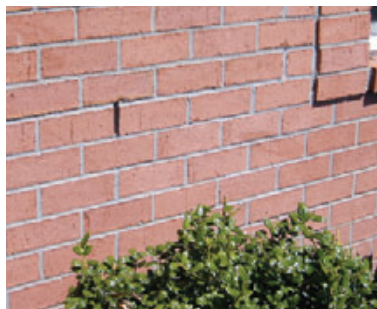
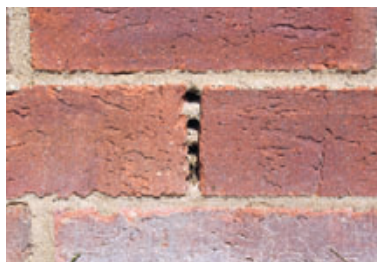
Figure 7. Randomly placed weeps (top) serve no purpose because there's no through-wall flashing to divert the water. Weeps drilled out after the brick is in place are a sure sign of missing flashing (above).

When inspecting leaky brick homes, I often note that there are no weep holes, or that they are in odd locations (Figure 7). Contractors, when pressed on the issue,

may insist that there are indeed through-wall flashings behind the brick, though at this point I have my doubts. Sometimes I'll find head joints that have been drilled out after the fact to provide weeps. In that case, even if there were flashings in the wall, there's a good chance that they would now have holes.

For through-wall flashings to work their best, there should be weep holes to allow the water out. The Brick Industry Association — my preferred source for details on the correct way to install brick veneer — recommends leaving an open head joint every 24 inches. The IRC allows for weep holes that are as small as $\frac{3}{16}$ -inch in diameter, every 33 inches immediately above the flashing.

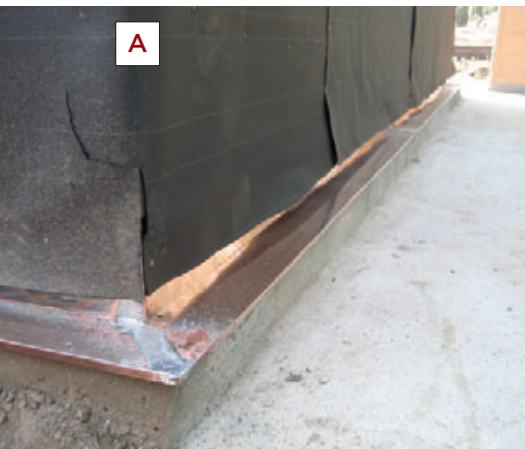
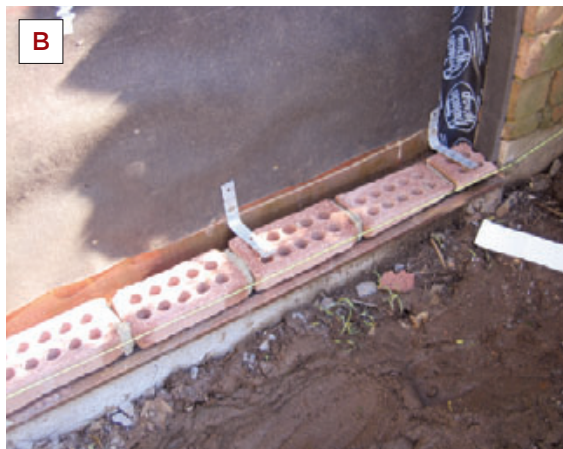
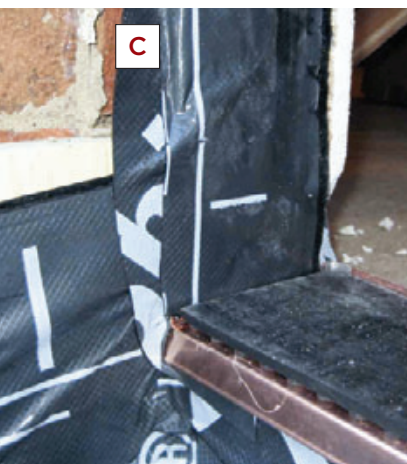
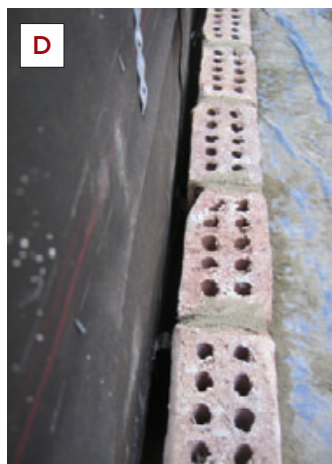
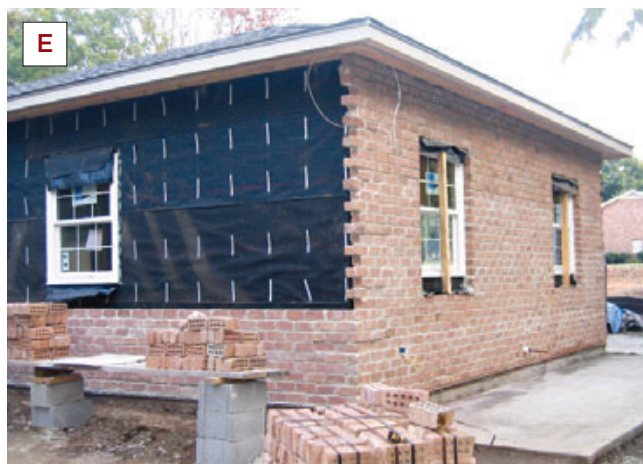
Figure 8. A durable job starts on a soldered copper base flashing (A), with the first course properly tied (B) and set on a weep cut from a Carlisle rubber traffic pad turned upside down, as seen in this photo from another job (C). The cavity is kept clean (D), and ties are spaced every 2 feet vertically and securely attached to the studs with galvanized ring-shank nails (E).

As the photos on this page show (**Figure 8**), it is actually possible to get a workmanlike brick veneer job, but it takes a mason who cares and a knowledgeable contractor willing to supervise and address the details. Given that combination, the brickwork should protect the structure indefinitely.
