## Scene of a Soggy Crime

## Mysterious Leak in Roof Membrane

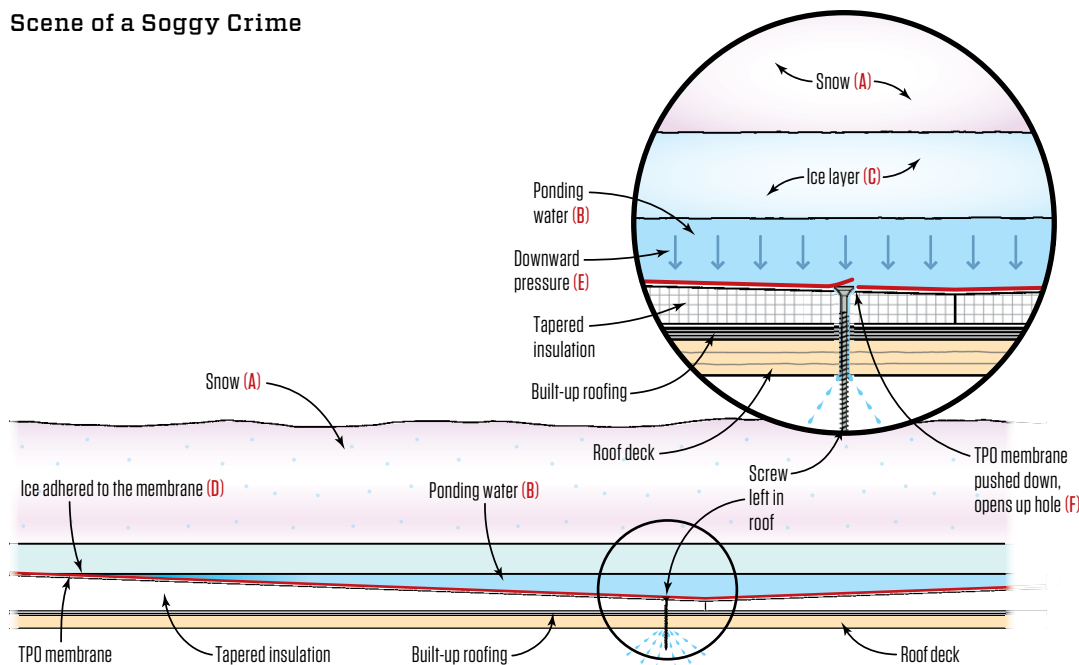
Heavy spring snow falls (A) and begins to melt, forming a pond on top of the membrane (B). Temperatures drop and ice forms (C), adhering to the roof at the edges of the pond (D) and trapping the water below. Ice continues to form, creating downward pressure against the membrane (E). Water pushes the membrane down around an overlooked screw, opening a hole and letting pressurized water flow into the ceiling (F).

Water also expands as it freezes, and the initial layer of ice can expand in all directions at the same time. But once the top layer has frozen solid to the membrane along the edges, any ice forming can only expand downward, adding pressure to the bubble of water below the ice. This pressure from the thickening ice, combined with additional snow weight, pressed down on the membrane around the screw head, finally causing the tiny flap to open like a valve, and the water—under pressure—squirting into the roof system.

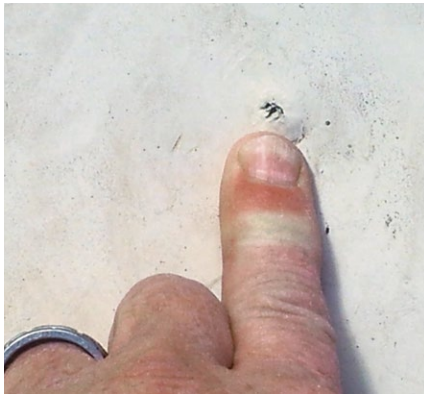
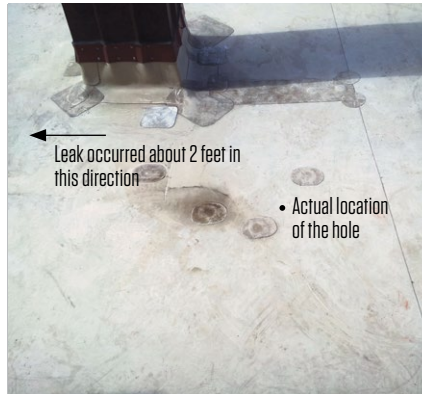
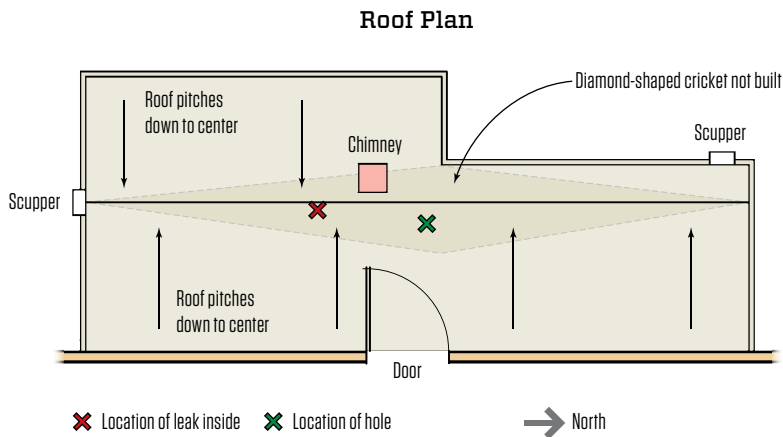
Instead of installing a cricket under the new TPO membrane, the roof was pitched to the middle and ponding occurred. The water then gushed into the roof system, via a breach in the membrane, and flowed south before leaking through the ceiling.

the leak location inside. The hole was over a screw, probably left from when the original EPDM membrane had been removed. It was barely visible until I pushed down next to it. With pressure against the screw head, the hole opened up like a flap. It was hard to imagine a hole that small could cause so much damage—until I thought through the logic of it.

The fix was simple: a patch applied over the hole. Once our spring snows stopped, a cricket was installed to minimize ponding. Had the cricket had been installed initially, the leak probably never would have occurred.
