# Restoring a Round Porch

**Rot-resistant materials and better details extend the life of this unique coastal porch**

by Ben Kelley

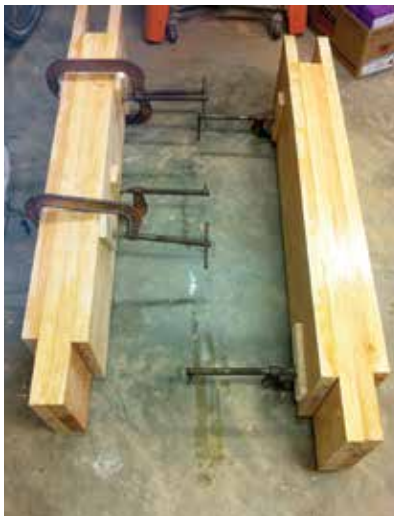
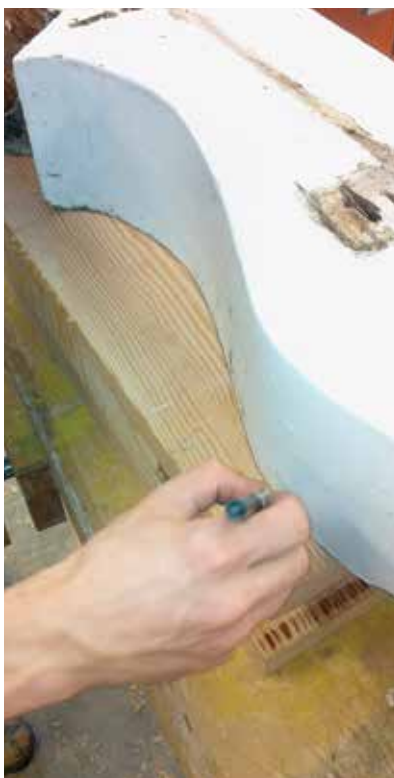
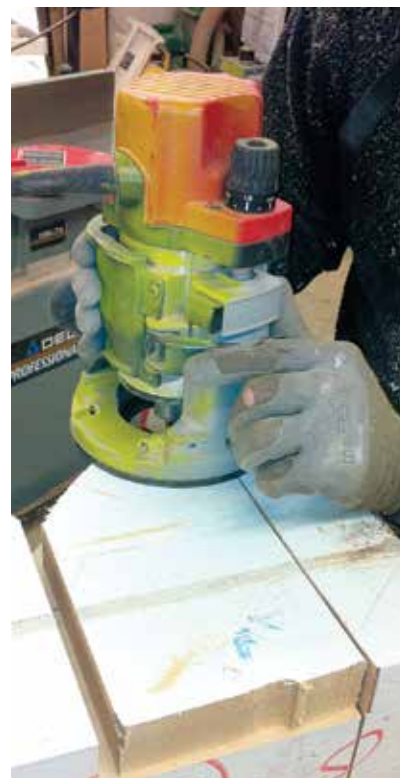
**Figure 1.** The 2x10 fir laminations of the partial replacement posts are offset to create a slot for joining to the original post sections (top left). After scribing the original column patterns (bottom left) and cutting them out on a band saw, the author created a matching tongue profile with a router (bottom right).

We assembled the replacement sections from four layers of 2x10 vertical-grain fir laminated together with West System two-part epoxy (**Figure 1**). We clamped the laminations together as the epoxy set, and also reinforced the assembly with torque screws and 1/2-inch-diameter through-bolts, countersinking the bolt holes and later filling them with fir plugs. To create a T&G profile that we could use to join the new and old column sections together, we offset the two outer laminations by 6 inches.

Using the removed column sections as templates, we scribed the appropriate profile onto each of the new blanks, then cut the profiles out on our band saw. We used a router with a 2-inch straight bit to give us a clean joint for the tongues on the old columns, then finished and fine-tuned the tenons with a chisel and belt-sanded the cuts smooth.

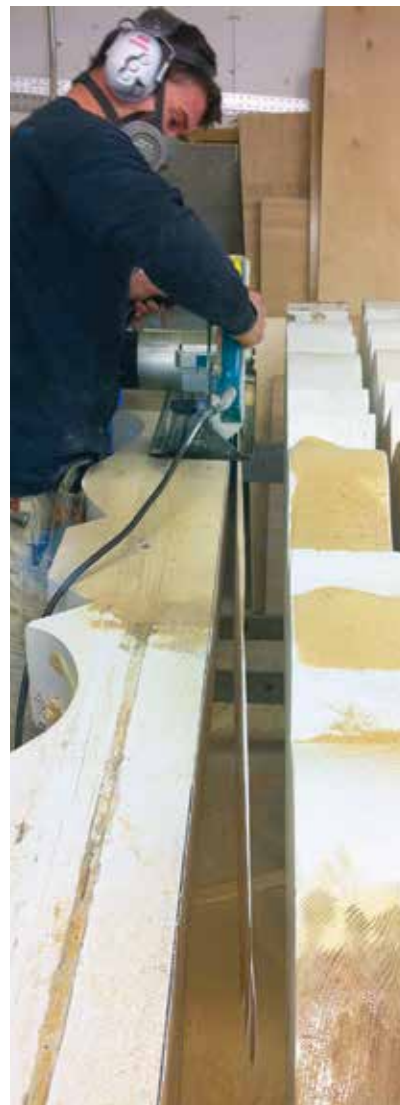
**Figure 2.** The new and old column sections were joined together with galvanized through-bolts and epoxy (left). Once the columns were reassembled, a worker straightened them with a large-capacity beam saw (right).

galvanized carriage bolts, which we drove through predrilled holes (**Figure 2**). We also countersunk these holes, and later filled them with wood plugs. Some of the old 6-inch-by-9 1/2-inch columns were warped, so we trued and cleaned them up with our 16-inch beam saw. We patched blemishes and minor areas of rot with epoxy thickened with epoxy filler, then smoothed the cut edges with a belt sander. To clean up the scroll work, we used a drill-mounted paddle-style sanding wheel and a Fein detail sander. Then we primed the columns and brought them back to the site.

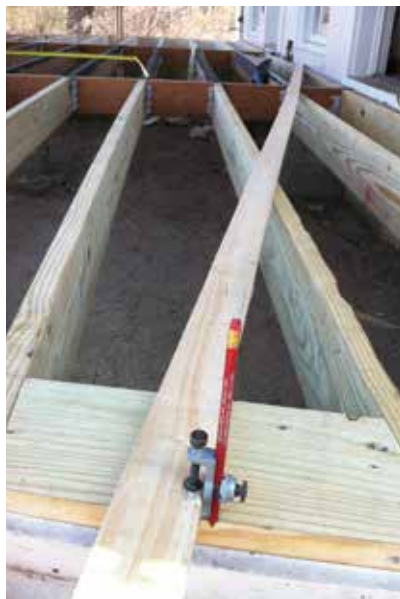
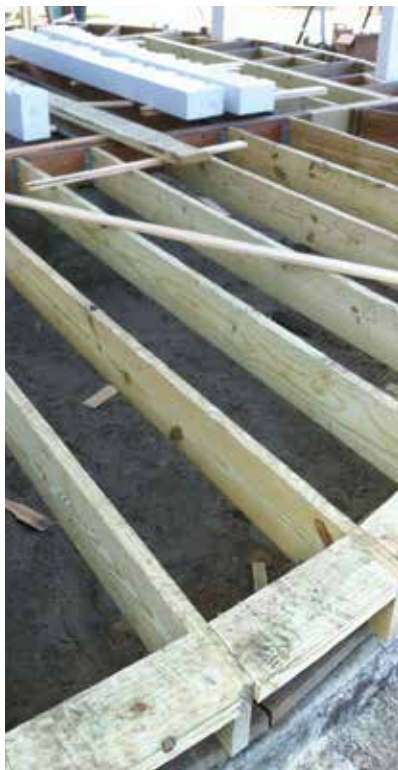
**Figure 3.** The author replaced the rotted joists with treated framing, then used a trammel arm (above) to scribe the deck's radius onto blocking installed on the flat around the perimeter of the deck (right).

Finally, to make sure the radiused sill and rim joist would provide fair and smooth backing for new fascia trim, we set up a large trammel at the centerpoint of the deck (**Figure 3**). Then we installed PT blocking on the flat around the perimeter of the deck, and used the trammel to scribe the radius on the blocking. After cutting the curved profile with a circular saw, we padded the framing below this cut to our new radius line.

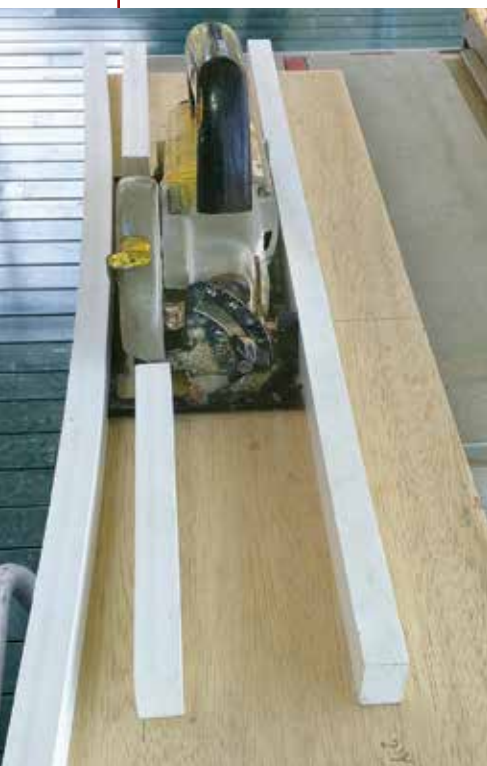
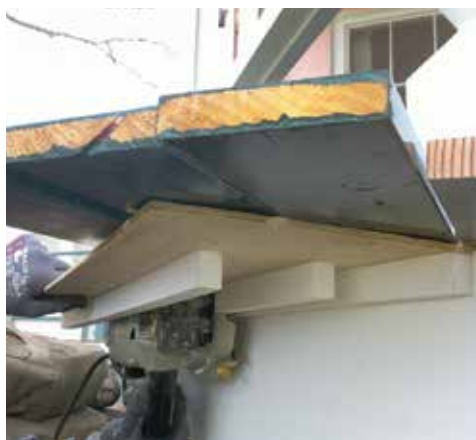
**Figure 4.** To cut the new decking to length after installation, the author made a plywood extension fitted with a curved fence for his Porter-Cable  $4\frac{1}{2}$ -inch trim saw (left). One person manned the saw while another crew member removed the off-cuts (above).

To cleanly cut the decking around the perimeter of the porch, we fashioned a simple jig for our circular saw consisting of a plywood table and a curved fence that matched the radius of the porch (**Figure 4**, page 46). With the saw clamped to the table, the jig was a little heavy but made it easy to safely and smoothly cut the radiused profile in the decking.

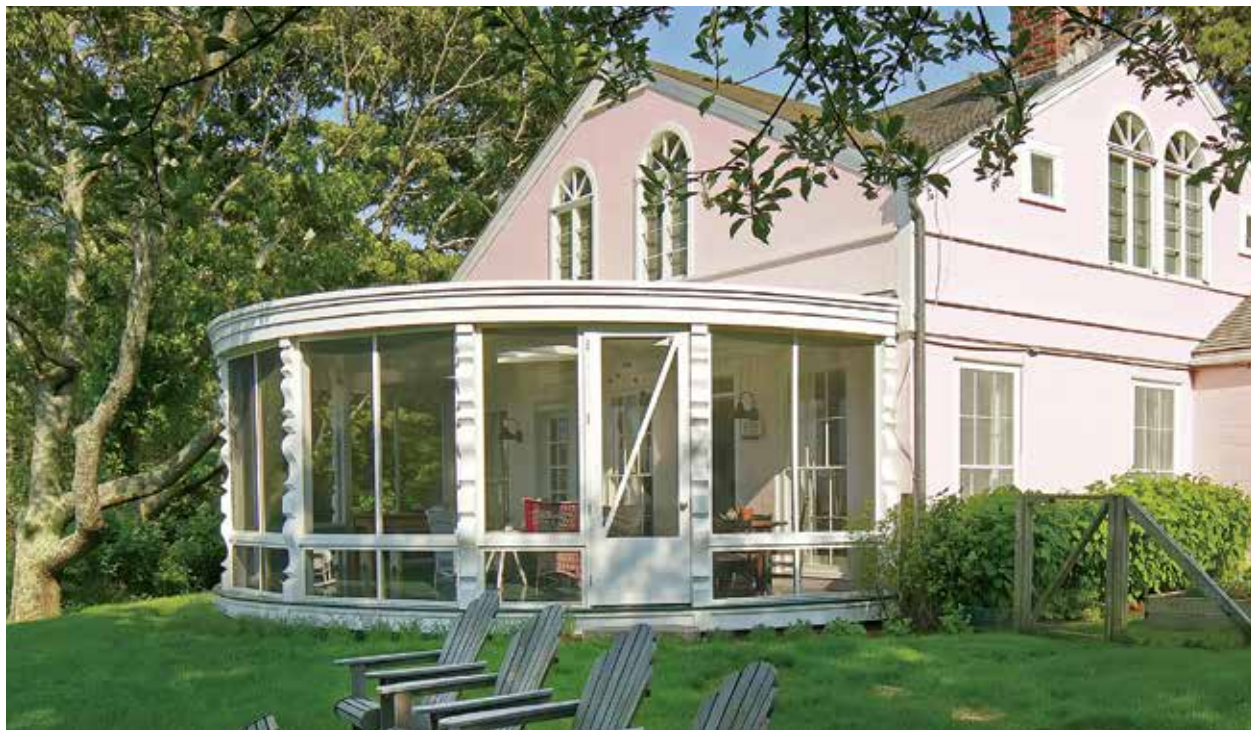
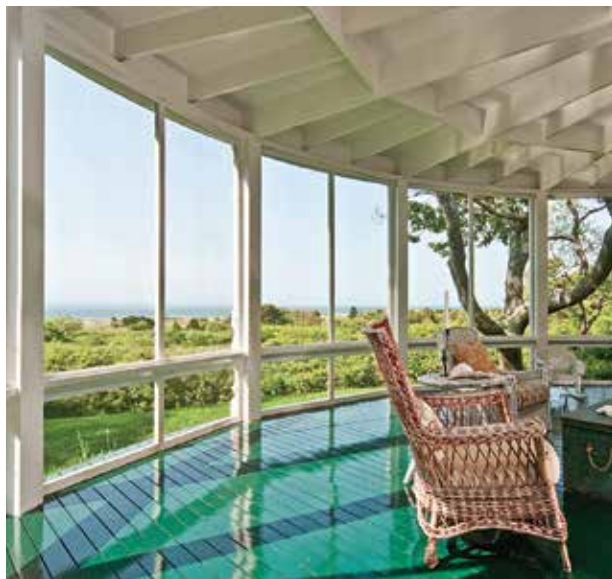
**Figure 5.** Documenting the existing ceiling height and panel dimensions before deconstruction made it much easier to reproduce the original appearance of the porch when it came time to put everything back together (top). The new vertical-grain fir decking for the refurbished porch was pre-finished with a durable marine topside paint (above).

We sent the new vertical-grain fir decking to a local painting contractor, who primed and applied the first coat of Pettit Easy-poxy (a one-part polyurethane topside paint) to all four sides. Even on Martha's Vineyard, marine paint isn't typically used on decks, but our client had previous experience with it and this particular brand had the color she was looking for. After the decking was installed, the painting contractor touched up the deck, primed again, and then applied the finish coat.
