BY GLENN MATHEWSON

## The Case of the Sobbing Siding

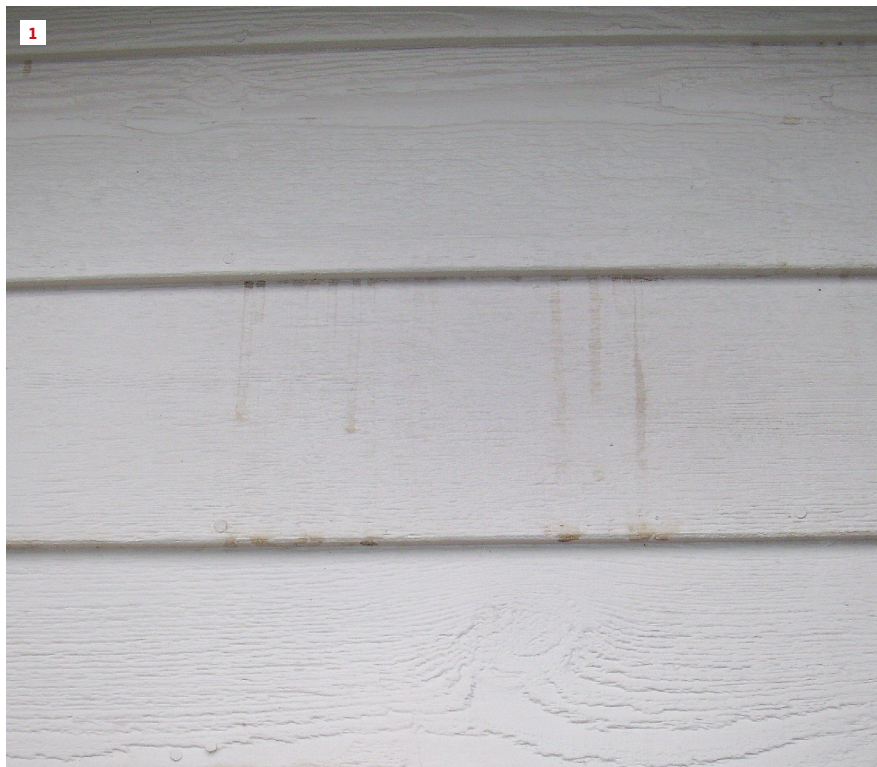
After I greeted the homeowner, she took me to the side of her garage at the front of her house and showed me the staining—evidence that water had indeed been dripping from her siding (1). This was going to be interesting.

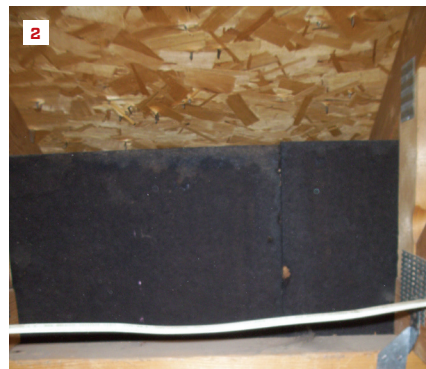
Not seeing anything unusual in the siding or in the roof, fascia, gutter, or soffit above the leaking wall, I went to take a look from inside the garage. Fortunately, there was no wall or ceiling covering, and the roof had been framed using raised-heel trusses. The exterior wall sheathing ran up the heel but stopped below the 2x4 truss tail. This space allowed me to see inside the soffit (2).

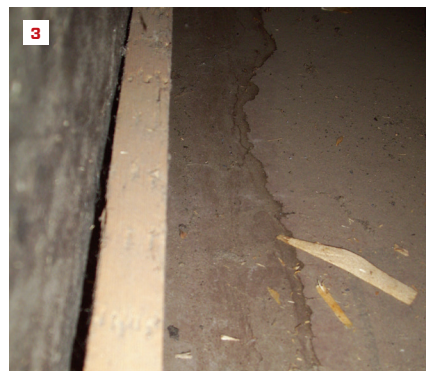
Peering inside the soffit with a flashlight revealed more water staining and more clues (3). Granules that had sloughed off the new shingles lay on the inside surface of the soffit, a clear sign that wherever this water was coming from, it had first run down the shingles.

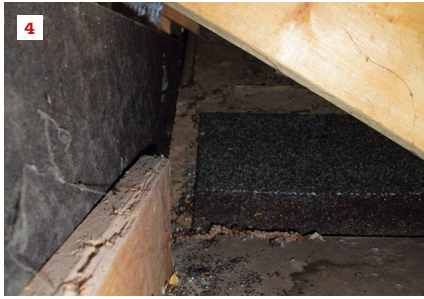
Looking both ways down the length of the soffit, I could see which direction the water was coming from. Working my way toward the source, it seemed that the water originated where the garage soffit intersected with the roof plane of the house, about 10 feet from the site of the staining (4). Now it was time to get out of the garage and back onto the roof.

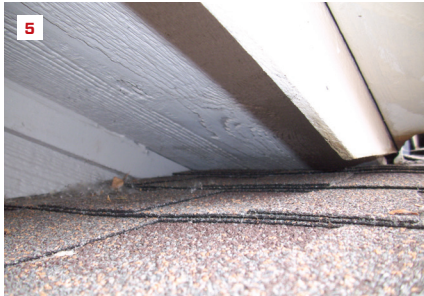
Still, these factors alone didn't create the problem. The soffit material had been run tight to the shingles (5) and past the angled edge of the fascia. This combination

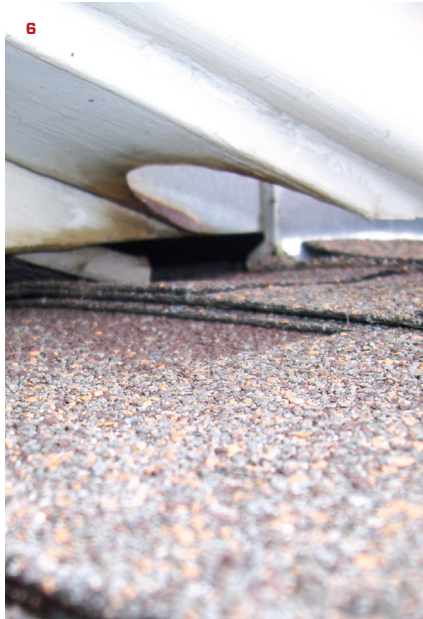
created a scoop that allowed water to flow under the fascia and on top of the soffit (6). From there the water made its way down the soffit and finally behind the siding. I thought, "Look on the bright side: At least the water-resistive barrier behind the siding did its job well!"
