BY DOUG HORGAN

## Leaking Shower Pans: How Far to Go?

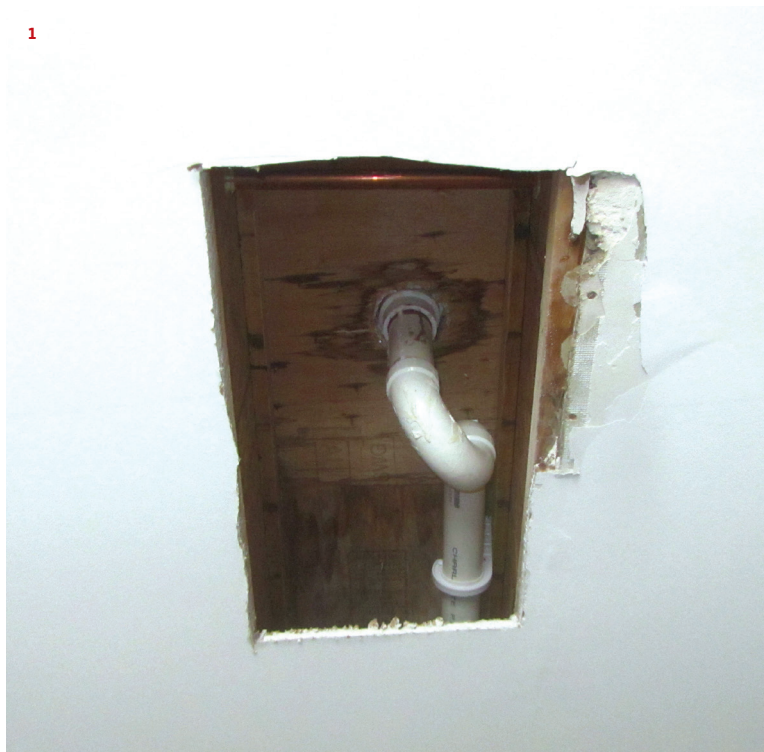
This was illustrated on a recent job where the customer had a ceiling leak. When we arrived, the plumbers had already cut a hole in the ceiling directly below the shower drain (1). Judging from the calcium buildup in the leak area (including stalactites a couple of inches long), this leak was a longstanding one.

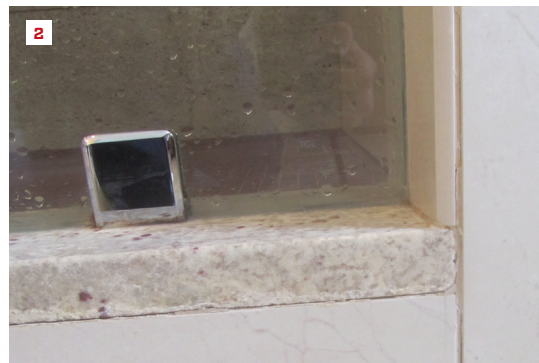
potential problems: cracks along the corners of the curb (2), voids in the caulk and grout (3), and buildup of efflorescence around some of the joints, indicating water flow that deposited minerals. The question was, how much water was actually flowing through these cracks? Was it enough to cause the leak in the ceiling below?

Cracks in grout lines are perfectly normal. We see a lot of cracks in curbs, often caused by movement of the wood structure below. If not properly waterproofed, the wood curb (usually a double 2x4) swells as it gets wet, which can create cracks as large as ¼ inch wide in tile.

A good caulk job that's well-maintained should stop, or at least slow down, leaks in the curb area. If the curb had originally been designed and built correctly (always a question to ask when you're looking at someone

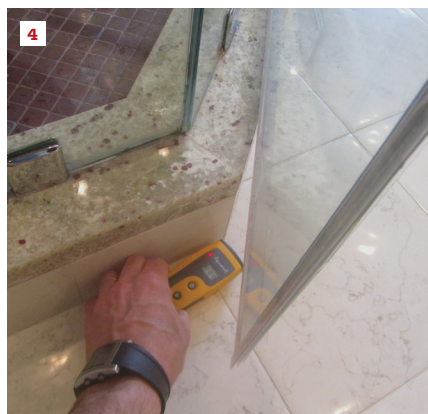
So we investigated a little further using a pinless moisture meter. The floor outside the shower was a bit wet in some spots (4), but there was no visible damage, and the readings were not very high.

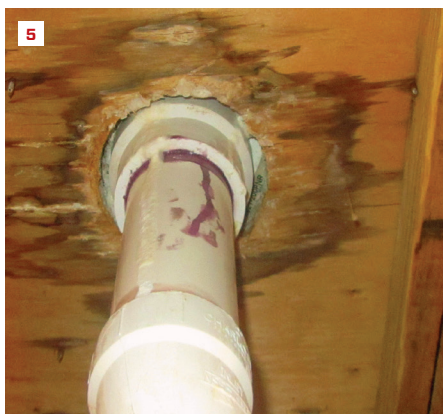
Next, we used an infrared (IR) camera to look at the ceiling, subfloor, and drain. IR cameras are great tools for evaluating moisture damage. You can scan large areas for water, quickly and accurately. We could see that except for very near the drain, most of the area was dry. In the IR image (5), the purple areas show where water evaporating out of the plywood has lowered the temperature of the wood. The warmer areas indicate drier wood.

That's good; the minor wetness at the curb we found with the moisture meter didn't seem to be enough to spread into the floor or drywall below. Similarly, there were no wet areas under the valves or the bench. The wet areas were localized to immediately around the drain.

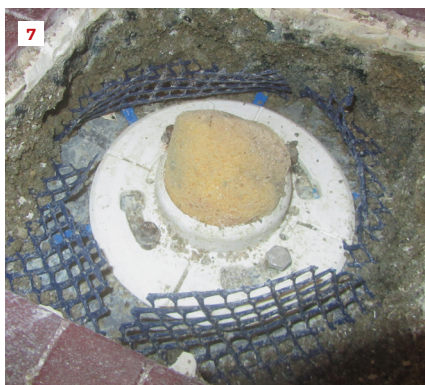
Second, someone had shimmed up the clamp ring with blue plastic shims spaced around the perimeter (8). This prevented the ring from firmly clamping the liner down onto the drain body below. Our best guess is that the tile guys who installed this drain turned the ring over in an effort to extend the thickness to account for a second layer of old tile underneath. But they knew that the upside-down ring needed weeps, so they tried to make a weep passage by shim-ming the clamp ring up a bit. Big mistake.

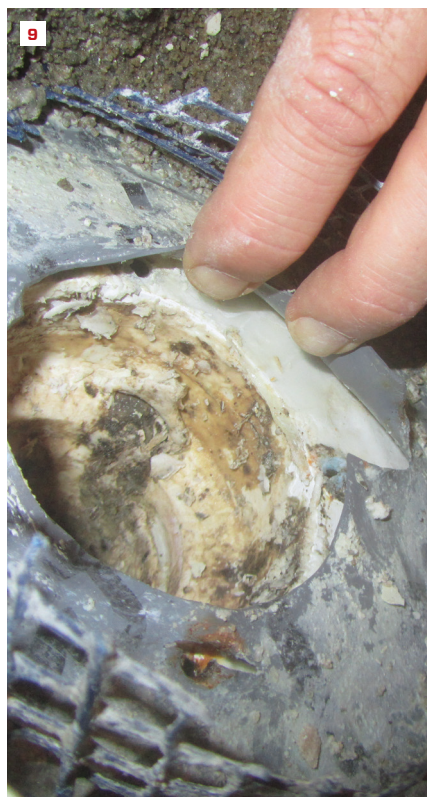
glued to the drain body (9). Someone had tried to use silicone caulk, which in our experience is not a long-term solution for water sealing. Predictably, it had failed. Personally, I would use silicone only where it can easily be seen and replaced when it fails, never in a concealed location where it is needed to hold back water for the long run. Since the silicone in this case wasn't adhered to either the drain or the liner, there were actually two paths for water to escape: between the liner and the silicone, and between the drain and the silicone.

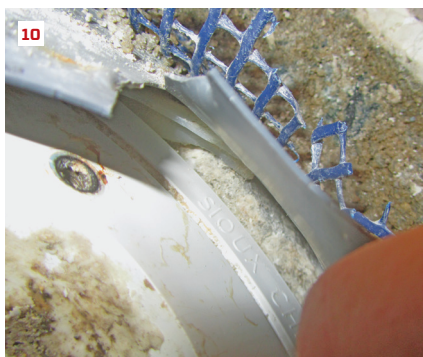
The silicone molded to the drain body below, which helped us find a fourth big problem: The clamp ring and drain body were from two different manufacturers and didn't seal properly. The words "Sioux Chief" (siouxchief.com) were molded into the silicone pieces we pulled out. Sioux Chief drains have a slot on top of the drain body, and the smooth clamp ring has a

molded bump that presses the liner down into the slot (10). In contrast, Oatey drains have a little bump molded into the top of the drain body, and the clamp ring's edge presses the liner onto the bump (11). If the glue fails (or is omitted), the physical clamping at the slot or bump will pretty reliably seal the liner to the drain. Unfortunately, if you use a mismatched clamp ring, it doesn't press the liner into the drain body to seal it.
