BY MIKE GUERTIN

Finding the Source of a 'Roof Leak'

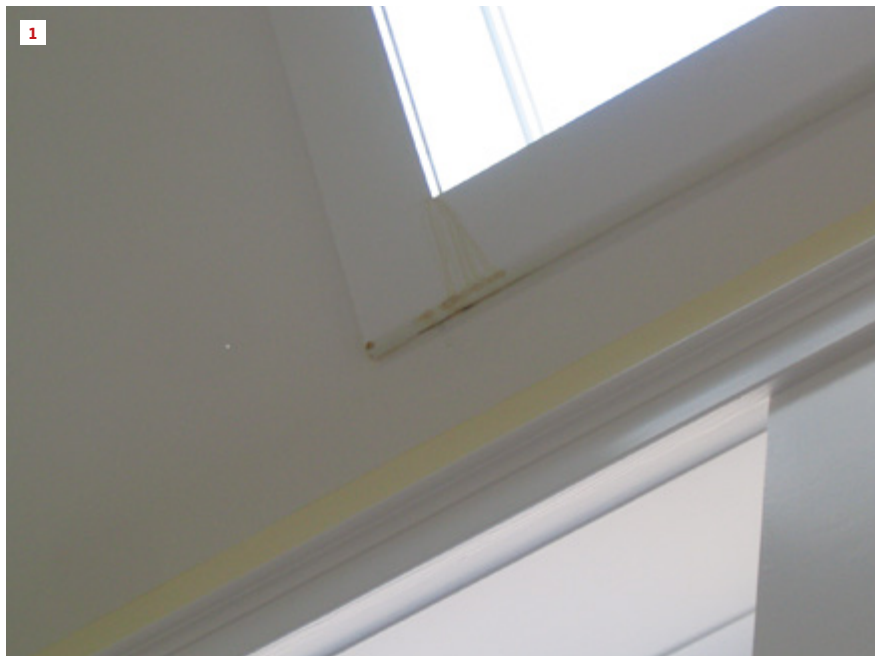
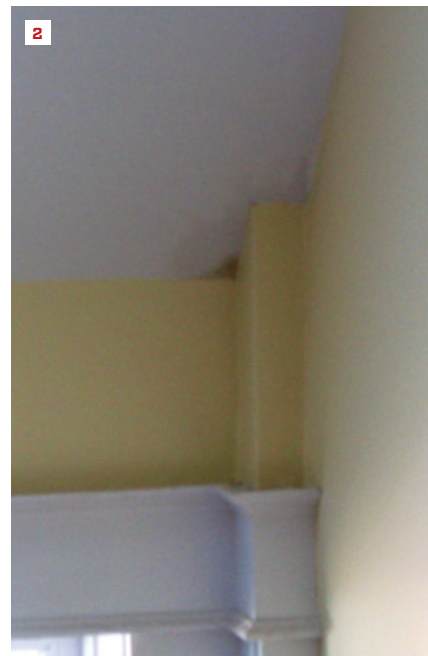
The house was built in the fall and the owner moved in just before Christmas. Moisture stains appeared within a couple of weeks (**1, 2**). Roof repairs were done in mid-January, but new stains showed up soon after.

was piggybacking on air leaks or moisture was diffusing through the drywall and condensing on the cold underside of the roof sheathing. What appeared to be roof leaks at the skylights were most likely condensed water saturating the drywall and dripping through the perimeter trim.

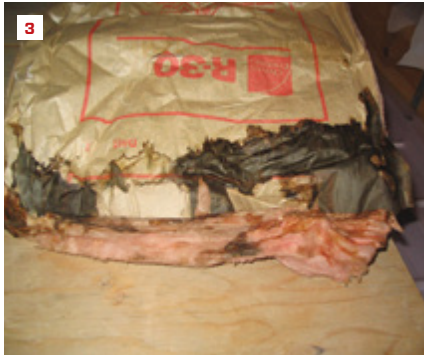
The first thing I noticed was that the indoor humidity was high, with water condensing on the inside of the windows and skylights. The relative humidity (RH) measured 65%. But there wasn't any obvious moisture source, like a wet basement or lots of house plants.

Then the owner mentioned that the foundation and first-floor walls of the house were built with insulating concrete forms (ICFs). The builder probably didn't realize how much water would dry out of the concrete during the first year. I calculated that more than 1,500 gallons of water was in the concrete that filled the ICFs. With the short construction period, a lot of that water was probably still drying to the interior of the house.

The Kraft facing on the insulation looked fine, but when I pulled the insulation out of a couple of rafter bays, I found saturated fiberglass (3) and saturated plywood roof sheathing (4). In some bays, there was actually frost on the sheathing and insulation (5).

I made several recommendations to fix the problem. First, the house needed to be dried out. There was no mechanical fresh-air ventilation system in the house, so one would need to be installed, preferably a heat recovery ventilator (HRV), which would exhaust moisture-laden air and bring in drier air from outside. In addition, dehumidifiers could be used to accelerate drying. When the weather warmed up, windows could be opened and fans used to circulate the air.

I also recommended removing the insulation from all the rafter bays. This would need to be done after the deepest winter cold had passed and would mean removing the

During the summer, after the roof sheathing and rafters had dropped below a 15% moisture level, the roof could be re-insulated with high-density spray foam. Spraying foam would be a messy job inside a finished house, but it seemed like the best choice. High-density foam would help block moisture vapor to keep the underside of the sheathing dry. Then new drywall could be applied to the ceilings in all three areas to cover the foam. Finally, the tongue-and-groove ceiling could be reinstalled over the drywall, but without recessed speakers or recessed lights that could cause air leaks.

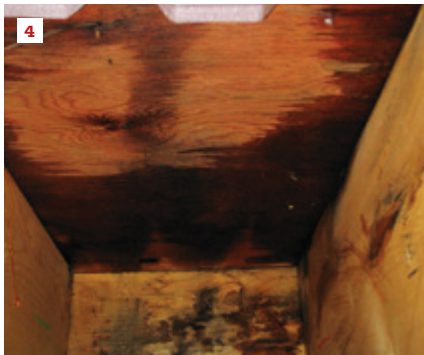
Vent chutes were installed in the rafter bays, but solid blocking between the rafters along the top of the exterior wall prevented any ventilation air from circulating. There were no intake vents along the eaves and there was no ridge vent at the roof peak.

Moisture-meter readings of the plywood ranged from 26% to 76%. Staining on the sides of the rafters showed where water had dripped down to the ceiling level. I removed a recessed light from the tongue-and-groove ceiling area of the loft and pushed the insulation aside. The moisture in the sheathing measured between 24% and 35%.
