Major Surgery for a Failing Fat Wall

Modern materials and proper details restored the double stud wall to a high-performance system

BY JIM BRADLEY

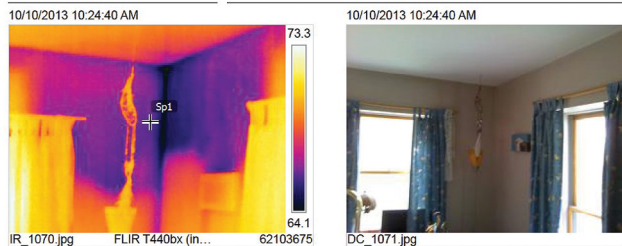
Infrared scans of the home's walls revealed an extreme example of settled cellulose insulation (1), as well as clear evidence that rodents had made tunnels within the walls (2). Removing the moisture-damaged OSB sheathing from the wall exterior confirmed that the insulation had settled badly (3).

In themselves, the air leaks would not have been difficult to address. But the infrared scan of the walls also revealed another kind of serious trouble: major settling of the insulation, which we could see on the infrared images from the outside of the house as red heat blooms in the walls, and from the inside as blue cold areas.

My report to the homeowners read, "All exterior walls were found to have significant settling of the cellulose insulation. We suspect that the cellulose, when installed in the 1980s, was not installed under pressure (dense-pack) as is the current practice. Some walls have seen as much as a 40% reduction in the insulation coverage through settling. There were also areas, notably the front wall of the master bedroom, where rodent pathways were visible

My recommendation to the homeowners was to remove the home's siding and sheathing and remove and replace all the damp, settled insulation. In rebuilding the wall, I proposed to install vapor-control membranes, airtight but vapor-permeable sheathing, and an effective drainage plane before re-siding the structure.

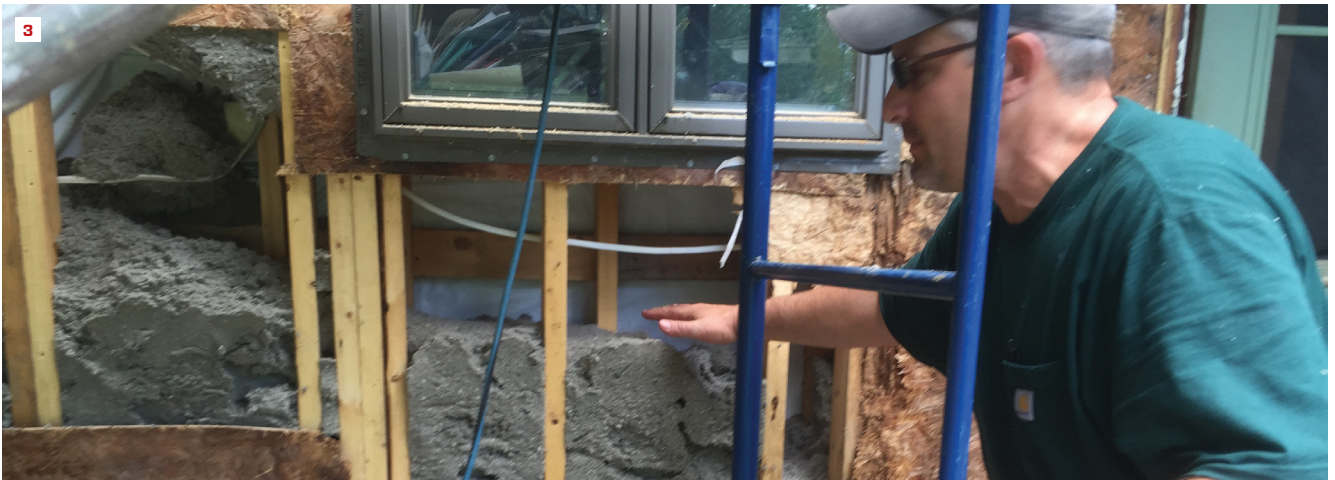
The dampness inside the wall was the result of a double vapor-barrier assembly, consisting of a poly liner behind the drywall on the interior wall, plus oriented strand board (OSB) sheathing with a standard housewrap on the exterior. While OSB may be structurally equivalent to plywood in the building code, the two types of structural panel don't have the same moisture transmission characteristics—OSB is less vapor permeable. Depending on the adhesives and the conditions of manufacture, OSB can have a perm rating low enough to be considered a vapor barrier

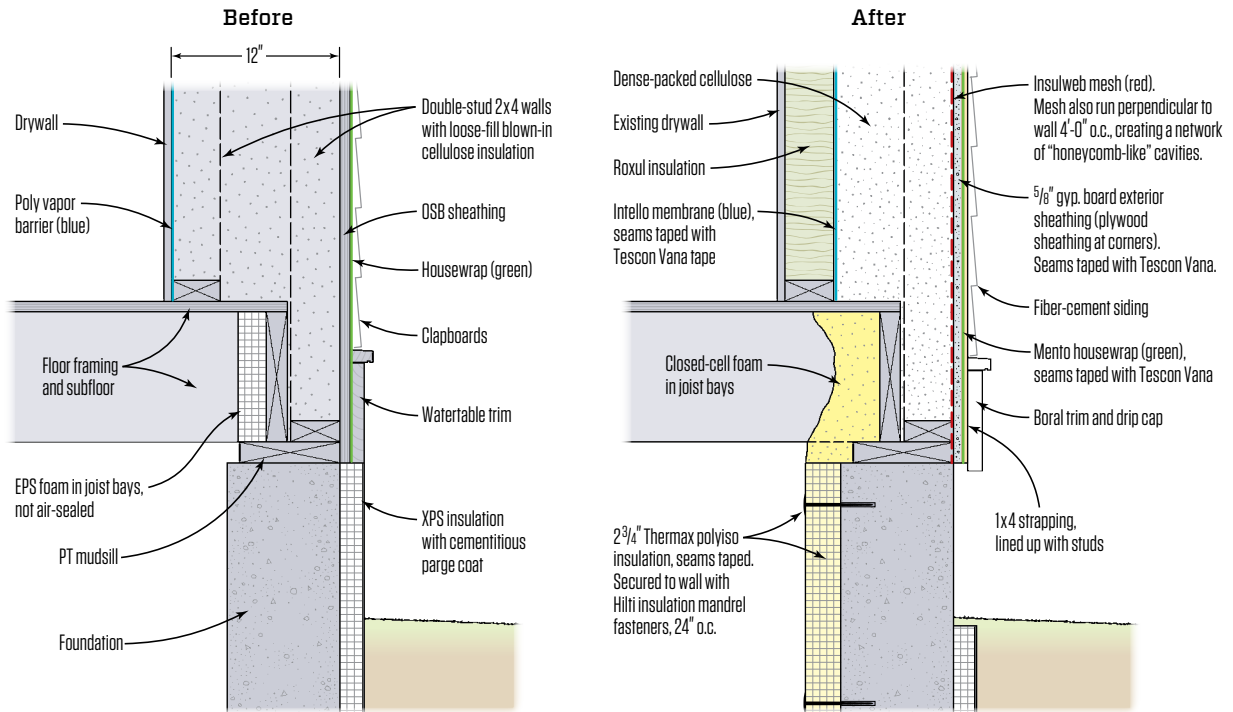
Simple in concept, the home's existing double stud wall (left) had failed in practice. Damp cellulose insulation in the open cavity had settled. The author rebuilt the assembly (right) by installing Roxul batts in the inboard stud bays, sealing that inner wall with a smart vapor barrier, and creating a contained honeycomb structure in the outer wall to hold dense-pack cellulose at 3.5 pounds per cubic foot. Vapor-open sheathing with a taped weather barrier and rainscreen siding lets the wall dry outward.

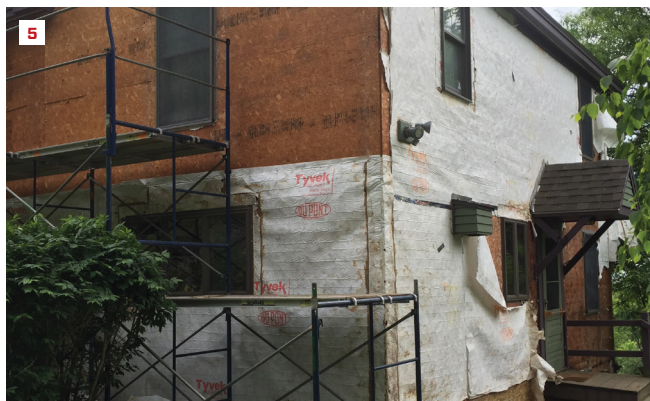
Built in 1983, the house had typical styling and materials from that era (4). Stripping off the siding revealed the usual OSB sheathing and housewrap, both in a deteriorated condition (5). Ants had tunneled into the foam insulation around the home's foundation (6), pursued by hungry woodpeckers. With the siding removed, the author found that he could flake away the moisture-damaged OSB sheathing with his fingers (7).

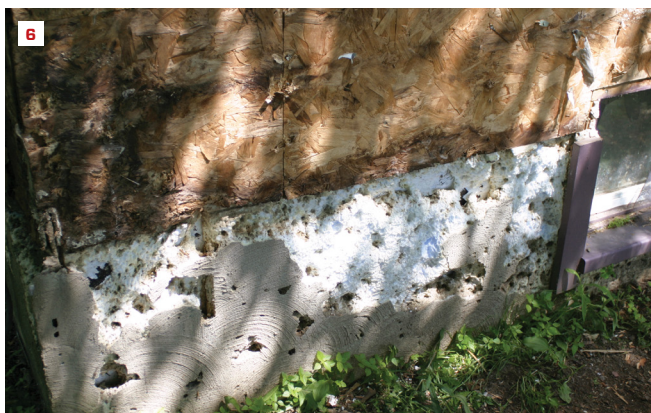
Our routine examination of a house includes a visual inspection, a blower-door test, and an infrared camera scan to identify heat-flow issues. In the case of this house, the visual inspection showed damage to the foam perimeter insulation around the basement foundation, caused by ants who made their home in the insulation, and by woodpeckers who were hunting the ants.

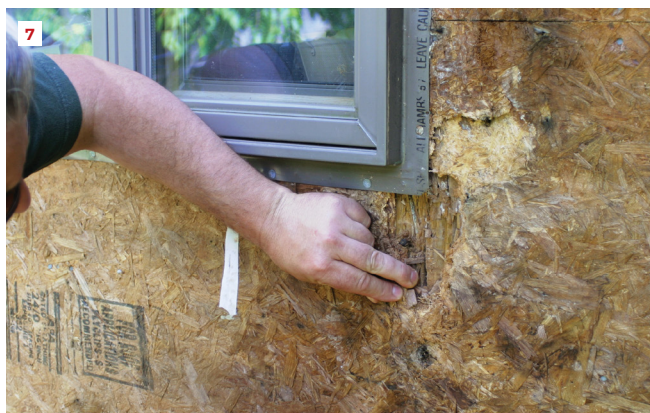
In order to protect the existing walls against the weather as we worked, I decided to demo and rebuild the house one wall at a time, sheltering each exposed wall with tarps until we had made the assembly rain-resistant again. As we stripped off the siding and sheathing, we uncovered damp, settled insulation, confirming the evidence of our infrared photos. We were also able to inspect the sheathing and framing directly, and we found that the sheathing was deteriorating from dampness and decay (you could easily pull the OSB apart with your fingers). Most of the wall framing was still

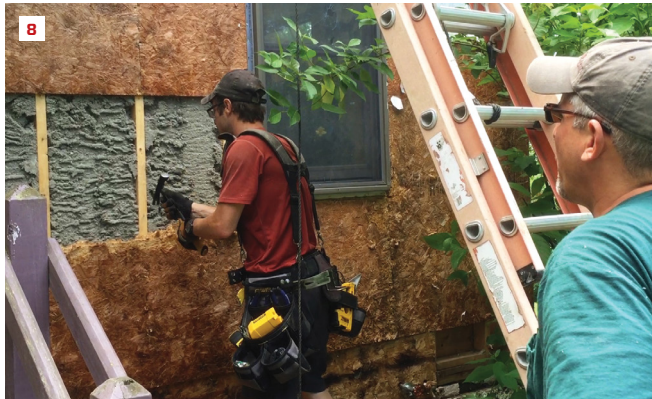
The author's crew stripped the compromised OSB sheathing off the stud wall (8), and vacuumed the damp, settled cellulose out from the double stud cavity (9). The team attempted to preserve the existing windows in place, but the failure of the OSB meant that the windows would have to come out in order to repair the sheathing (10). The wall's condition was worst at its base (11), where it rested on the ant-infested perimeter insulation and floor framing.

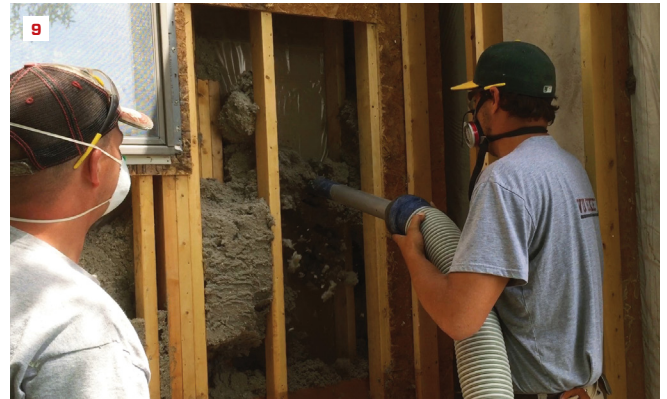
After opening up the walls, we vacuumed out the moisture-damaged and settled cellulose insulation, along with its load of animal droppings, urine, hair, insects, and mildew. That contaminated material and its load of allergens got pumped into disposal bags inside the dumpster.

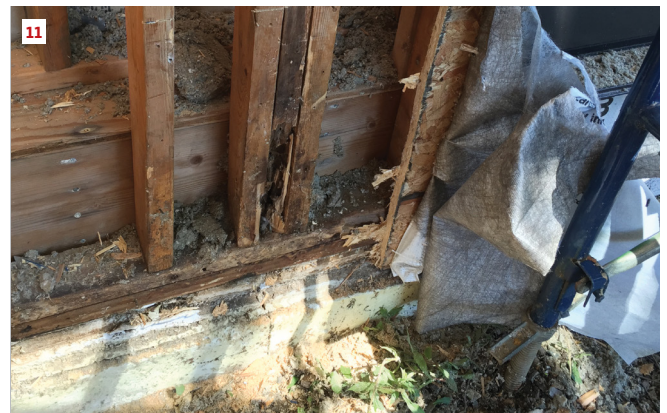
sound, but the floor framing was not; we discovered that we would need to remove and replace portions of the first-floor band joist where the wood was rotted and infested with ants.
