BY TED CUSHMAN

## OSB as an Air Barrier

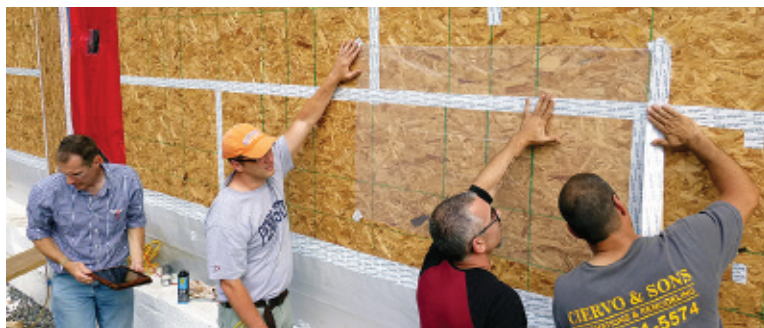
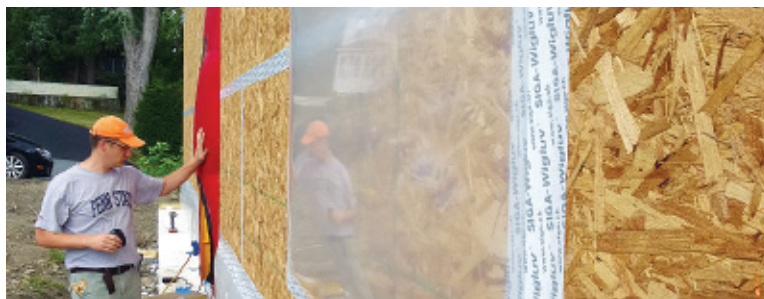
That's the method architect Richard Pedranti chose for his first Passive House, in 2014 in Scranton, Pa. But to his dismay, Pedranti's house failed its first blower-door test. The reason? Under 50 pascals of pressure, the OSB leaked air—not at the taped seams, but all across the faces of the panels.

“We never questioned using OSB as our vapor and airtight layer,” Pedranti told *JLC*. “The industry accepted it.” But with walls and roof framed and sheathed (but no I-joist layer yet), the building tested at 1.5 ACH50. “We spent hours and hours chasing leaks,” said Pedranti, “but at the end of the day we were still at 1.1 ACH50.” Then Pedranti's HERS rater, Pete Vargo, suggested reversing the blower-door fan, pressurizing the building, and taking a look at the outside. When the crew taped plastic over the OSB walls, Vargo's suspicions were confirmed: Air was leaking through the OSB.

Architect Richard Pedranti, HERS rater Pete Vargo, consultant Bryan Kehm, and builder Rob Ciervo tape plastic over the OSB sheathing during a blower-door test (top). At bottom, the plastic balloons out under air pressure.

Also, Pedranti noted, he had already air-sealed the OSB joints with Siga Wigluv tape, which has a water-based adhesive. Solvents in the fluid membranes might attack the tape. So Pedranti decided to apply another Siga product to his building: Siga Majpell air-barrier fabric, sealed at the joints with Siga Majvest double-sided tape.

The fix cost more than \$3,000, said Pedranti ("the tape is good, but it's expensive," he said). But it took just a few hours—and with a layer of Majpell over the OSB, the house was tighter than 0.3 ACH50.

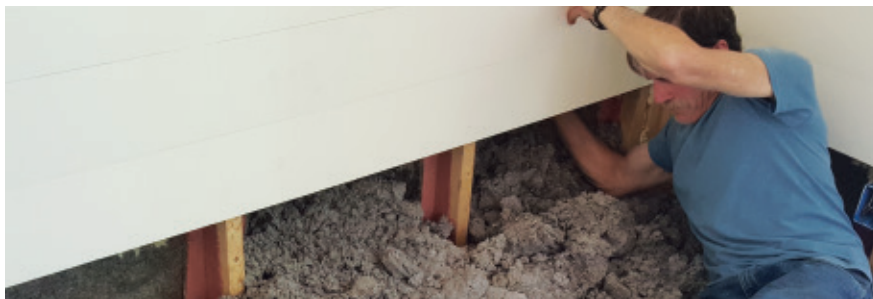
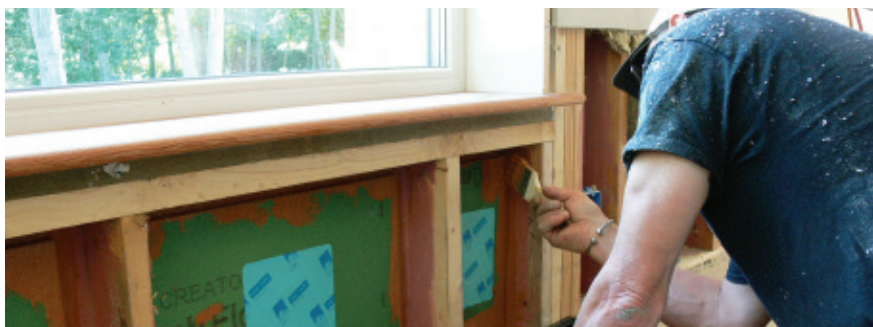
After a plumbing break flooded a newly built Passive House, an EcoCor crew cut open the OSB air barrier to remove damp insulation from the outer cavity (top), then patched the holes (bottom) with Zip sheathing, Pro Clima Uni Tape, and Prosoco R-Guard Cat5.

Ironically, said Corson, the field-expedient fix to the leaky OSB air-control layer "saved the house" when the flood occurred. "This could have been a complete and total tragedy," he said. Unprotected by the waterproof membrane, "that OSB could have wicked the water all the way up the whole first floor as if you had 8 feet of water in there." As it was, he said, the flood fix was simple. "I took my guys off other jobs and we came in and fixed it," he said. "It was a little painful—it was all plastered and painted. We cut 55 holes in the sheathing, pulled out all the wet insulation, dried the walls out, re-insulated, patched it all up, and sealed it." The polished concrete slab floor was undamaged.

After the repair, Corson tested the house again. "We were at 0.28 ACH50 pressurized, and 0.32 depressurized," he said. "That's it. We're done."
