BY DAN WATSON

Replacing Rotted Beams on a Seaside Condo

Cripple-Wall Failure

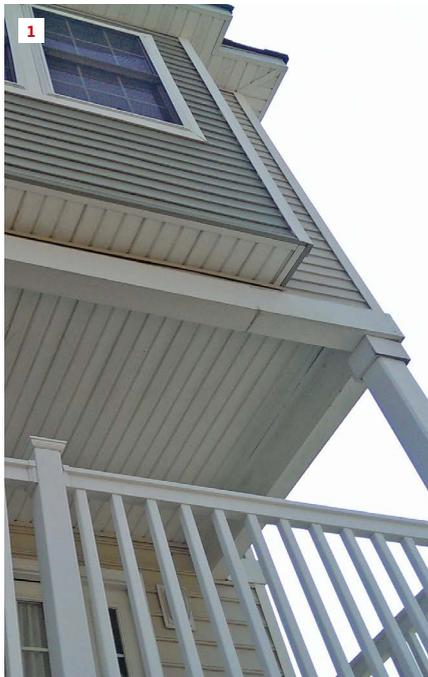
The problem was originally discovered by one of the condo-unit owners, who saw water pouring out of the aluminum capping that covered a beam above his second-floor balcony (1). We were contacted to investigate the leak and discovered mold and rot in the beam under the capping (2). The balcony on which we were standing was supported by a similar beam, in the first-floor ceiling of the carport. We also removed the cladding from this beam, and discovered similar conditions (3).

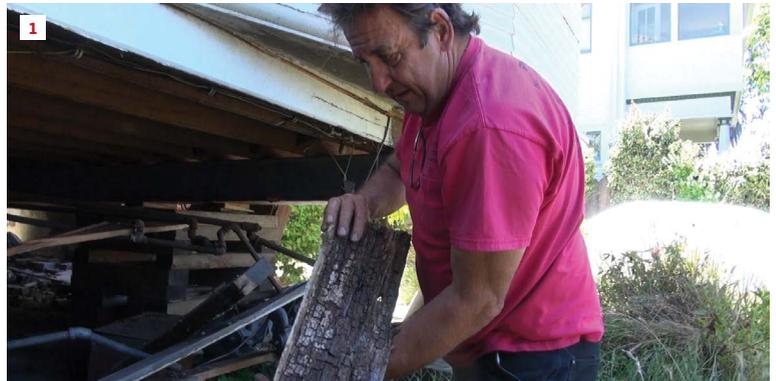
“Right now it seems like we’re having an epidemic of hundred-year-old buildings falling down,” Joy told *JLC* in an email. “This is due to flawed underfloor framing. The buildings typically have redwood V-rustic siding on the lower 3 feet. They don’t have plywood sheathing. The V-rustic siding below the floor line doesn’t have much shear capacity to begin with, and the redwood rusts the nails. So when the nails rust, the houses have a tendency to lean over and slowly fall down.”

Many existing cripple walls in the San Francisco Bay Area are deteriorated to the point of collapse. “V Rustic” lap siding is rotted (1), and nails are corroded (2). To lift a house after its cripple walls fail, Joy has to lever the building up one side at a time (3). When the building is raised and oriented over its footing, he suspends the house on cribbing to allow reconstruction of the foundation and cripple wall (4).
