BY KYLE DIAMOND

## Premature Trim Failure

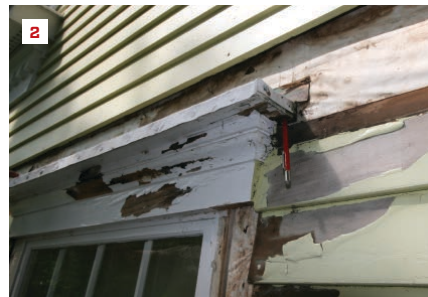
To begin with, on the windows, the metal cap flashing at the head was not sloped properly and the wood cap trim was not kerf cut **(2)**. This caused water to pond, then run off the ends of metal flashing and behind the siding **(3)**. The siding was scribed around decorative head trim and no thought was given to directing water outwards from the WRB, so it ran down the factory-applied pine trim, collecting at the sills. Roughly half of the home's 30 windows exhibited the level of sill rot shown in photo **(4)**.

**A better head detail.** We joined the Koma head, jamb, and sill stock on the ground and fastened the resulting trim surrounds in place using the Cortex hidden fastening system. Out of Koma, we milled cap trim with a slope for drainage and a continuous kerf cut, and decorative molding. With our Tapco Pro-III metal brake and metal cut-off wheel, we fabricated the copper cap flashings on site.

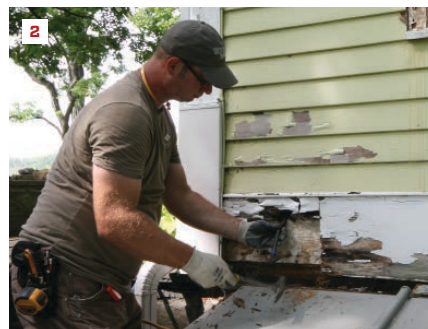
Also, the cedar water table trim was rotted throughout the house **(5)**. Traditionally, water table was topped off with a wood drip cap, which makes it prone

to rotting if regular maintenance painting is not kept up. And if, as was the case here, it has no metal flashing installed over the wood drip cap, it's doomed to failure.

**Rot-proof water table.** We replaced the existing rotted cedar water table, base, and corner board trim with Koma; the home's upper trim (fascia, frieze, rake, and soffit) was in good shape. For the water table, we purchased new Azek PVC drip cap; its trim profile was sloped for drainage and had a continuous kerf on the bottom edge. We fastened off the 12-inch-wide water table with Cortex screws and then installed the PVC drip cap with white aluminum L-flashing on top (lapped under the WRB) to prevent water from getting behind it.

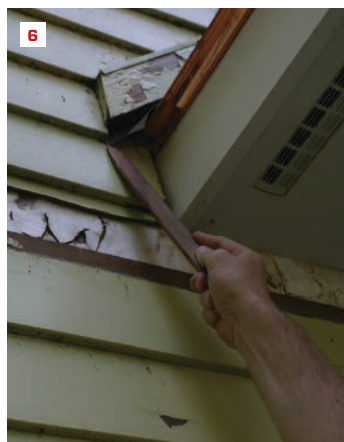
Another problem was at the entry portico, where kickout flashing had not been installed. Here, trim was placed over the step flashing, but no attempt was made to direct water running down the step flashing outward at the bottom (6)—water was allowed to flow behind the siding. This problematic detail occurred in couple of other locations higher up on the roof too.

**Portico roof.** For aesthetic reasons, we doubled up on the new kickout flashing; the larger, upper kickout sheds most of the water, allowing the lower one to be more subdued (13). We salvaged as much as we could of the portico roof. We rebuilt rake-return boxes to slope, trimming them out with Koma. The rake-return cap flashing was made with three pieces of copper, its seams soldered to act as one piece (14).

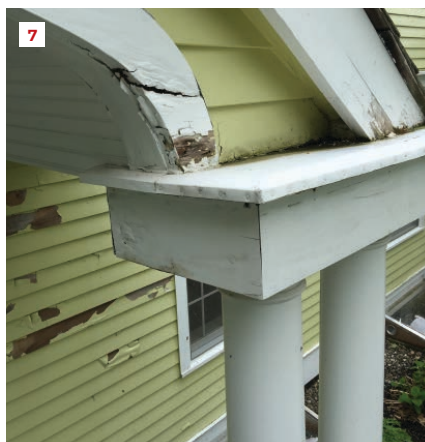
Finally, at the rake returns, the aluminum cap flashing sloped the wrong way, which caused water to pond against the trim and siding (7). The returns were probably built with too little slope to begin with, and over the years, settling caused them to reverse slope. Eventually, the silicone caulk sealing the aluminum cap flashing failed. When we started our repairs, we found the underlying rake-return boxes, adjacent trim, and framing had turned into compost (8).
