BY JIM BRADLEY

## Fixing a Wet Roof

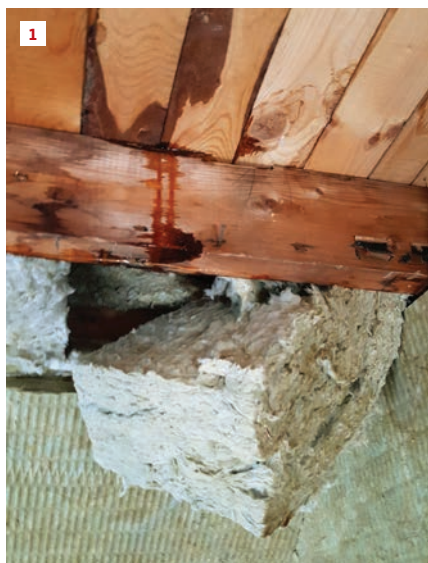
When the author's crew exposed the underside of the cathedral roof sheathing (1), they saw what appeared to be a roof leak. However, when they removed the roof shingles to investigate, they found instead a condensation problem: Bulk water was collecting under the impermeable synthetic roof underlayment installed as part of a recent reroof job (2, 3).

between the joints in the matched-board roof sheathing. At first glance, the roof appeared to have a leak.

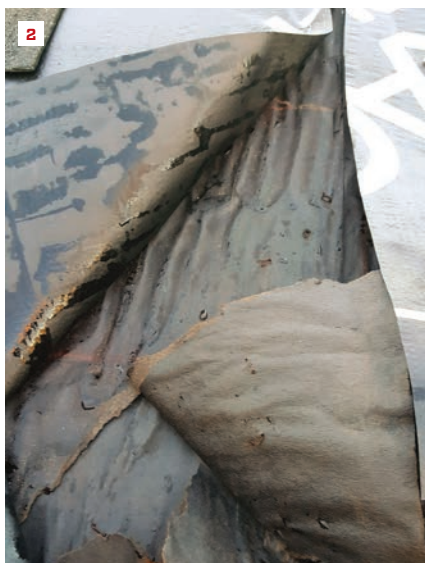
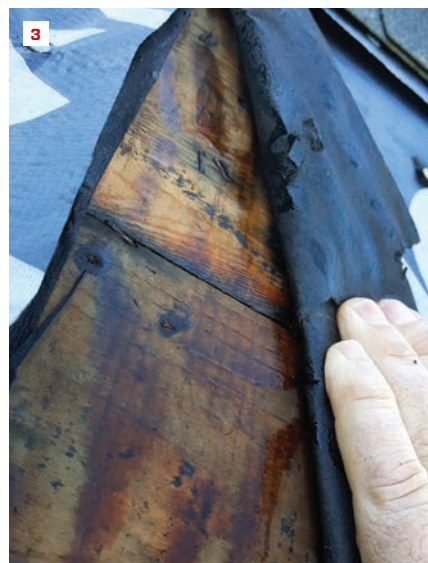
The roof shingles were good-quality IKO shingles, installed only two years previously. As we inspected the roof from the outside, we found an unusual bulge in the shingles. We removed some roofing at that location to see what we could learn. But to our surprise, the nearly new Grace Tri-Flex synthetic underlayment under the shingles was bone-dry.

When we sliced open and peeled back the synthetic underlayment, we found a different situation. The asphalt felt paper under the Tri-Flex, left in place during the most recent reroof, was wet. And when we slit the asphalt felt and pulled it back, we found roof boards that were soaking wet.

Evidently, the source of the dripping water was not a roof leak, but condensation of interior moisture under the vapor-impermeable Tri-Flex underlayment.

and reshingle the roof. But on further consideration, Chris and I recommended a more robust solution: We would build a ventilated roof assembly above the vapor-open membrane, so that any moisture diffusing through the membrane out of the insulated cathedral roof would be carried out of the vent space by air transport.

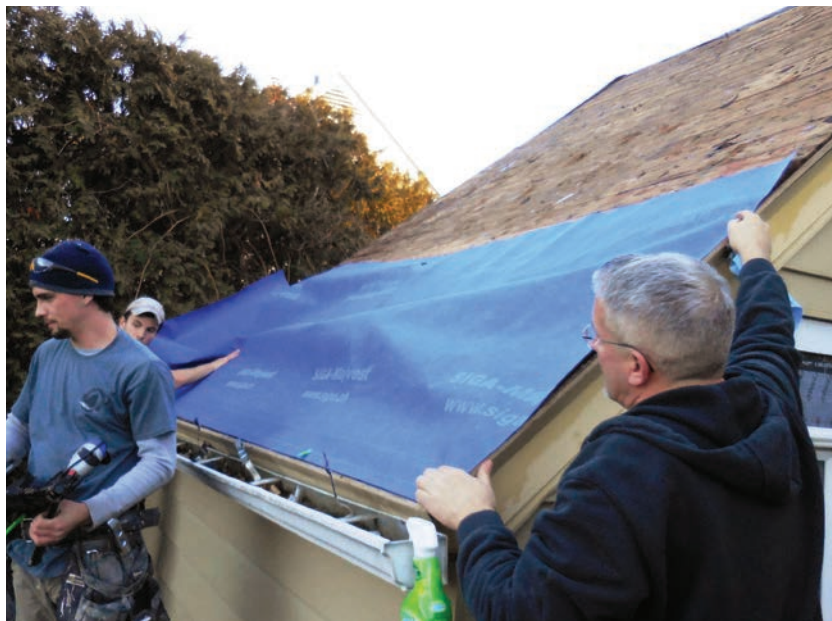
The author and his crew spread Majvest weather barrier membrane over the original board sheathing of the roof. With a perm rating of at least 34, Majvest is vapor open, but it resists driving rain.

After stripping away the almost-new existing roof shingles, we applied Siga Majvest membrane to the roof (see photo, page 34). With a perm rating of 68, this fabric would allow good drying.

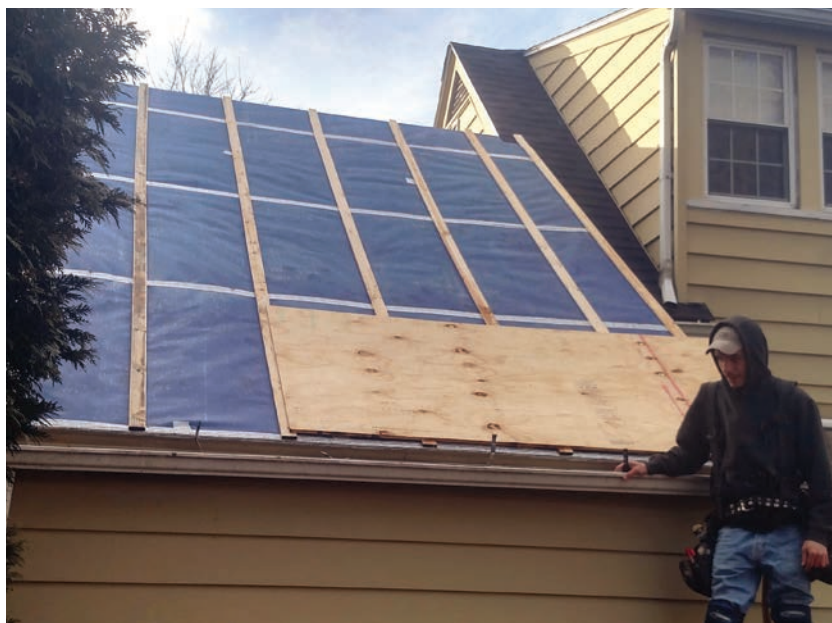
The crew installs plywood roof sheathing over  $\frac{3}{4}$ -inch wood strapping as a nailbase for asphalt shingles. This creates an air space that will allow moisture diffusing out of the cathedral roof to escape the assembly through convection.

Over the membrane, we attached  $\frac{3}{4}$ -inch strapping, run vertically, to create an air space for convective drying. This  $\frac{3}{4}$ -inch air space is about the least we like to use—a full inch or even  $1\frac{1}{2}$  inches would be better. But a  $\frac{3}{4}$ -inch space is enough to do the job, and using anything larger in this case would have introduced problems for trim and roof intersections. Even at  $\frac{3}{4}$  inch, we had to install a new fascia of Boral mineral-based trim to hide the raised roof plane.

Over the strapping, we applied another layer of sheathing, using plywood rather than OSB because of plywood's better resistance to moisture attack. We installed
