BY EMANUEL SILVA

## Fixing a Poorly Supported Beam

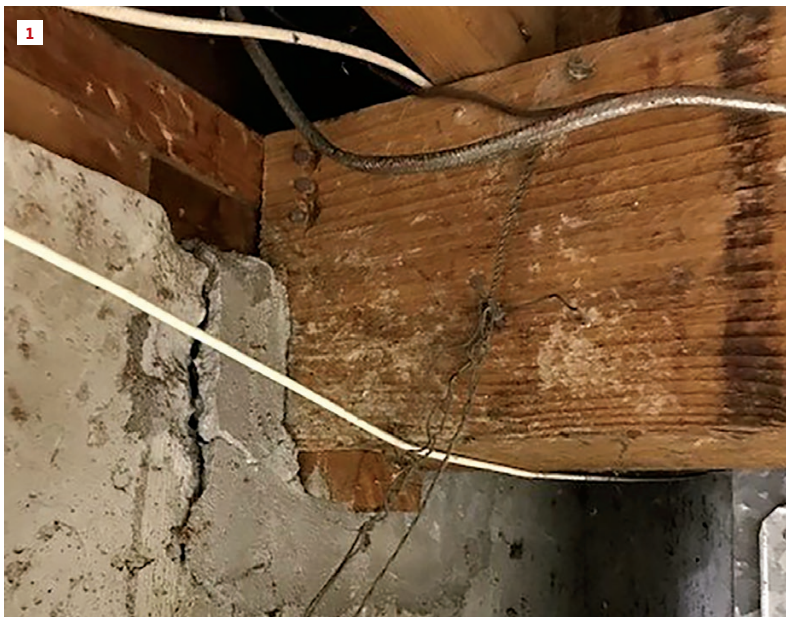
The main girder for the house was sitting in an oversize beam pocket with cracked parging around it **(1)**. But the real issue was that the beam was not long enough and provided insufficient bearing **(2)**. A house jack temporarily lifted and supported the girder for the repair **(3)**.

**Investigation.** After clearing away stored items and debris from where I needed to work, I finally was able to check out the specifics of the problem more closely. The girder terminated in a beam pocket, but that pocket seemed to be much wider than the 6x10 beam needed. At some point, the pocket around the girder had been parged, and I could see a pair of wooden wedges sticking out below the girder (1). The parging was cracked and loose on one side, so I started pulling some of it away.

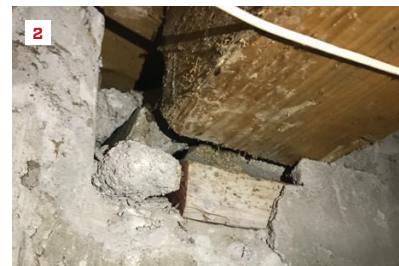
With the material removed, I looked into the pocket and saw that the end of the girder was just inside the plane of the foundation (2). To make matters worse, the bottom edge of the beam pocket had broken away, probably from having the load of the girder concentrated there. A makeshift

solution had been to drive wedges below the girder. Over the years, the wedges had compressed and the parging cracked, allowing the girder to drop down. Luckily, the girder had dropped only a short distance instead of failing completely.

**Weighing options.** After assessing the issue, the engineer determined that the main girder was too short and did not have enough bearing on the foundation. He provided a number of solutions, which the homeowner explained to me when I arrived at the house. The first option was to install a 4-inch concrete-filled Lally column below the end of the girder, with a 2-foot-square, 1-foot-deep
