## Rebuilding a Wind-Damaged Deck

BY ROB CORBO

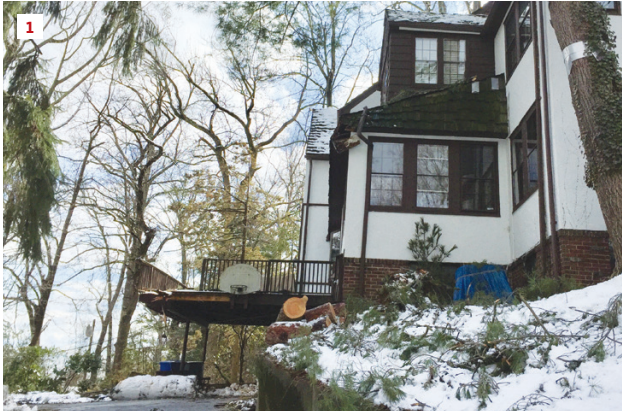
The original red-cedar deck sustained damage when a tree fell on it during a windstorm (1, 2), but it was due for replacement anyway, thanks to sketchy ledger connection details and extensive rot. The columns and W10 steel girder supporting the deck were the only components that were reused. To stabilize the steel girder, the crew braced it with a 2-by and a cable tensioned by a come-along (3).

**In March 2018**, four nor'easters blew through my home state of New Jersey. A client we occasionally hear from called and asked us to look at her deck, which had been hit by a large oak tree uprooted during one of those storms (1). It turned out that the damage resulting from the uprooted tree—which took out two sections of rail and damaged five joists (2)—was the least of the deck's problems; the rest of the deck was rotten to the core. Our client was lucky the tree hit the deck and revealed its other problems before someone was seriously hurt.

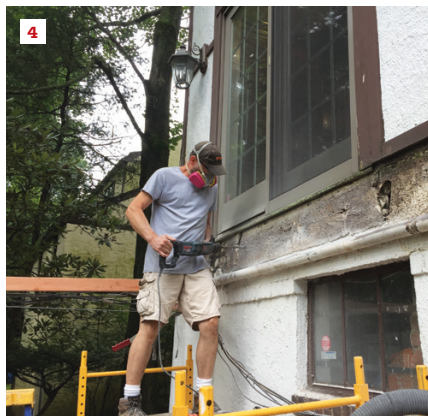
Cutting away the stucco (4) revealed considerable damage to the sheathing and cripple studs underneath the sliding door leading out onto the deck (5, 6). A solid PT header was installed underneath the slider to replace the cripples (7). After resheathing, the crew flashed the assembly with Vycor (8) and installed a new ledger (9).

When project manager Danny DoCouto examined where the old ledger had been attached to the house, he determined that there was no rim joist to which we could bolt a new ledger. It also appeared that behind the house's traditional three-coat stucco siding, a number of areas had rotted where the old deck ledger had been fastened. We had no choice but to remove the stucco siding down to the framing where the new ledger would be attached (4).

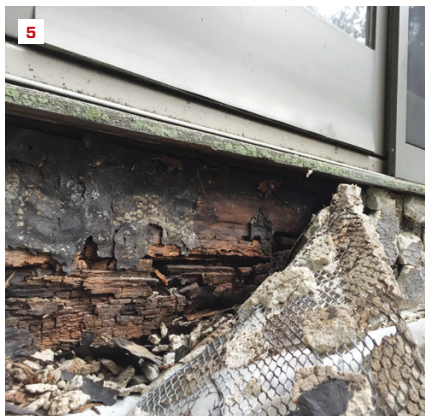
To remove the stucco and the wire mesh, we cut through them with a grinder and chipping hammer, uncovering a balloon-framed system clad with rotted sheathing (5). Most of the cripples underneath the sliding door that provided access to the deck were rotted as well (6).

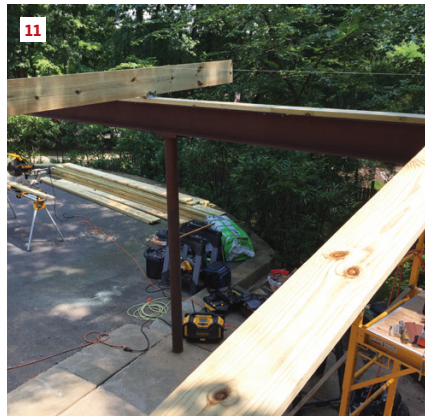
Still, when we checked elevations on the girder and house with a laser level, we discovered that the girder was  $2\frac{3}{4}$  inches out of level. Whether the impact of the tree had bent the beam or fatigue was a factor (or both), others who were higher up the food chain had approved the girder for construction. So rather than continuing to speculate, we concentrated on a solution for installing joists on the out-of-level girder.

The new ledger was lag-bolted to the house framing (10), while the old girder was primed, painted, and capped with a flashing membrane and a treated 2x6 plate (11). A string line established a reference elevation for the out-of-level girder, and notches (12) or shims (13) were used as needed to bring the joists flush with the string (14). Here, the deck is almost completed (15).

After scraping and priming the girder, we applied Vycor flashing tape to the top of the beam and bolted a PT 2x6 plate in place (11). We placed the first joist on the high side of the girder, where the joist was dead level. Because we wanted to pitch the framing slightly from the ledger to the outside edge of the deck, we notched the 2x6 plate with a circular saw and chisel so that the joist was recessed into the plate by  $\frac{1}{2}$  inch (12).
