Close Encounter With a Garage Support

BY EMANUEL SILVA

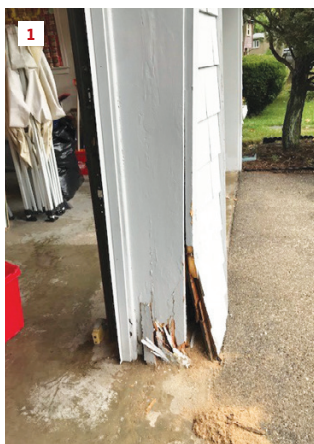
After being struck by a car, the garage support showed signs of internal rot as well as structural damage (1). The author peeled back the siding and sheathing to find that the support framing had been placed directly on top of an untreated 4x6 timber that had rotted (2). Before doing any more work on the support, the author propped up the continuous 6x12 header spanning the openings with a pair of house jacks (3).

Investigation. The first thing I noticed was that the siding and sheathing had separated from the bottom of the support (1). The boards on the side jambs of the garage door opening appeared to be rotted at the bottom. I tore back the sheathing and siding and saw that the support had been framed on top of an untreated 4x6 timber in direct contact with the ground (2). The aprons for each of the garage bays had then been poured around the support. The timber had totally rotted and the studs were well on their way.

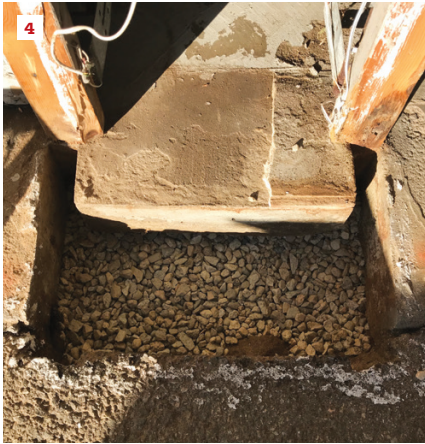
The author cleaned away the rotted wood, dug out the hole, and added a layer of crushed stone (4). He epoxied rebar into the garage slab as well as the aprons (5) before forming and pouring the concrete footing (6).

Pouring a footing. With the opening reinforced, I took out the rest of the rotted lumber and cleaned away the debris from the hole. To give the support a solid base and to raise it above the ground, I wanted to pour a concrete footing. I began by excavating down between the aprons, then added a layer of crushed stone on the bottom of the hole (4).

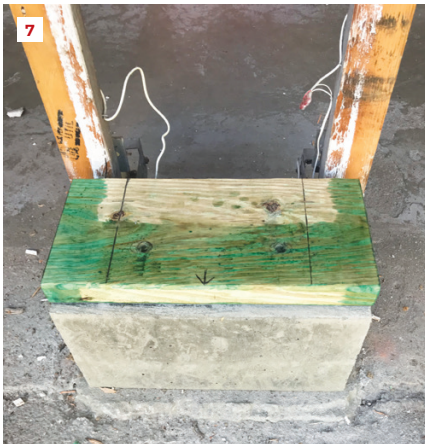
After letting the concrete cure, the author capped the footing with a treated 2x8 sill (7). He drilled and epoxied galvanized hold-downs into the concrete footing (8) and drove special lag screws to secure them to the bottoms of the new support studs (9).

Framing and hold-downs. Reframing the garage support started with a section of treated 2x8 that I tacked to the footing as a mudsill (7). The original support had a single 2x6 on either side, with additional 2x8s that acted as the finish surface for the openings. To create adequate support, I planned to use double 2x6s from the footing to the header on both sides of the support. I started by measuring and drawing a line 3 inches from each end of the sill.

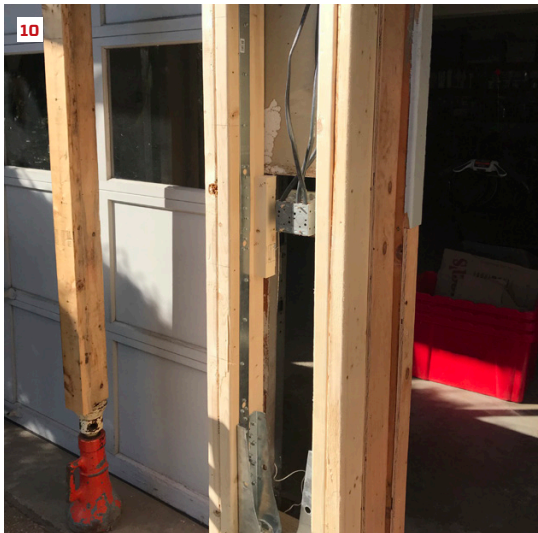
Flat straps attached with structural screws to the hold-downs and to the inside faces of the support studs reinforce the framing assembly (10). At the top, shorter straps reinforce the connection between the studs and the header (11).

bumper at the bottom of the support, but I worried that without reinforcement, the studs could crack in the middle or separate from the header at the top. So I installed 16-gauge SST HTP straps to strengthen the sides of the studs, attaching the straps to the hold-downs at the bottom and overlapping a couple of lengths to within an inch or so of the tops (10). These straps are screwed to the studs with the same SDS lag screws that I used to attach the studs to the hold-downs. SST HRS straps designed to be attached to the edges of 2-by stock reinforce the connection of the studs to the header (11).

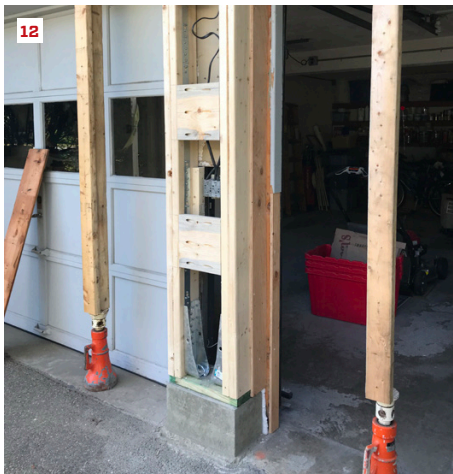
Solid 2-by blocks span between the studs on either side of the garage support to add rigidity (12). The treated sill had been kept back 1/2 inch from the face of the footing so the sheathing could be installed flush (13). The exterior of the support was finished with cedar shingles and PVC trim to match the house.

To finish the framing, I cut and installed solid blocking that I pocket-screwed to the double studs. To anchor the garage door

tracks, I screwed blocking between the support studs and the 2x4s holding the track (12). Then I nailed 1/2-inch plywood sheathing to the support framing (13).
