BY DAVE COYNE

## What a Long, Strange Drip It's Been

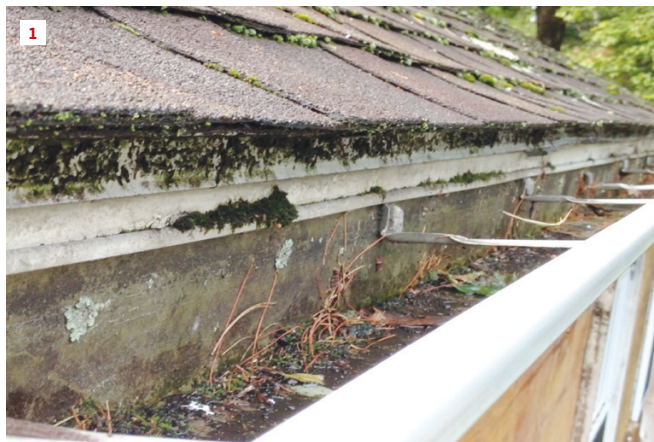
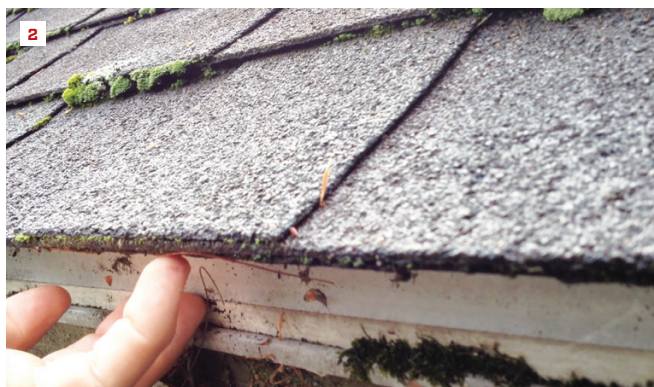
Drip edge installed tight to the fascia was directing water behind the gutters (1, 2), causing saturation and major damage in the house walls (3). To fix the problem, the author first had to strip away and replace the siding and sheathing.

What we found when we inspected the roof was not a roof leak. Instead, the trouble had begun with the installation of the drip edge and gutters. One simple oversight started the entire problem: The drip edge was applied too tight to the fascia trim. I couldn't even fit a fingernail between the drip edge and the fascia board. That meant that the water would run straight down off the roof, wrap around the drip edge and onto the coil-wrapped fascia, and run down behind the gutter instead of falling into the gutter where it was supposed to go.

In this case, our scope of work didn't include reroofing or replacing the drip edge. We did go around the house and pull and bend the lower edge of the drip edge away from the fascia as much as the material would allow, to facilitate dripping into the gutter instead of behind it.

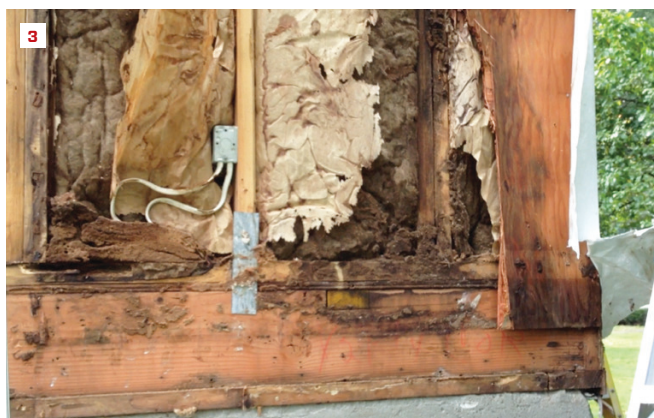
Water soaked the sheathing. Over the years, the water rotted the sheathing in multiple places. When we removed the sheathing, we found rot around all the windows below the eaves, and some even on the gable-end windows. Housewrap on the walls stopped short of the windows, and wasn't integrated into any kind of tape or flashing. The window trim was installed in a way that let water penetrate to the sheathing and the window openings.

But our main project was to remove all the siding and sheathing, repair rot (including reframing windows), replace the bug- and mold-infested insulation, resheath the building, construct a working drainage plane, and flash all the windows correctly into the housewrap.
