FOUNDATIONS

A Partial Foundation Retrofit Save what's solid and replace what's not

BY JAKE LEWANDOWSKI

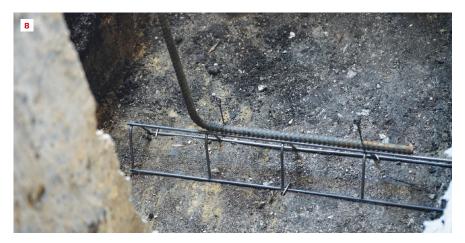
The new footing was reinforced with 1/2-inch rebar, which was tied to chairs pinned to the base of the footing trenches (8). The rebar in the footing was wired together with vertical rebar that extended up through holes in the existing sill plates (which would later be replaced), tying the footing to the concrete-block replacement foundation (9).

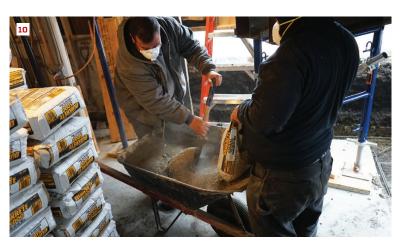
With limited space and limited exterior access, the crew had to mix all the concrete by hand (10). Each batch was dumped into the trench until the footing was level with the basement floor (11). To remove air bubbles and create the densest concrete for the footing, the crew vibrated the wet concrete (12). Vibration not only consolidated the concrete but also made the mix more liquid, which made it easier for the crew to smooth the wet concrete surface of the footing with a float (13).

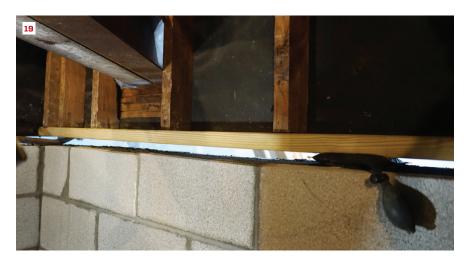
With the block wall finished, the crew replaced the old sills with new treated sill stock (19). Using inflatable shims and heavyduty pry bars to hold the new plates tight against the bottoms of the existing studs for fastening, the crew then drove galvanized toe screws through each stud and into the sills to secure the sills to the studs (20).

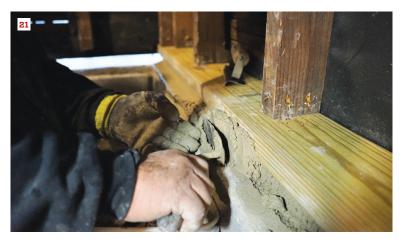
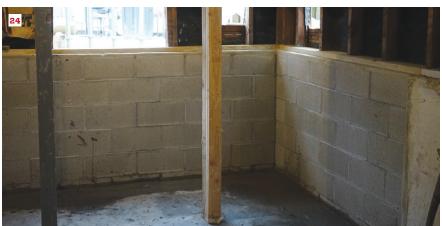
The crew filled the gap between the block foundation and the sills with high-strength non-shrink grout, forcing it under the sill from the inside (21) and outside (22) with a margin trowel. They used an edging trowel to smooth the grout along the top of the foundation and to smooth the seam between the existing foundation and the new block foundation (23). After allowing the grout to cure, the crew removed the needle beams, leaving the corner of the house fully supported by the new foundation (24). The crew anchored the sill to the new foundation with Simpson Titen bolts (25), then removed the temporary LVL supports (26).

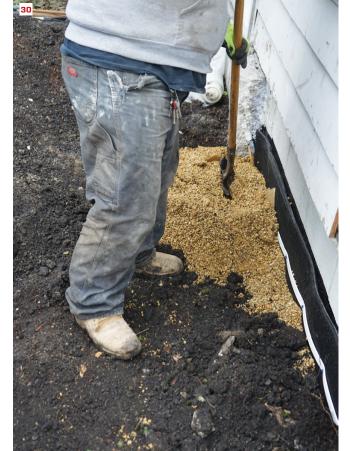
To finish the exterior of the new foundation, the crew applied waterproofing to the block, after first masking off the part of the block wall that would extend above grade (27). Removing the tape left a clean line on the block (28). Then they secured drainage mat to the block with concrete fasteners (29) and backfilled with pea gravel to provide additional drainage next to the mat (30). Once the topsoil was in place, the only remaining task was repairing the beam holes in the siding (31).
