## Lessons From Restoring a Fire-Damaged Home

BY TUCKER FOSSIANO

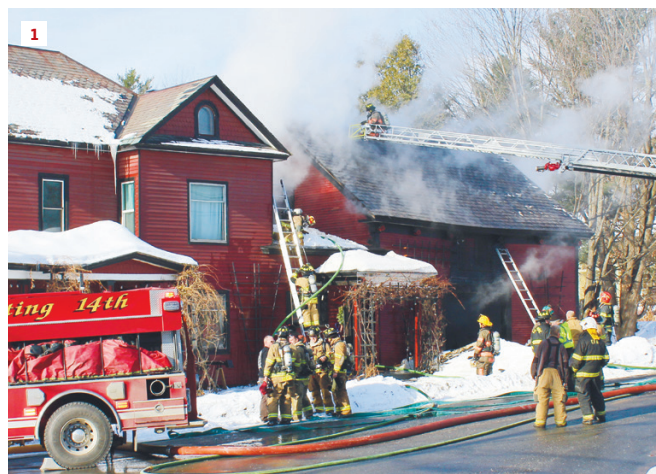
The fire started in an attached carriage barn (1), destroying stored family belongings (2). Abutting the barn, a butler's pantry was severely damaged as well (3). Smoke found its way into the main home via wall framing cavities (4).

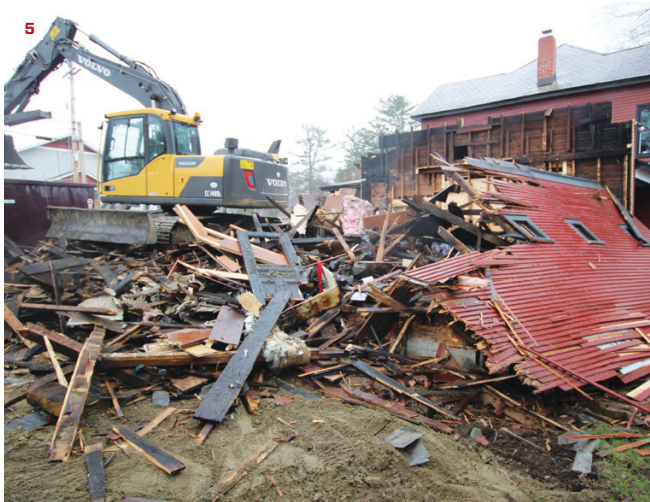
The demo work was completed within a week, with an excavator doing the bulk of the work in one morning (5). After gutting the home's one-story connector and sealing the framing with primer (6), the crew poured a new garage foundation.

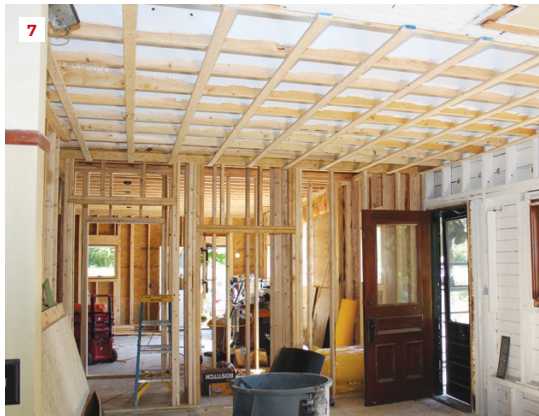
The existing ceiling and hardwood floors were removed in the connector's kitchen area. Wall, ceiling, and roof framing was primed and left "open" for three months to air out (7). The first-floor framing in the connector was primed approximately 8 feet back from the abutting fire-damaged barn location (8). In the main house, plaster, lath, and insulation from the walls facing the fire-damaged barn were removed. Here, the existing framing is primed in a second-story bathroom (9). Cabinets are being installed in the new kitchen (10).

**Smoke mitigation.** Priming the existing framing was pretty much the extent of our smoke-mitigation work. We left it open as long as possible to air it out, periodically sniff-testing the sealed framing at various temperatures and humidity levels. We primed the worst smoke-damaged areas with three coats of Bin Advanced Synthetic Shellac Sealer and spot-primed where we smelled hints of smoke. We then drywalled at the end of summer.
