Repairing a Bungalow Balcony A beam replacement project with a Storybook ending

BY GERRET WIKOFF

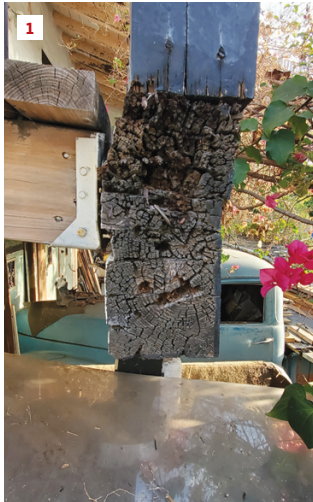
Over time, the replacement glulam beam had rotted to the point where the top half started to curl away from the house (1), causing a "hinge joint" to open up between the top of the posts and the decorative wood capitals original to the home's 1929 construction (2). The wood capitals were toenailed to the posts and to an existing—and still sound—6x8 beam, which supported the rafters.

Installed in the 1970s, the existing glulam had rotated outward due to rot (1), causing a “hinge joint” to open up between the top of the posts and the decorative wood capitals (2). A 30-ton jack was used to separate the beam from its saddle-bracket connector (3).

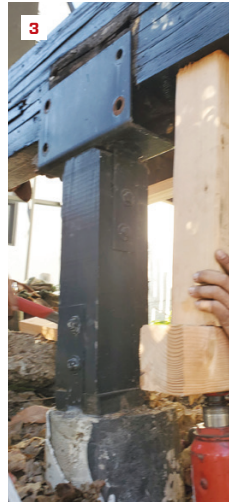
existing 6x6 hangers connecting the joists to the glulam and began to jack the balcony and roof back to level, unbolting the two post saddles at each end of the glulam and using a 30-ton jack to raise the balcony and roof up 2-plus inches (3). We installed temporary posts, then removed two of the outer decking planks to make room for shoring and moved on to supporting the roof.

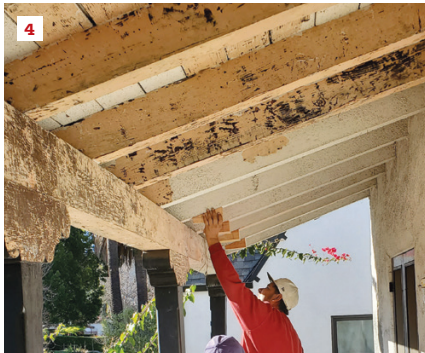
To provide level bearing for a temporary shoring to support the clay tile roof, sloped blocking was nailed into place (4). To remove the existing posts, workers cut the toenailed connection between the beam and the decorative capitals (5). The existing glulam was cut into sections prior to removal (6).

Supporting the roof. Rather than posting up each rafter, we ripped some 4x10 beam offcuts into wedges cut at an angle to match the roof slope. We nailed them to the bottom of the 4x6 rafters to create a level bearing surface for two temporary 12-foot-long 4x6 beams run perpendicular to the rafters (4). Then we nailed the two temporary beams to the wedges. Six steel shoring posts, run from grade to the underside of the 4x6s, were installed to support the roof. Then we used a reciprocating saw to cut the toenails holding the existing wood capitals and 6x6 posts in place and removed them (5). We had planned to reinstall the capitals per HPOZ requirements, but they were too rotted to salvage.

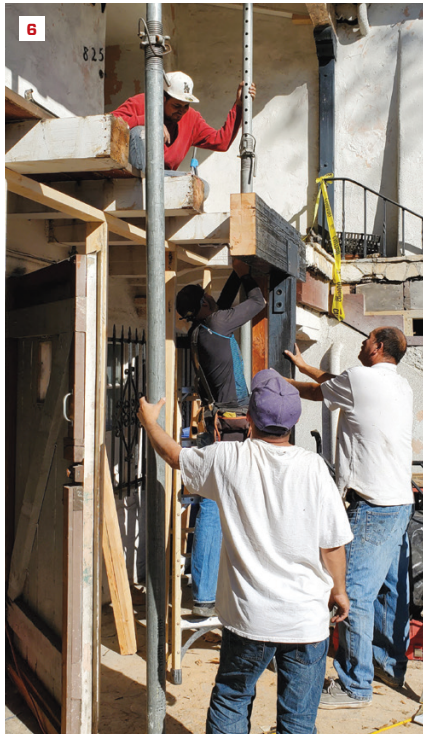
Beam. We cut the existing 6x12 glulam into pieces (6) and placed the beam saddles aside. Next, we installed the two new 6x6 posts, attaching the bottom of the posts to the metal connectors embedded in the existing pier footings. We reinstalled the old beam saddles on the top of the posts, ready to receive the new beam, which we lifted into place and fastened to the saddles.

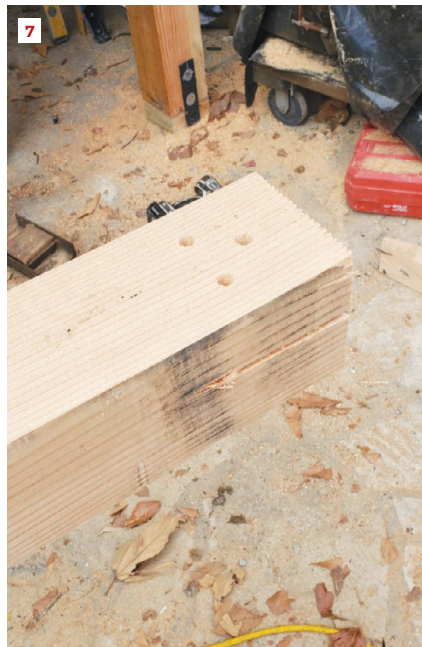
The new balcony-level 6x6 posts were slotted and bored to receive concealed post tie connectors (7). After the new 24-foot-long glulam was set in the beam saddles (8) and the posts installed, they were chamfered to match the original beams.

At the balcony level, we wanted the four new posts supporting the roof to look as original as possible, so we used Simpson Strong-Tie CPTZ concealed post ties to connect the post tops and bottoms to the beams. Using a beam saw, we sliced the posts to receive the concealed hardware, taking multiple passes to widen the kerfs so that the fins would fit. Then it was a matter of drilling three 1/2-inch holes for the pins (7).

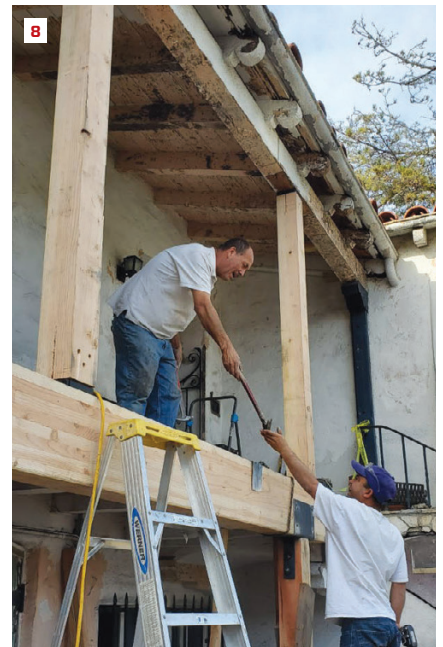
We lag-screwed the base plates of the fasteners to the upper and lower beams, installed their cover plates, and slid the posts into their future home, sometimes with a little persuasion from a single jack hammer. Once the pins were driven into place, we disassembled the shoring jacks, took down the temporary 4x6 beams, and removed the wedges (8). All in all, that was eight hours of work for the six of us.

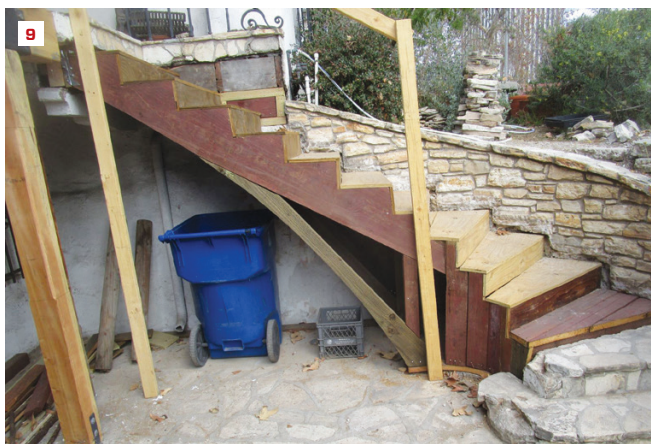
The new stairs were built with pressure-treated 2-by stock and PT plywood with compatible screws (9). Then the framing was sealed with a liquid-applied waterproofing and crack-prevention membrane (10).

We were required to match the new staircase as closely as possible to the original, which included reusing the wrought-iron rails and flagstone veneer. For the new stair carriage, we installed four pressure-treated 2x14 stringers for the straight run of stairs. To make the radius turn for the winder, we framed a series of platforms using PT material. We built a short wall midspan to cancel out any flex, then sheathed the treads and risers with 3/4-inch PT plywood (9).

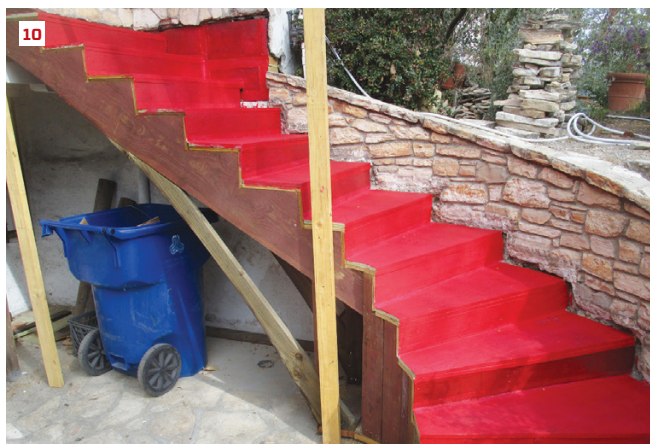
The masonry sub wanted a second layer of plywood at the treads to make sure they wouldn't flex. Also, he suggested coating the stairs with a liquid-applied waterproofing and crack-prevention membrane by Red Guard (custombuildingproducts.com). He applied the membrane with a 3-inch paint roller, in two coats, then let it cure over the weekend (10). The following Monday, he applied thinset over the Red Guard on the treads and risers, then set the salvaged stone he was able to save, and new similar flagstone, on a layer of mortar troweled over the thinset.

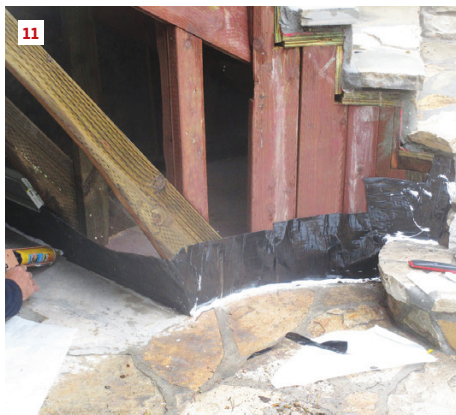
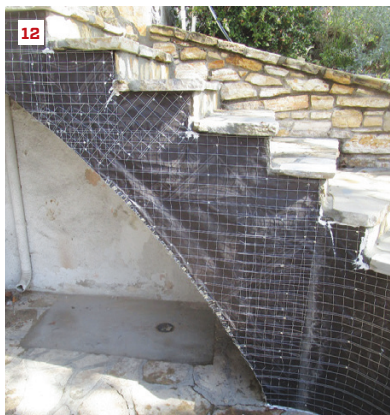
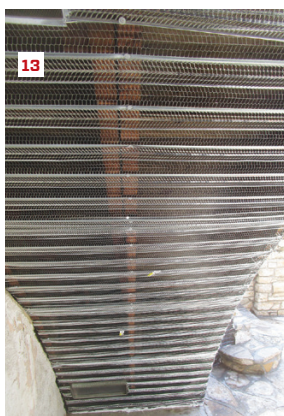
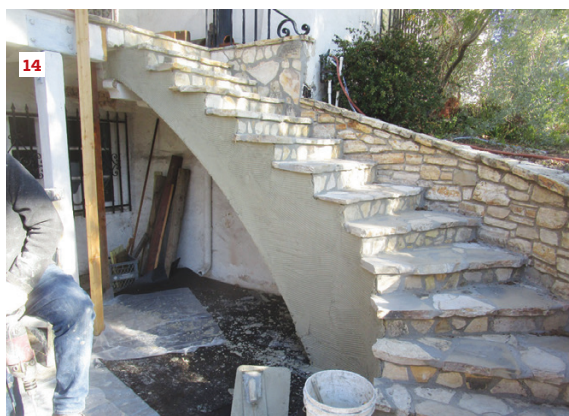
To prevent water intrusion, flashing that runs up the framing was sealed to the masonry (11). Then the stairs were papered and lathed with stucco wire on the stringers (12) and with rib lath underneath (13) prior to the application of a traditional two-coat stucco finish (14).

On the staircase walls, the stucco sub installed a membrane base flashing, which ran up the framing and was sealed to the masonry to prevent water intrusion (11). The side walls were black-papered and lathed with stucco wire (12), while the underside of the stairs was lathed with rib lath (13). Conforming to 1920s construction, a traditional two-coat stucco finish consisting of a scratch and brown coat was applied (14); the brown coat was later painted (15).

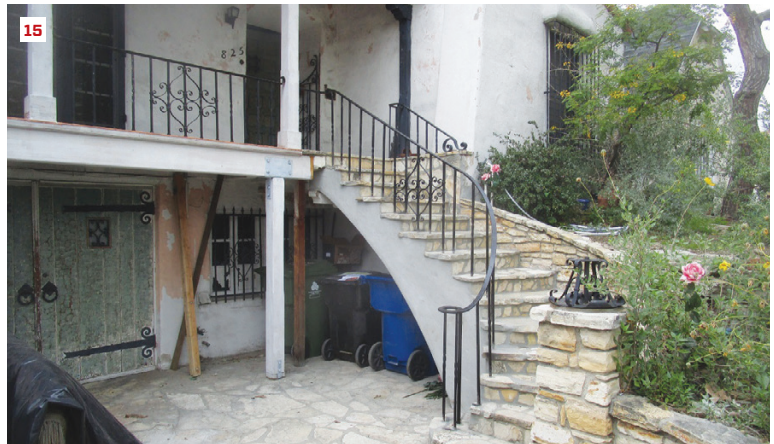
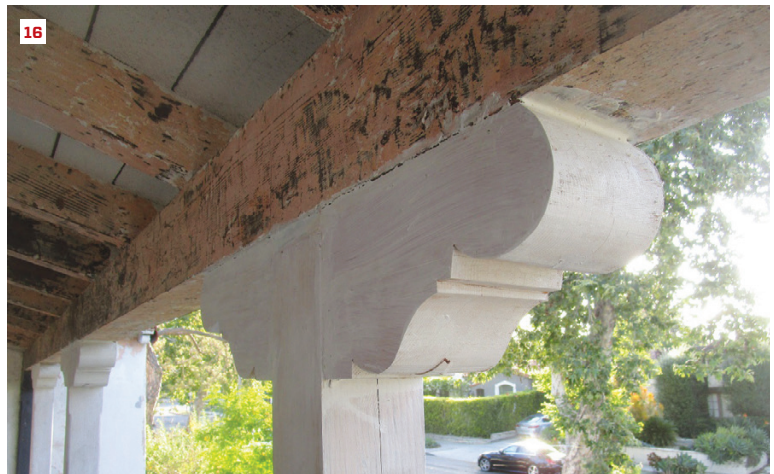
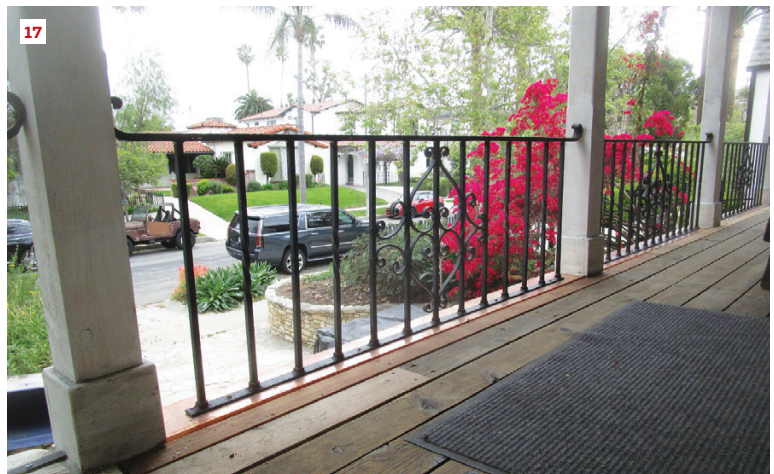
Finishing up. Some of the original decorative capitals were unsalvageable. Also, to avoid re-creating a hinge joint, I had new capitals matching the existing made by a mill my lumberyard uses and fastened them on either side of the new posts with Timberlok screws (16).

To reinstall the wrought-iron railings, which originally had been assembled with screws that had since rusted, we had to weld the railings back together. In addition, the balusters had been individually screwed down to the glulam, which created a passage at each picket for water intrusion. Instead, our welder fabricated a new hammered steel plate for a bottom rail and welded the balusters to it, which reduced the number of screw holes per handrail section down to three. This choice was to make the new piece more period correct.

We installed a copper cap on top of the new glulam beam to keep water from soaking into it and rotting it out a second time. To avoid the possibility of galvanic corrosion, we placed peel-and-stick flashing (protecto wrap.com) between the new steel bottom rail and the copper flashing (17).

Wrought-iron railings are reinstalled (15) and new capitals are installed on either side of the new posts (16). A copper cap is installed on top of a new glulam beam to prevent water from soaking into it (17).
