# Replacing a Failed Ridge Beam

BY JAKE LEWANDOWSKI

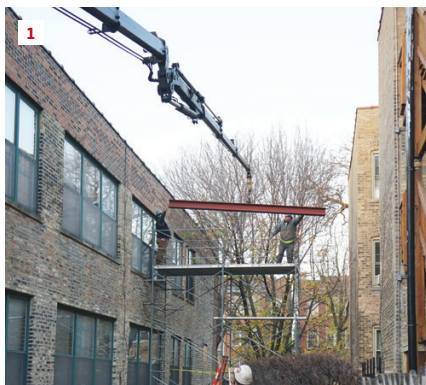
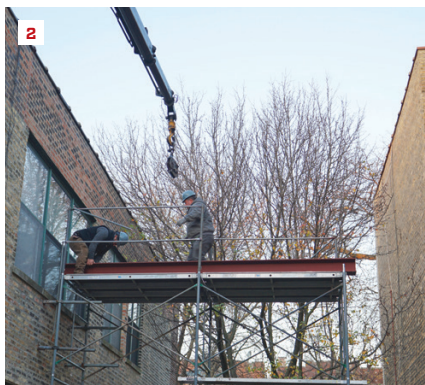
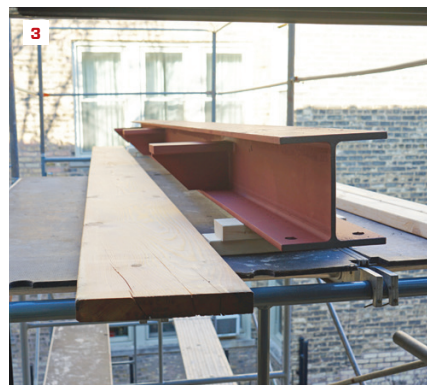
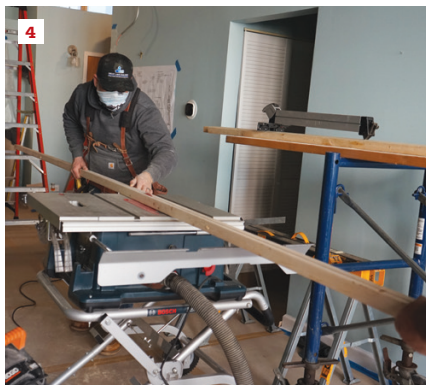
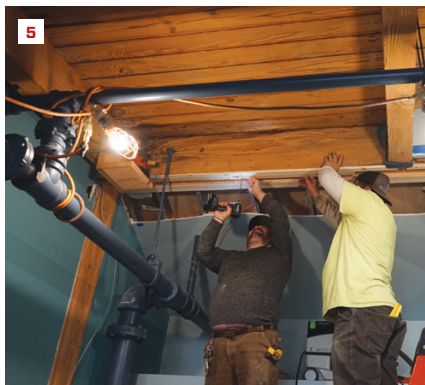
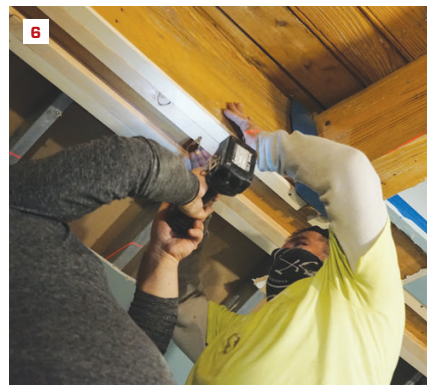
The author's crew set up scaffolding and craned the replacement beam onto the top lift (1), positioning it in front of a window (2). Note the gusseted flanges on the left side of the beam; these were added to support the purlins (3). Once the demo crew had cleared the site, the author set up shop and began ripping leveling strips (4), which his crew screwed to the bottom of the failed beam (5, 6). These strips would provide a level surface against which they could place the new steel beam.

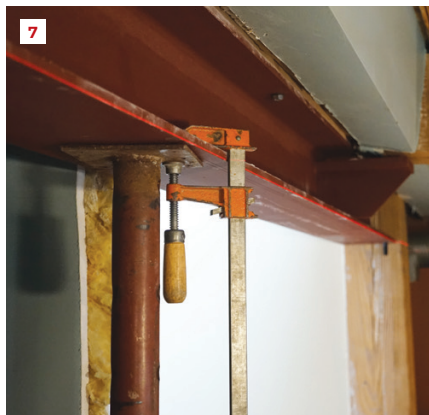
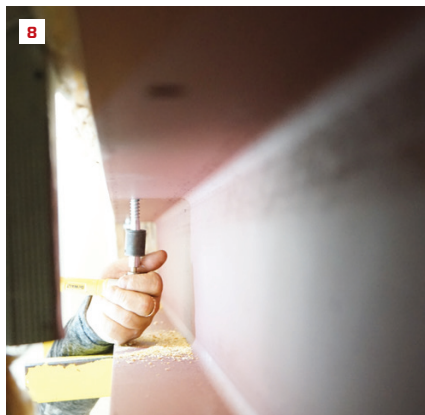
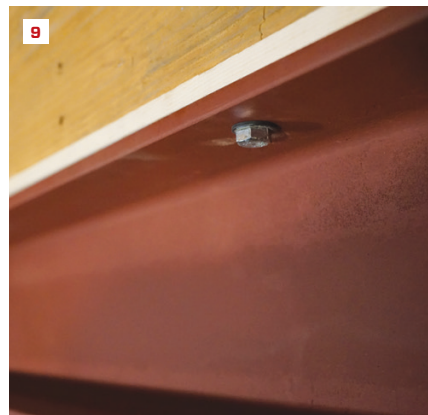
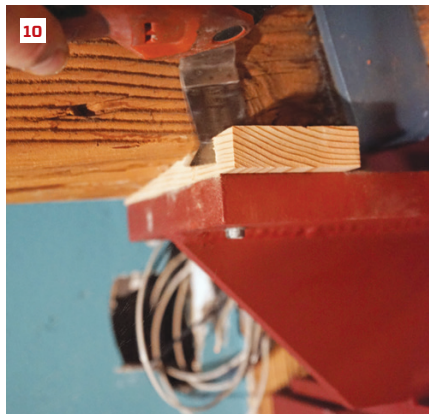
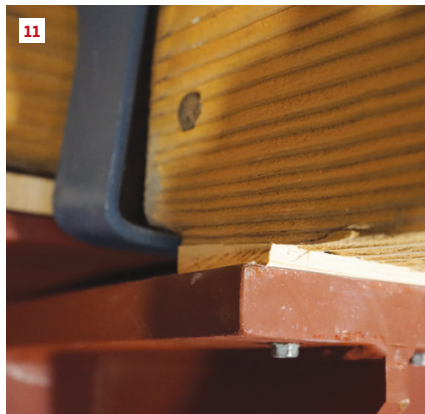
Once the beam was positioned and checked for level with a line laser, the crew set up post shoring for temporary support (7). The crew installed lags through the top beam flange (8, 9) to secure the beam's position. The primary load would come from end brackets (see photos on next page). Before the end brackets could be installed, the gusseted brackets on the steel beam had to be shimmed (10, 11). Since the purlins were at varying elevations and angles relative to the steel beam, these shims were cut at compound angles.

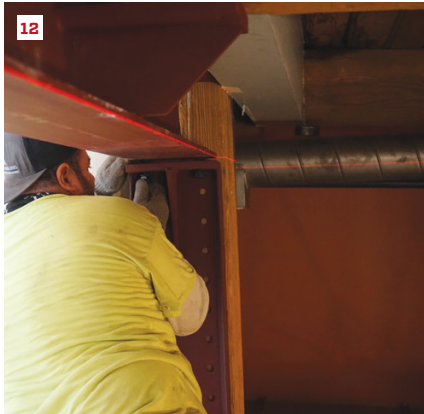
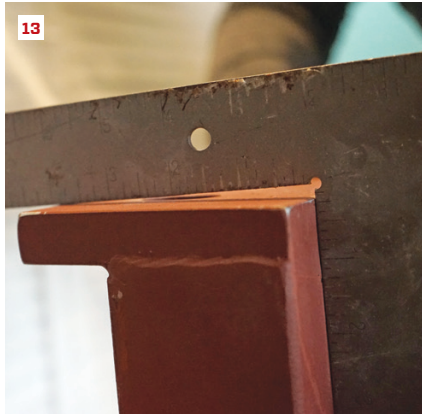
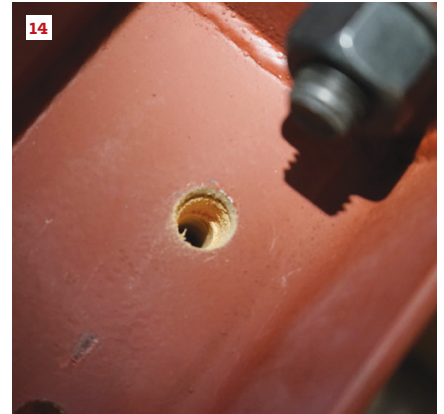
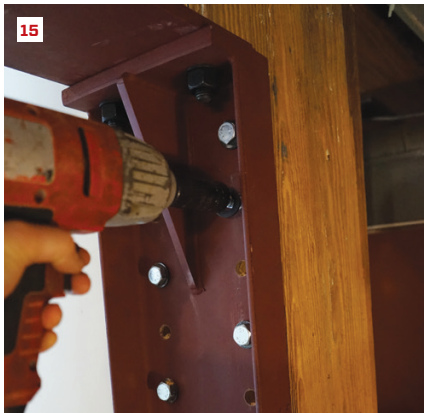
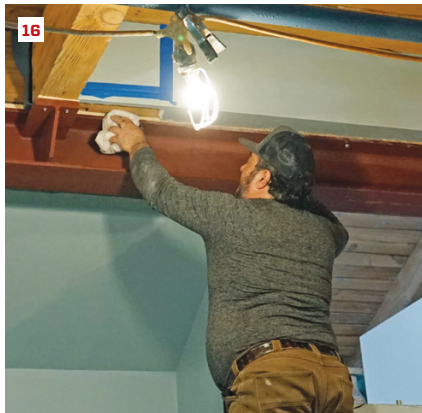
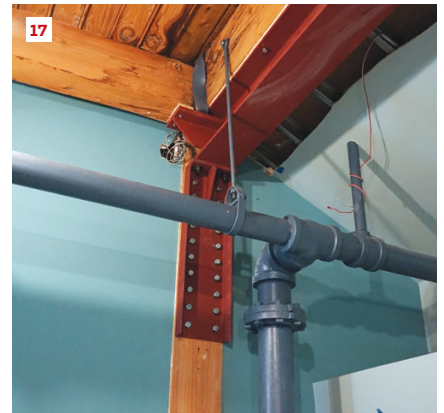
With the beam secured, a crew member lifted one end bracket into position (12). Note how the bracket was purposefully fabricated out-of-square to accommodate the out-of-plumb column (13). Each bracket required 20 lag screws, and each hole for the lag screws was predrilled using two different drill bits—one sized for the threaded shank and one for the shoulder of the lag (14). The crew alternated holes when driving the lags (15). As a final step, the beam was wiped clean (16, 17).

Each bracket was fabricated slightly differently to align with the existing columns, one of which was slightly out of plumb. As shown in photo 13 above, the top bearing flange on this bracket

was purposefully fabricated out-of-square to accommodate the out-of-plumb column. (This underscores how critical it is to get proper field measurements of existing structures. Good measurements make for accurate shop drawings, which make tricky jobs go much smoother, in my experience.)

We installed the brackets with lag screws, using a two-step predrill—one bit for the diameter of the shank in the threaded section, and another for the diameter of the shoulder section. When installing these lags, we alternated holes to draw the bracket in uniformly.
